HISTORIC ARCHITECTURAL RESOURCE SURVEY FOR THE PROPOSED DEVELOPMENT NEAR THE SHELBYVILLE MUNICIPAL AIRPORT, BEDFORD COUNTY, TENNESSEE

Cultural Resource Analysts, Inc.
119 West Summit Hill Drive
Knoxville, Tennessee 37902
CRA Project No.: T240252

September 2024

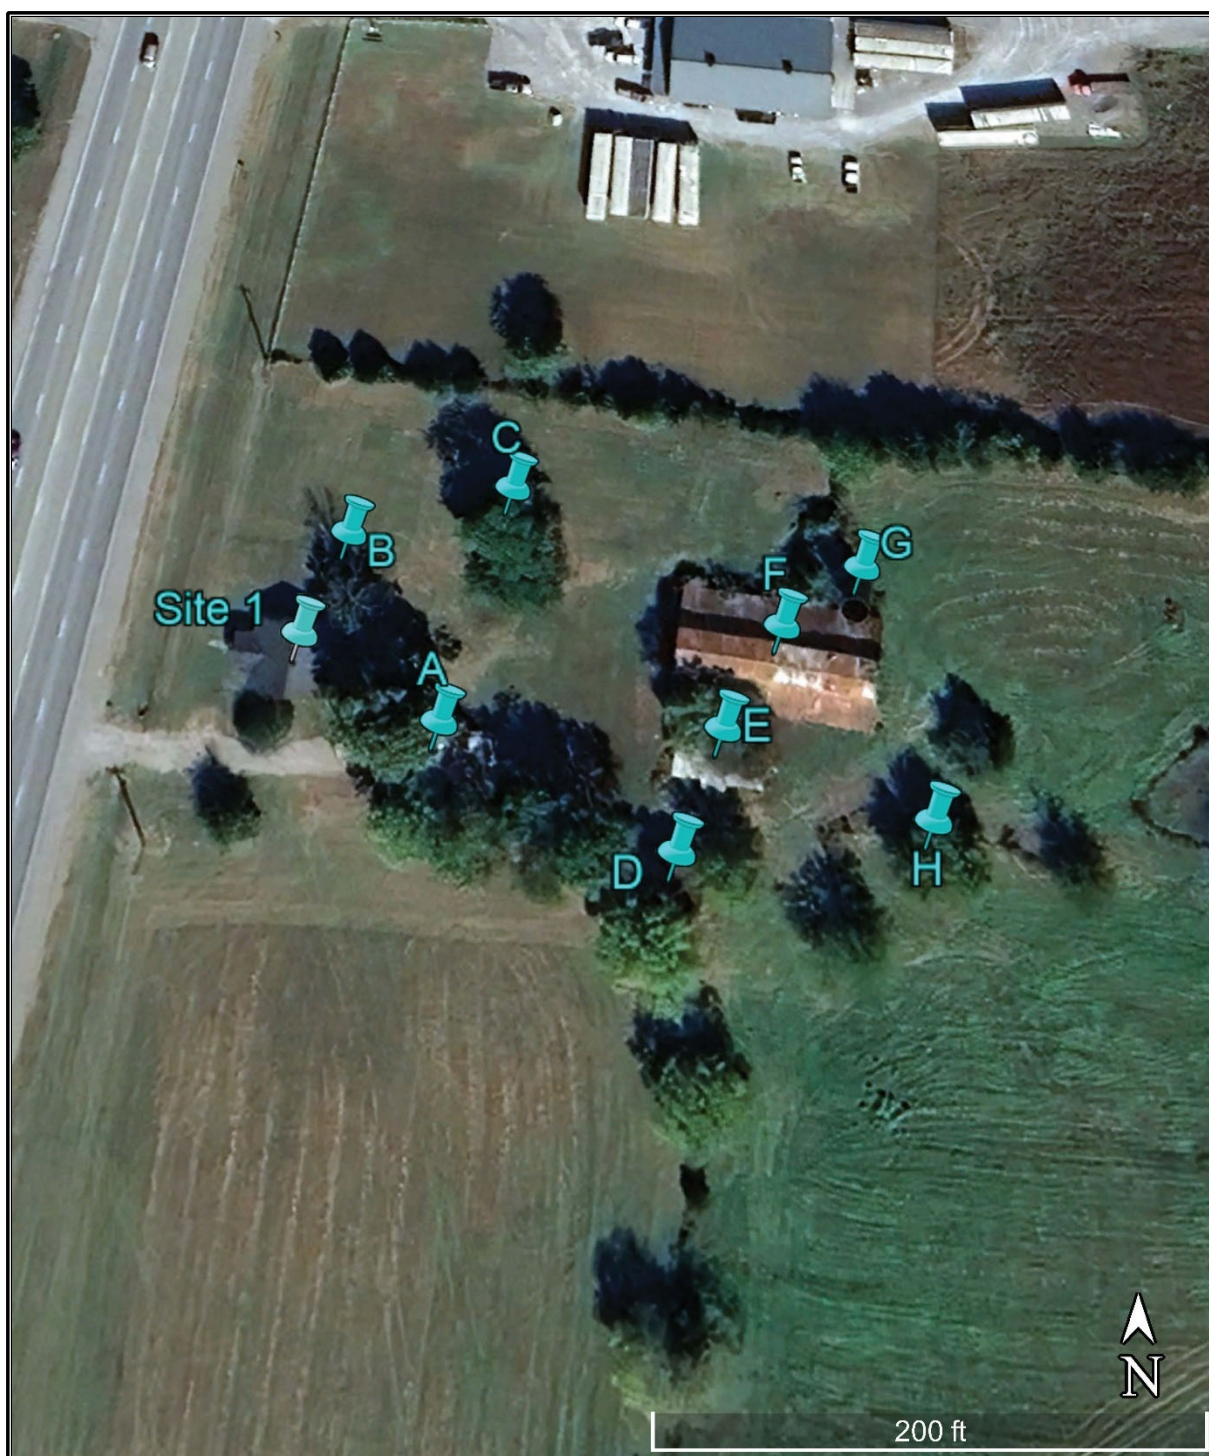
Figure 7. SP 1: Aerial photograph depicting the locations of surveyed resources.

Description: SP 1 consists of a residence, a store, and multiple outbuildings, located at 2778 US 231 N (Figure 7). The buildings are situated within an approximately 42-acre parcel east of US231 N, and south and west of the Shelbyville Municipal Airport. The residence is located approximately 50 ft from the ROW.

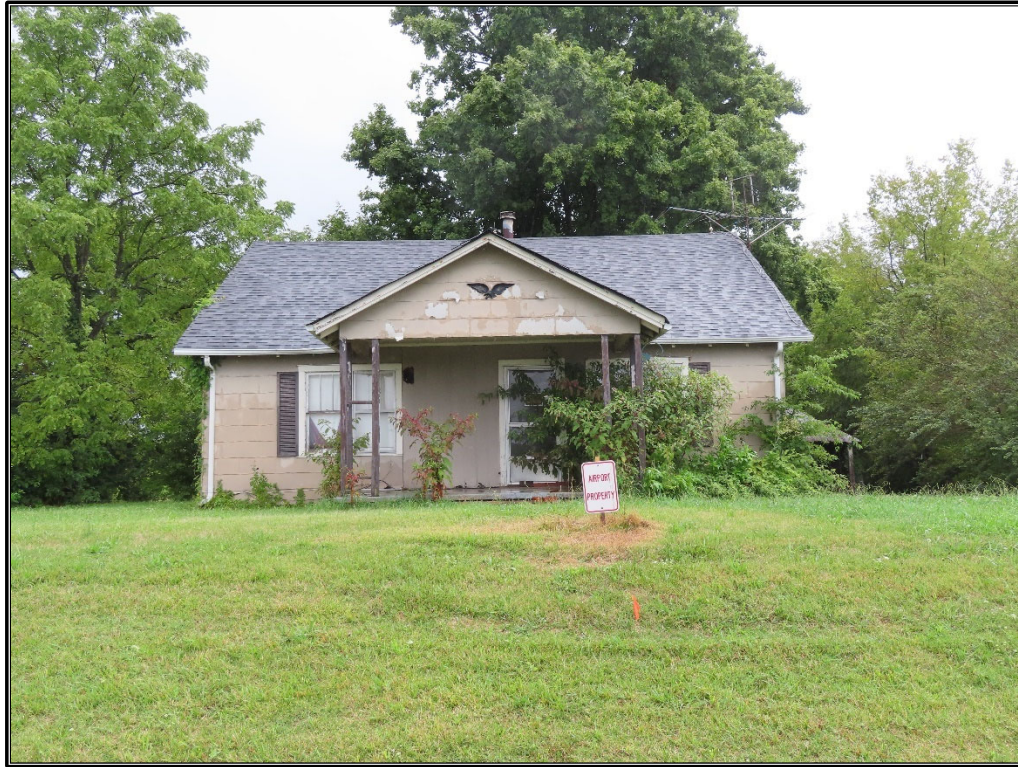
Oriented west, the residence at SP 1 is a one-and-one-half-story, three-bay (ww/d/ww), side-gable dwelling (Figure 8). It is set on a rusticated concrete-block foundation, is clad in asbestos siding, and rests beneath a roof sheathed in asphalt shingles. Piercing the roof ridgeline is a cylindrical metal vent pipe, which likely replaced a chimney. Windows exhibit original three-over-one, double-hung wood sashes. The façade is characterized by an off-center single-leaf entry filled with a wood door that opens onto a partial-width porch sheltered by a prominent front gable supported by wood posts set on a concrete deck. The entry is flanked by double window bays. The south elevation of the residence is pierced by three single window bays and a double window bay on the first floor, and one single window bay at the one-half story (Figure 9). The north elevation is pierced by four single window bays on the first floor and a single window bay at the one-half story (Figure 10). The east (rear) elevation is pierced by a single window bay and single leaf entry filled with an original three-light wood door; the entry opens onto a partial-width porch sheltered by a modern shed roof supported by metal posts set on a concrete deck (Figure 11). To the right of the porch is a sheltered area that is partially enclosed.

Figure 8. SP 1: Façade (west) elevation of residence, looking east.

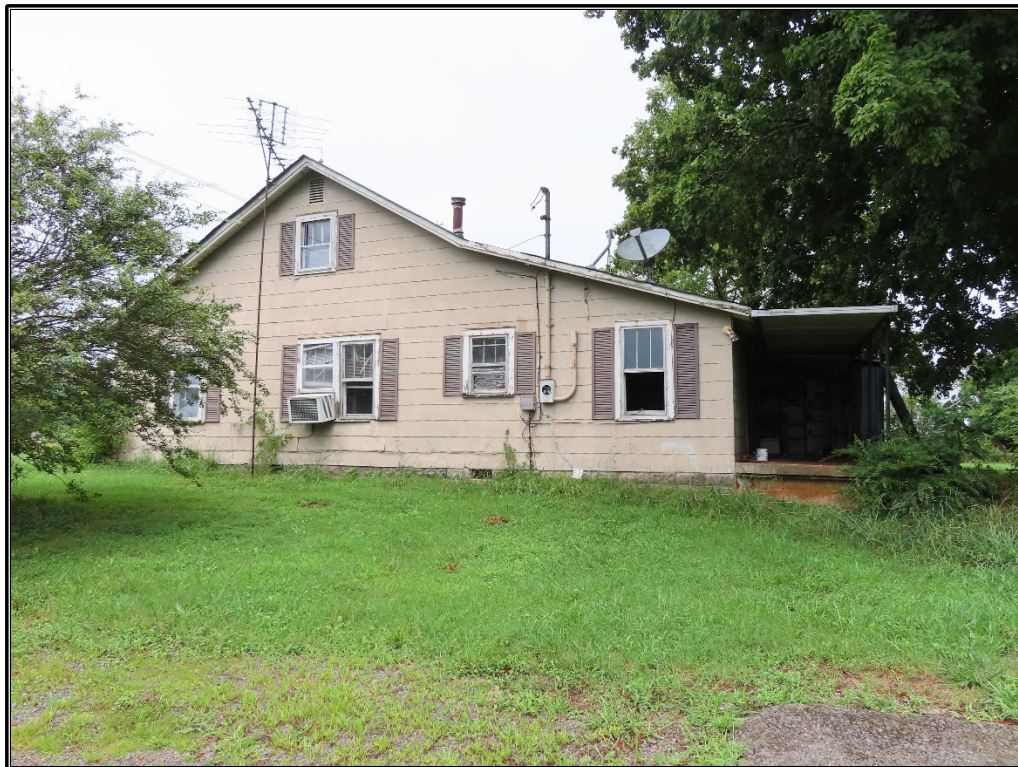
Figure 9. SP 1: South elevation of residence, looking north.

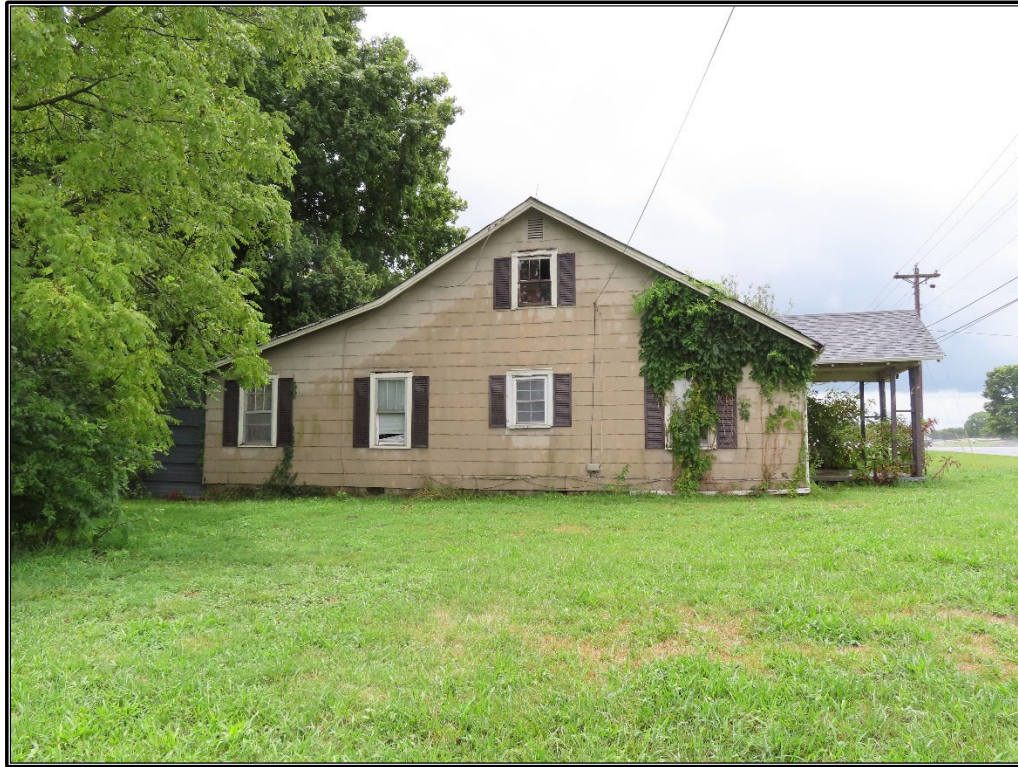
Figure 10. SP 1: North elevation of residence, looking south.

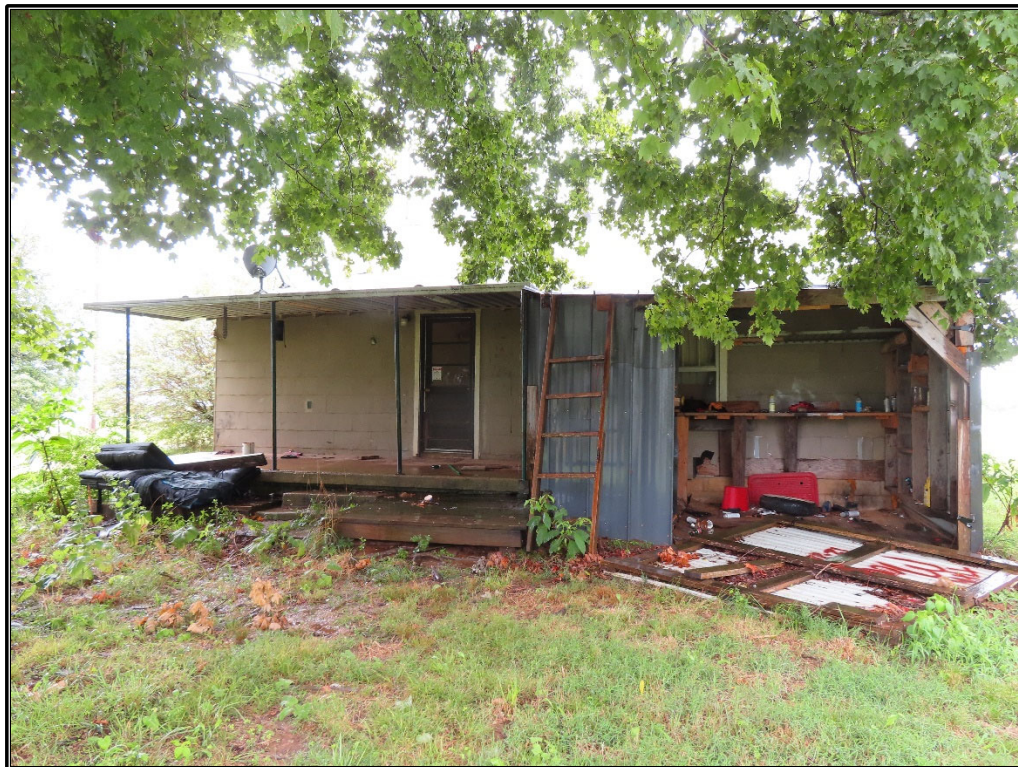
Figure 11. SP 1: East (rear) elevation of residence, looking west.

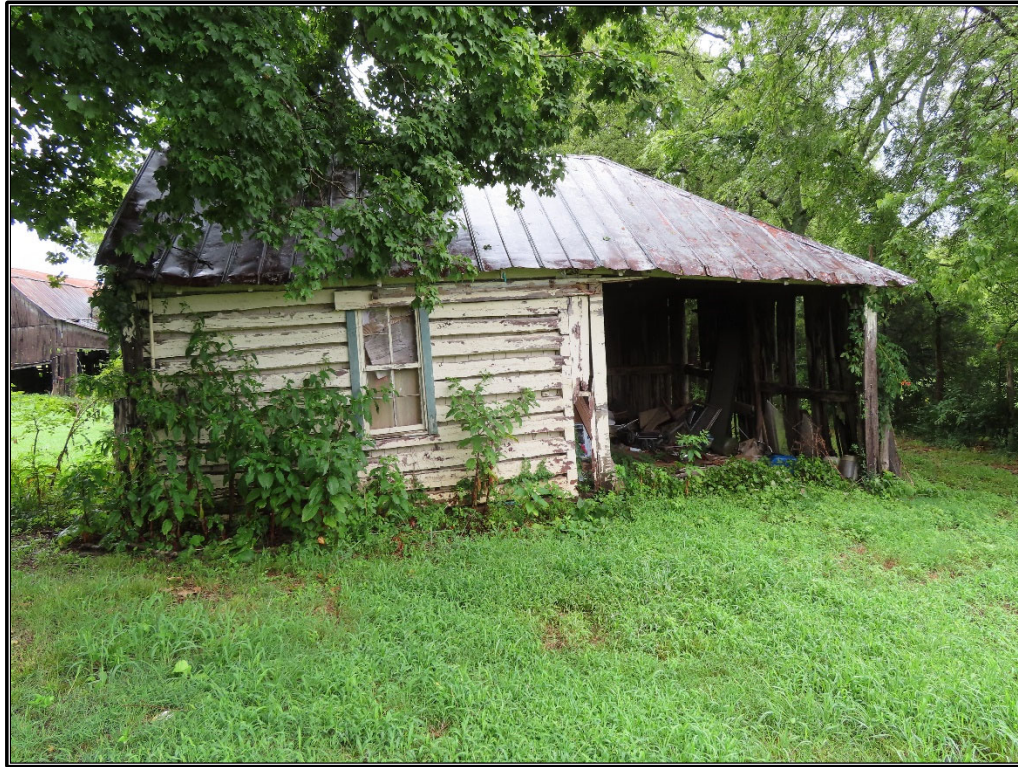
Figure 12. SP 1: Façade (west) elevation of store (Resource A), looking east.

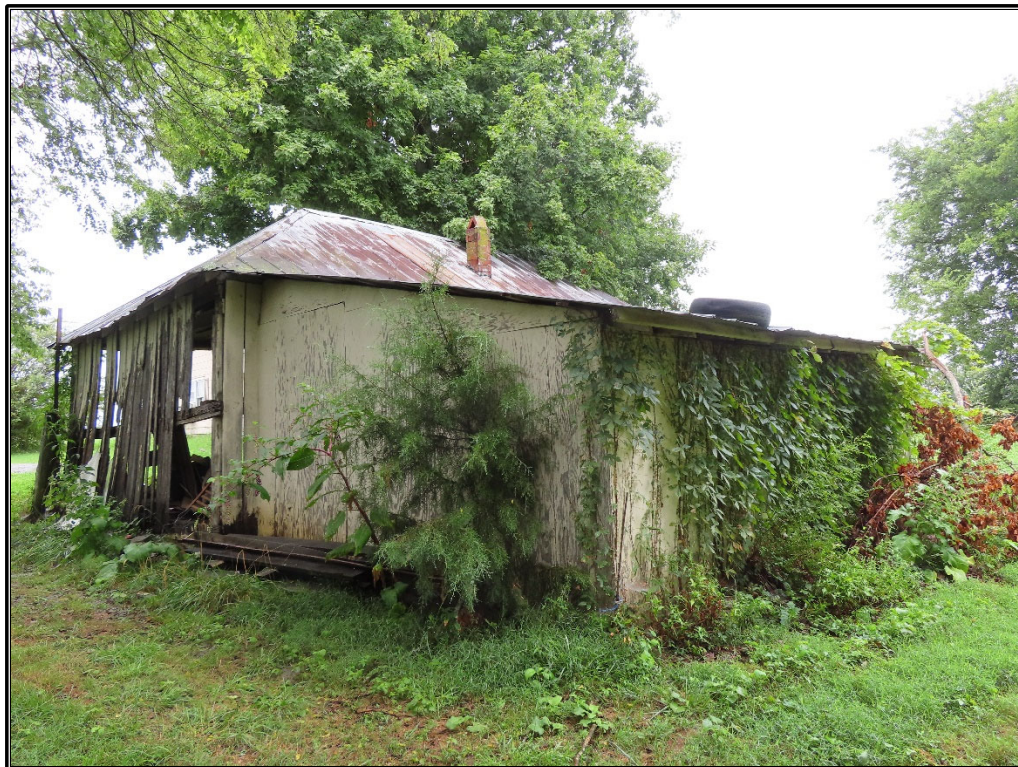
Figure 13. SP 1: South and east elevations of store (Resource A), looking northwest.

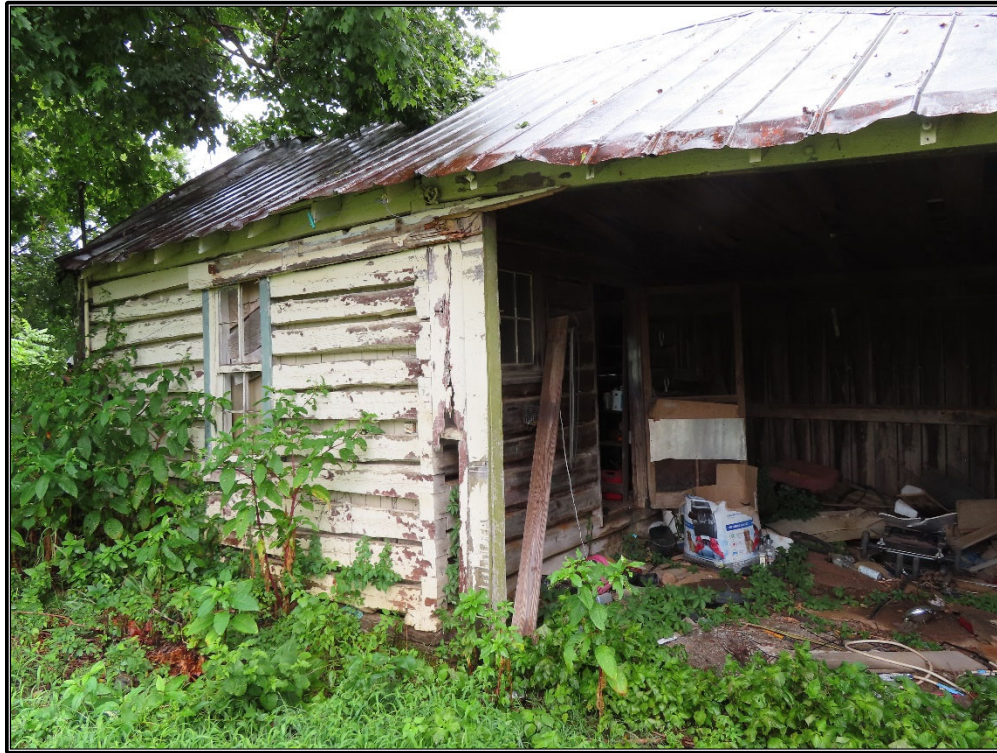
Figure 14. SP 1: Façade (west) and south elevations of store (Resource A) showing current main entry, looking northeast.

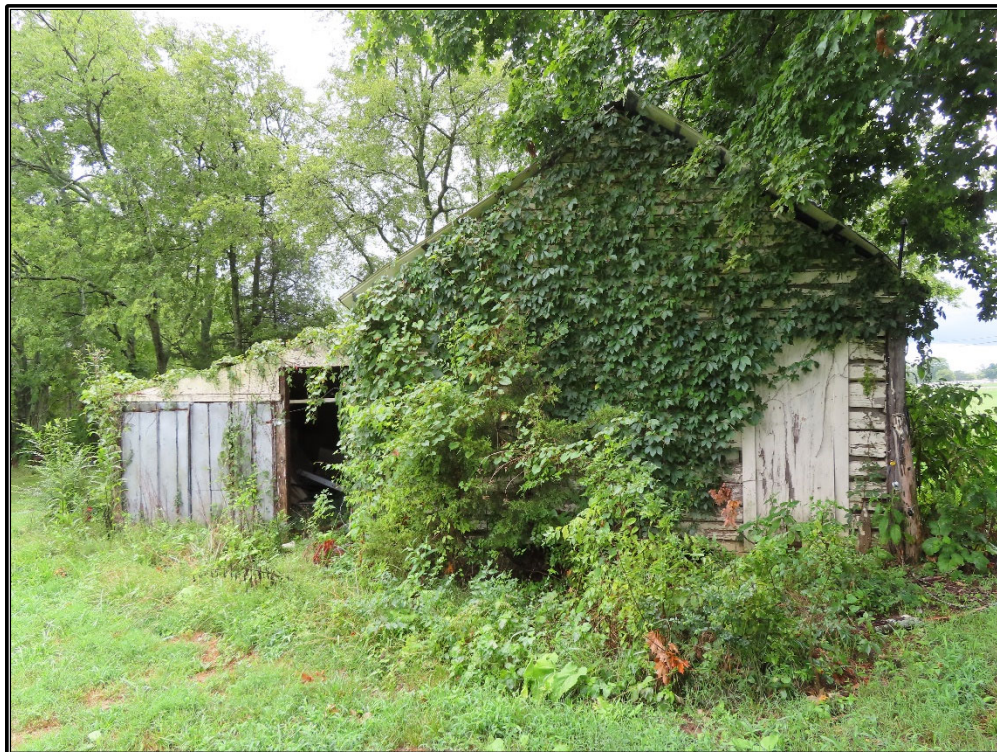
Figure 15. SP 1: North elevation of store (Resource A), looking south. Entry at right might have previously functioned as the main entry when the building was in its original location near the highway.

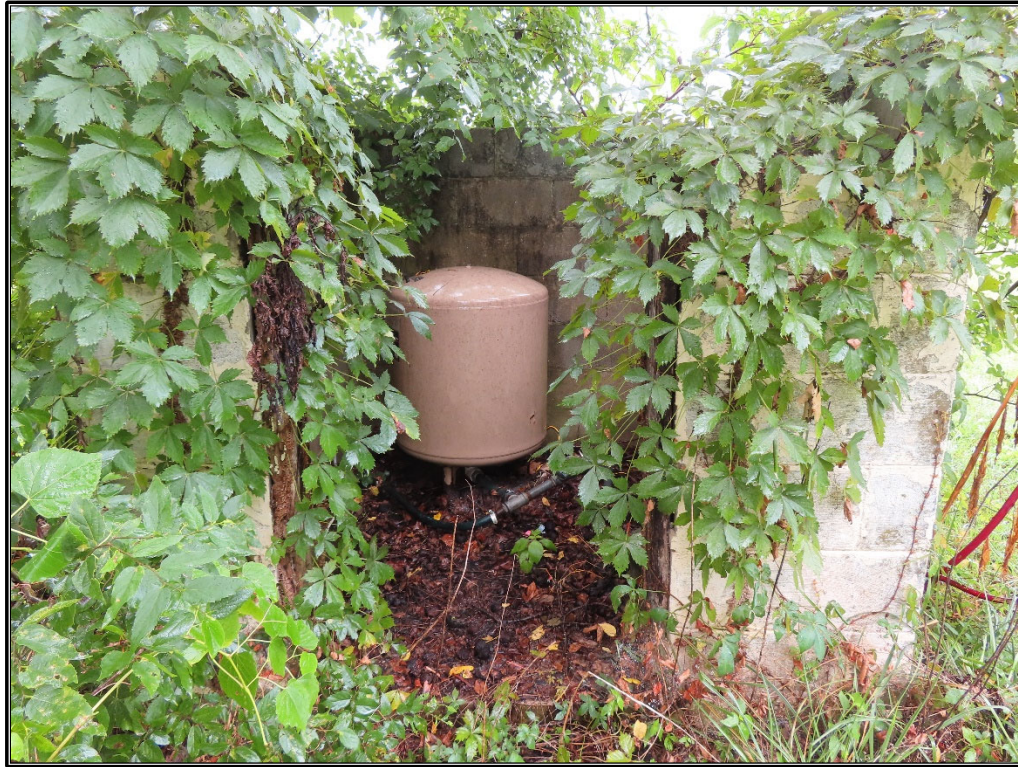
Located approximately 30 ft north of the residence is a small pump house (Resource B) (Figure 16). The pump house has concrete-block walls and is missing its roof. The pump house seems to be visible in a 1958 aerial photograph. Based on map evidence, form, and materials, the pump house likely dates to the mid-twentieth century. Behind the house there is evidence of a well, which likely supplied water to the house in the early twentieth century, prior to installation of the pump house.

Figure 16. SP 1: East elevation of pump house (Resource B), looking west.

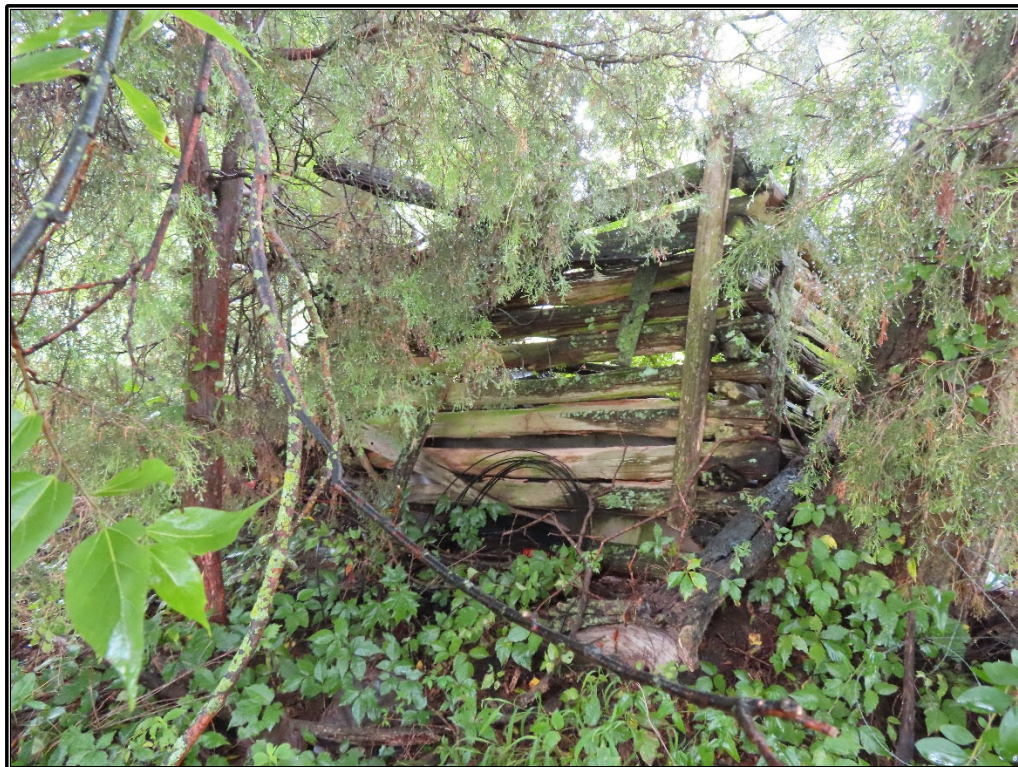
Located approximately 75 ft northeast of the residence is a one-story log corn crib that has partially collapsed (Resource C) (Figure 17). Based on form and materials, the crib likely dates to the early twentieth century.

Figure 17. SP 1: East and north elevations of corn crib (Resource C), looking southwest.

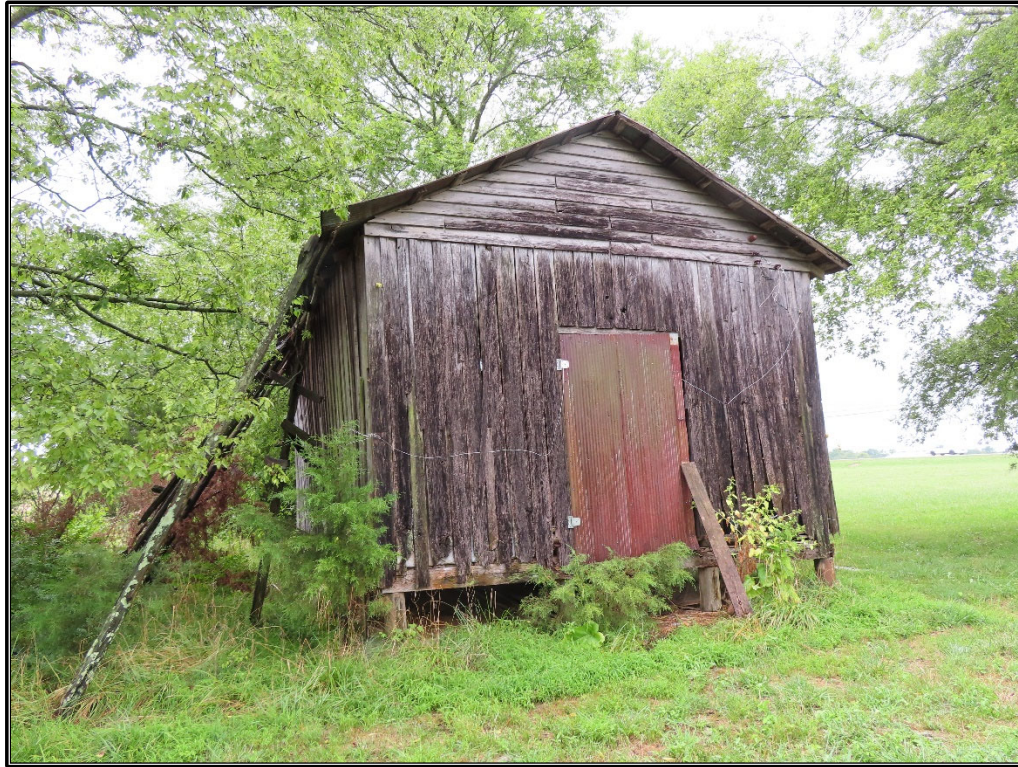
Located approximately 140 ft southeast of the residence is a one-story granary or seed-cleaning building (Resource D) (Figures 18 and 19). The granary is elevated above the ground on cylindrical posts clad in tin to keep out rodents, supplemented later with concrete-block piers, is clad in board-and-batten and vertical-board siding, with weatherboard in the gable fields, and rests beneath a front-gable roof sheathed in corrugated-metal panels. The north elevation is pierced by a single-leaf entry filled with a corrugated-metal door, which likely replaced the original wood door. The west elevation is pierced by a window-sized opening near the roof line; a chain wrapped around the rafter tails above the opening suggests that materials were hoisted into the building through the opening. The east and south elevations exhibit no visible fenestration. Attached to the east elevation is a section of lattice leaning from the roofline to the ground that was likely once a roof that formed a sheltered area on the east side of the building. Local residents remember visiting the granary to purchase seed/grain in the early to mid-twentieth century. The seed-cleaning machine, called “The Clipper,” is extant inside the building (Figure 20). Based on available evidence, the granary likely dates to the late nineteenth century or early twentieth century and was associated with the original house on the property.

Figure 18. SP 1: East and north elevations of granary (Resource D), looking southwest.

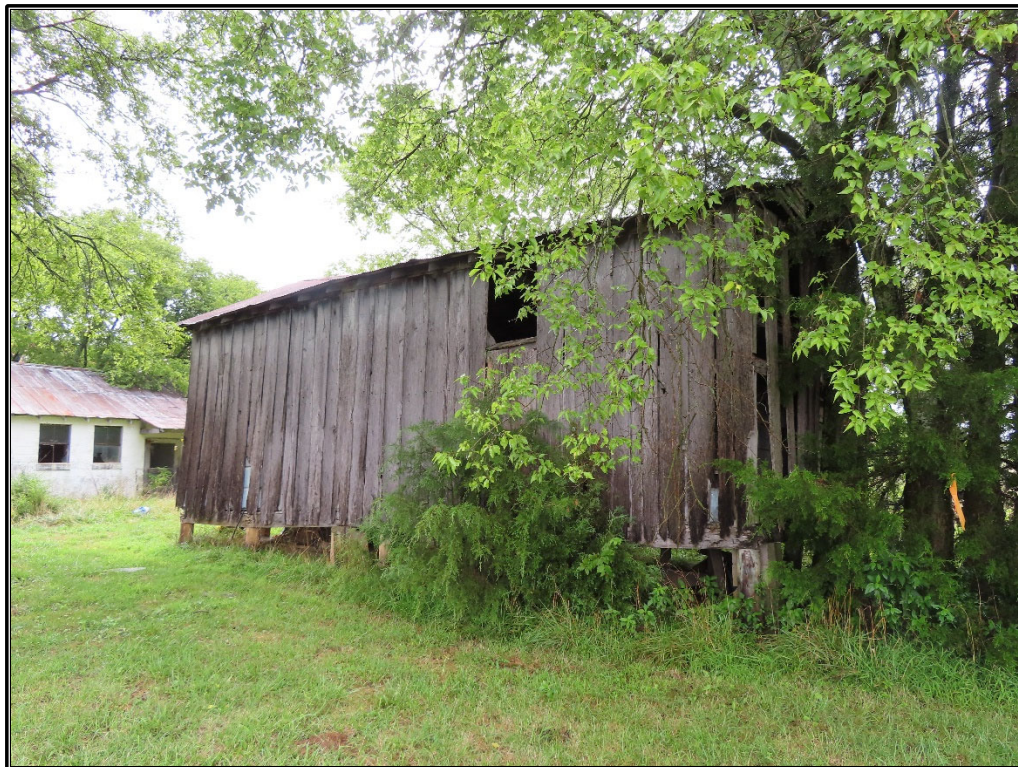
Figure 19. SP 1: West and south elevations of granary (Resource D), looking northeast.

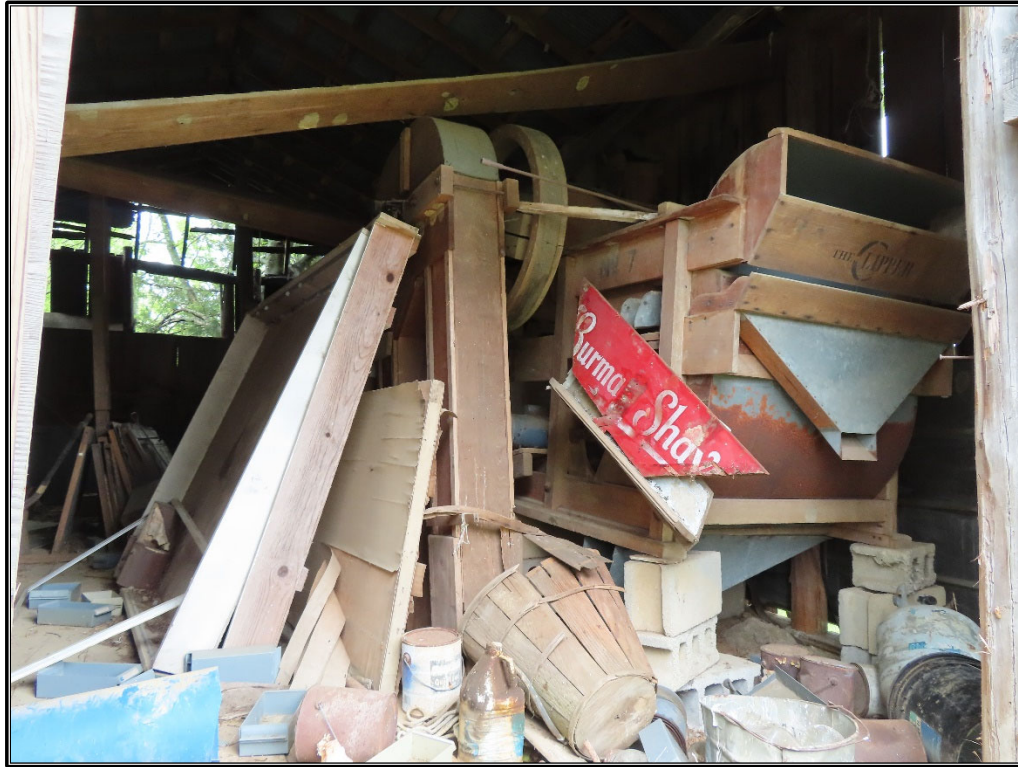
Figure 20. SP 1: Interior of granary (Resource D) showing "The Clipper" seed cleaner.

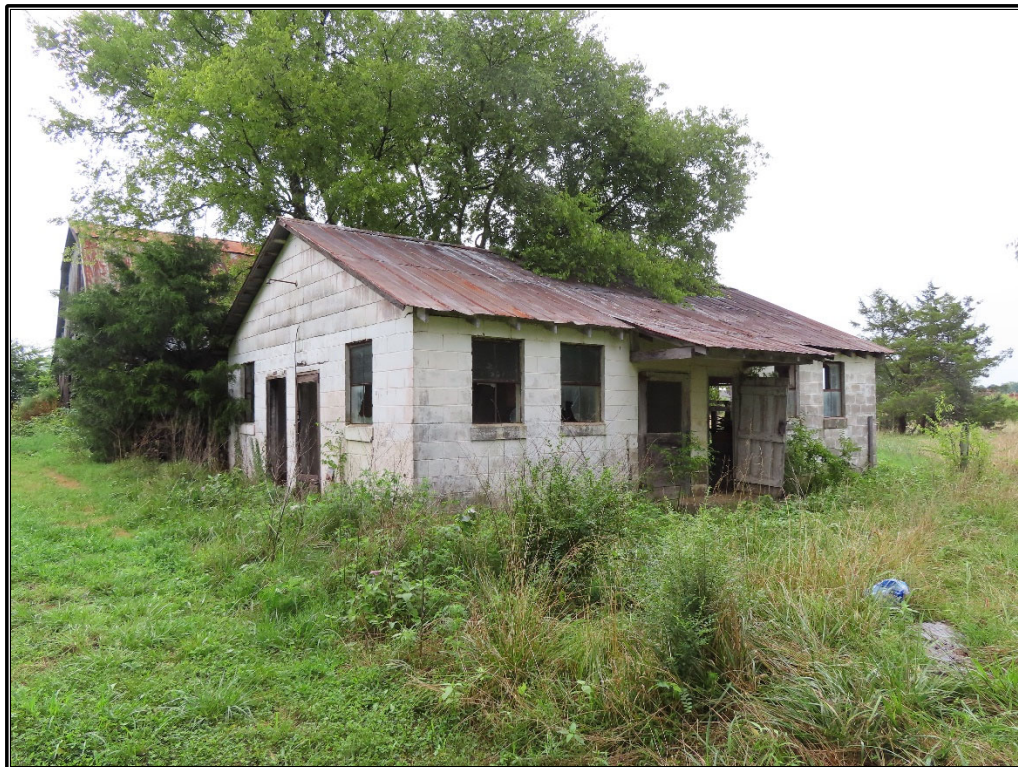
Figure 21. SP 1: West and south elevations of milk house (Resource E), looking northeast.

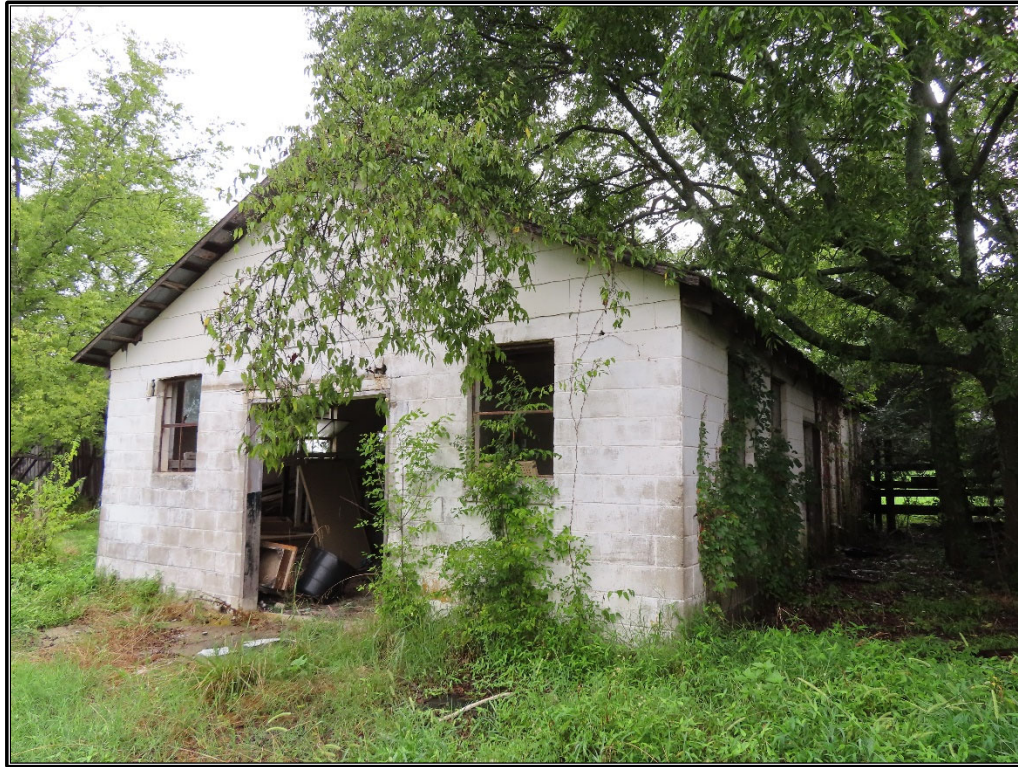
Figure 22. SP 1: East and north elevations of milk house (Resource E), looking southwest.

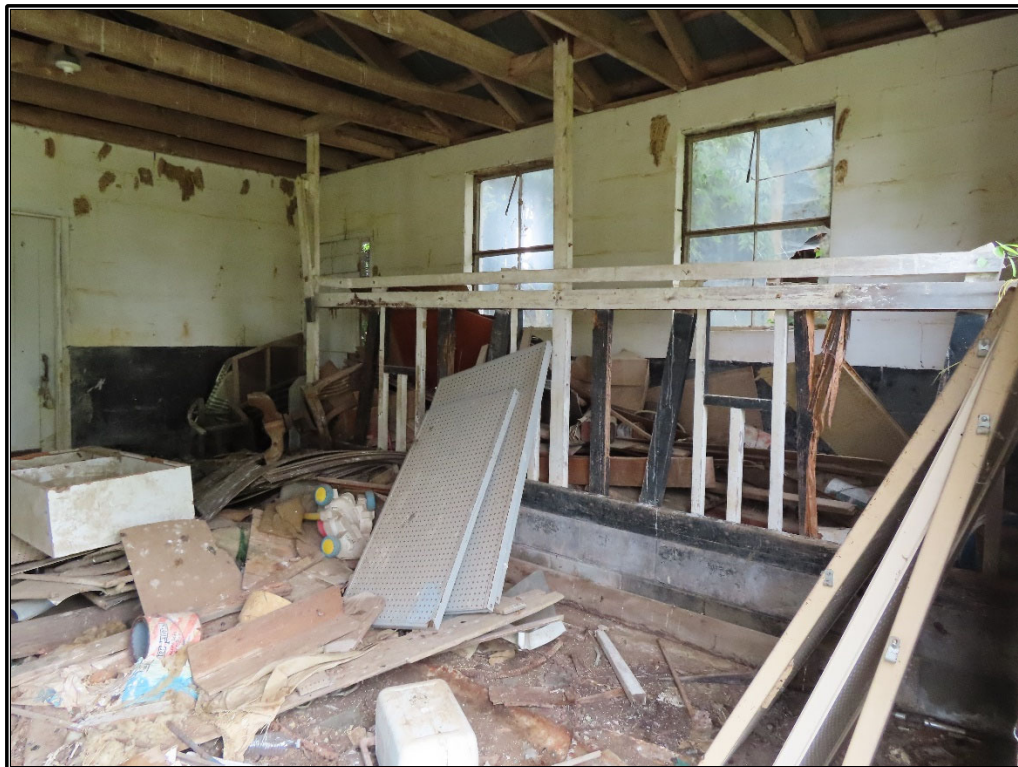
Figure 23. SP 1: Interior of east section of milk house (Resource E), looking northwest.

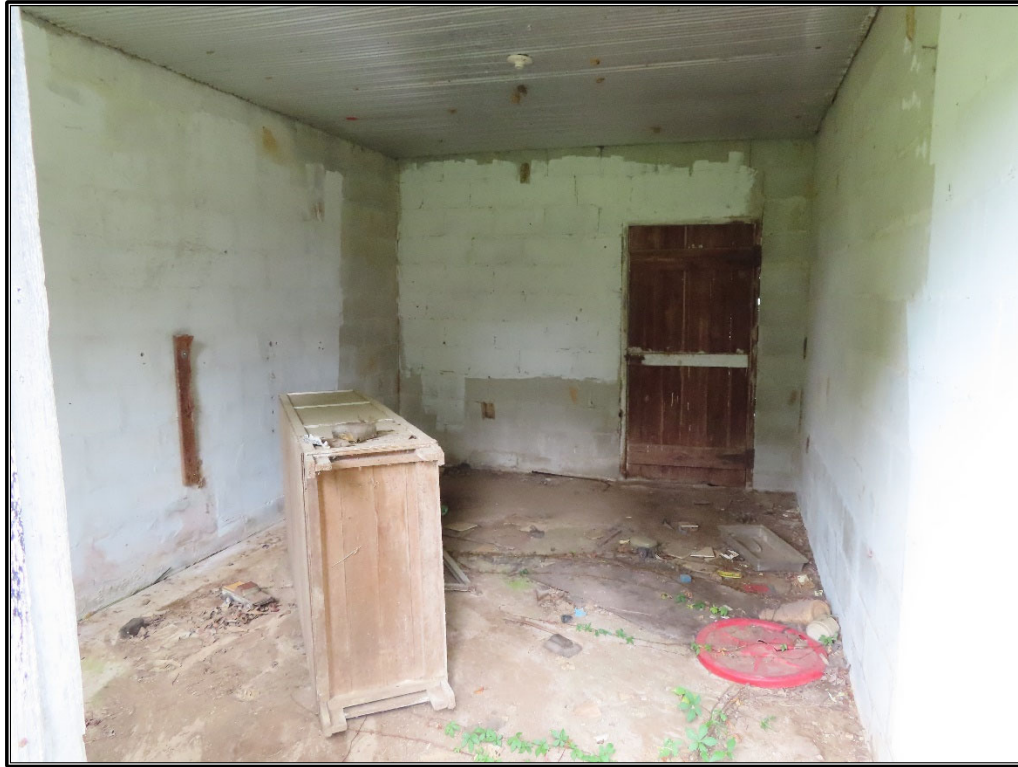
Figure 24. SP 1: Interior of northwest section of milk house (Resource E), looking east.

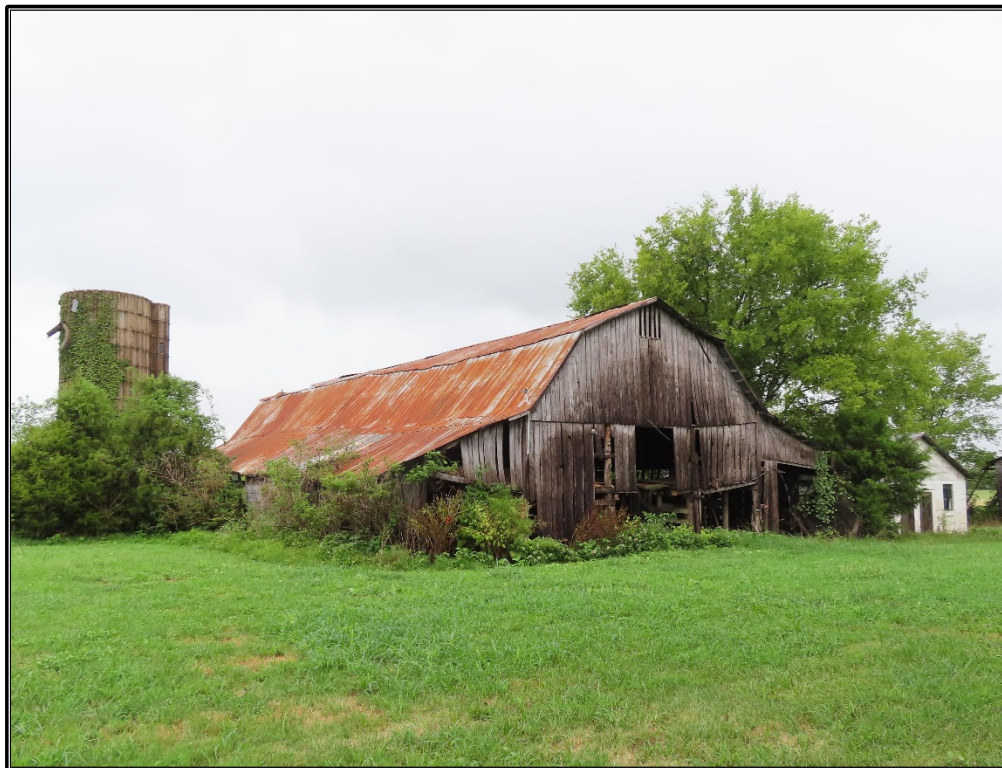
Located north of the milk house is a two-story, gambrel-roof livestock barn (Resource F) (Figures 25 and 26). Attached to the north and south elevations are one-story lean-tos. The barn is clad in vertical-board siding and rests beneath a roof sheathed in raised-seam metal panels. The west elevation is pierced by a central runway and runways in the lean-tos. The east, north, and south elevations are missing much of their cladding, and none of the building’s doors are extant. The interior shows a raised platform that runs the length of the center portion of the barn (Figure 27). A barn at this location first appears on the 1951 topographic map; the 1936 topographic map does not depict the locations of barns. Based on the map evidence, form, and materials, and information from local residents, the barn likely dates to the late 1940s/early 1950s.

Figure 25. SP 1: North and west elevations of livestock barn (Resource F), looking southeast. At right is the milk barn (Resource E); at left is the silo (Resource G).

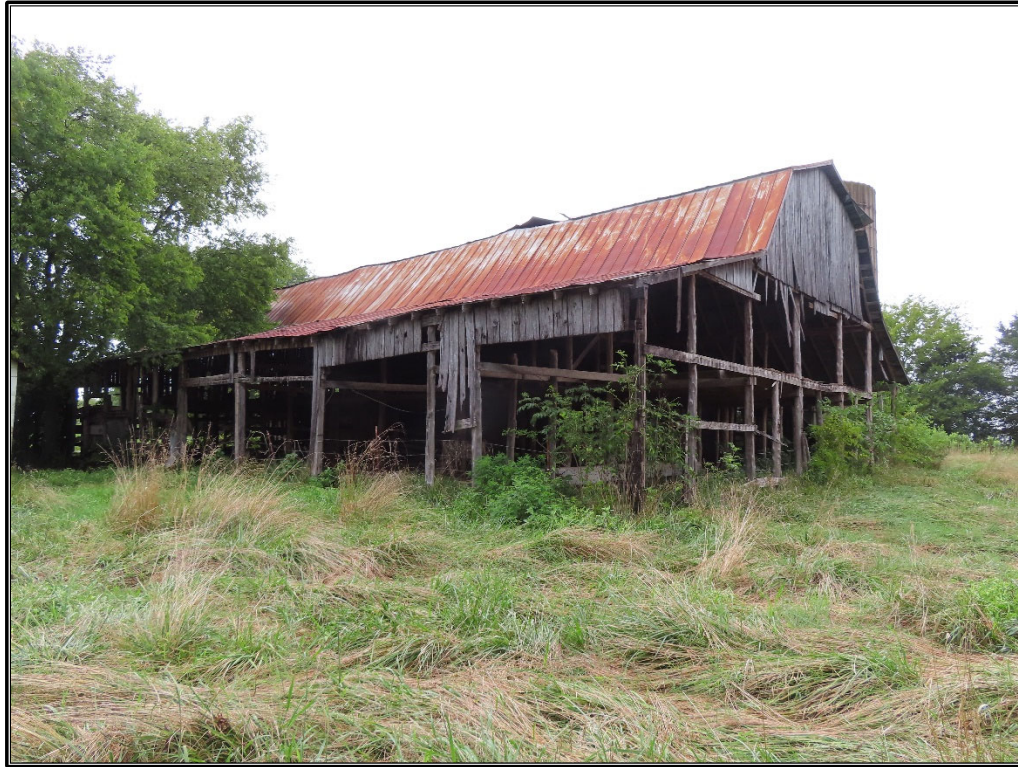
Figure 26. SP 1: South and east elevations of livestock barn (Resource F), looking northwest.

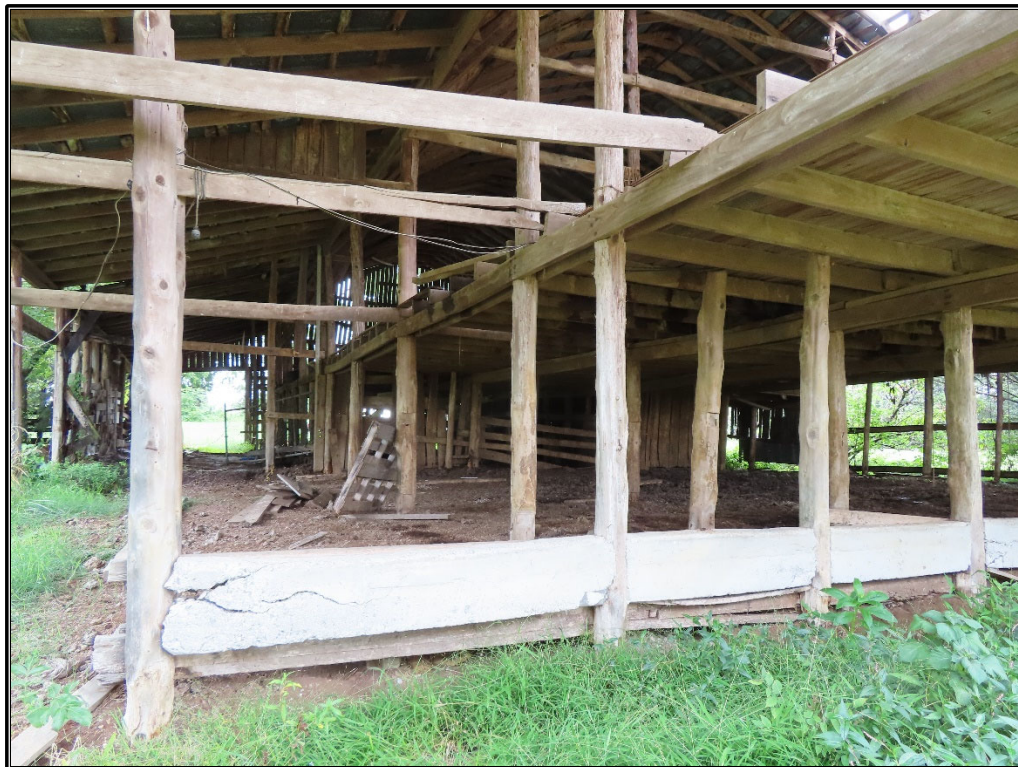
Figure 27. SP 1: Interior of livestock barn (Resource F), looking northwest.

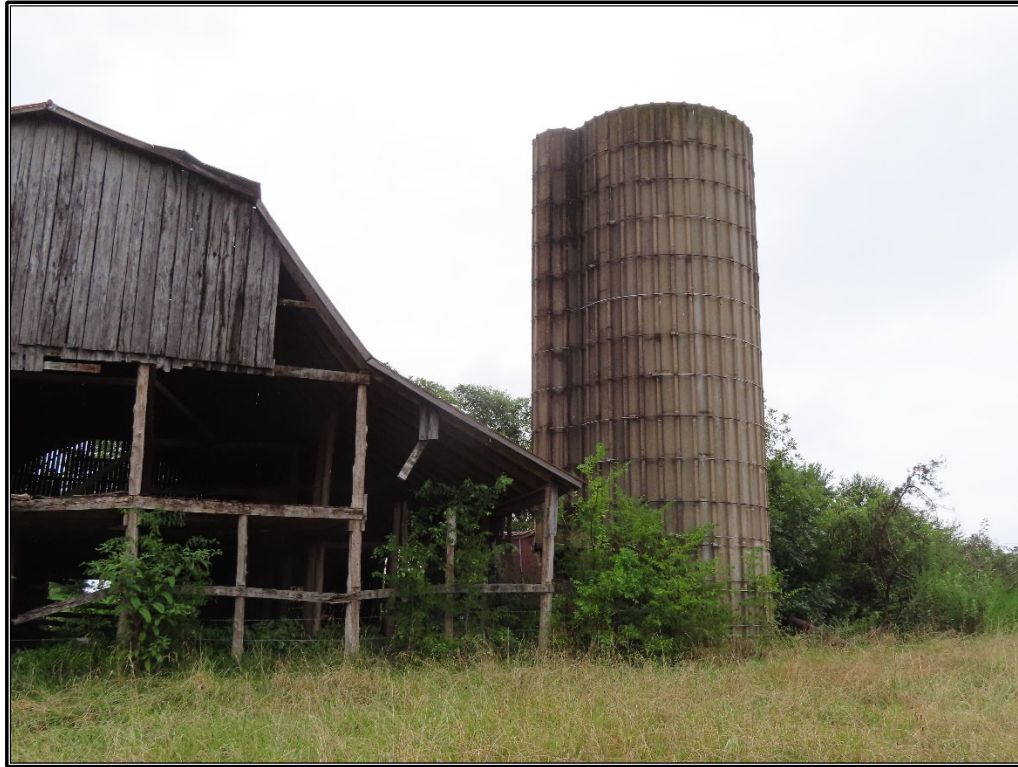
Located at the northeast corner of the livestock barn is a concrete-stave silo (Resource G) (Figure 28). The silo has been missing its domed metal cap since the early 2000s. The silo was likely built in conjunction with the barn and also dates to the mid-twentieth century.

Figure 28. SP 1: East elevation of silo (Resource G), looking west. At left is the livestock barn (Resource F).

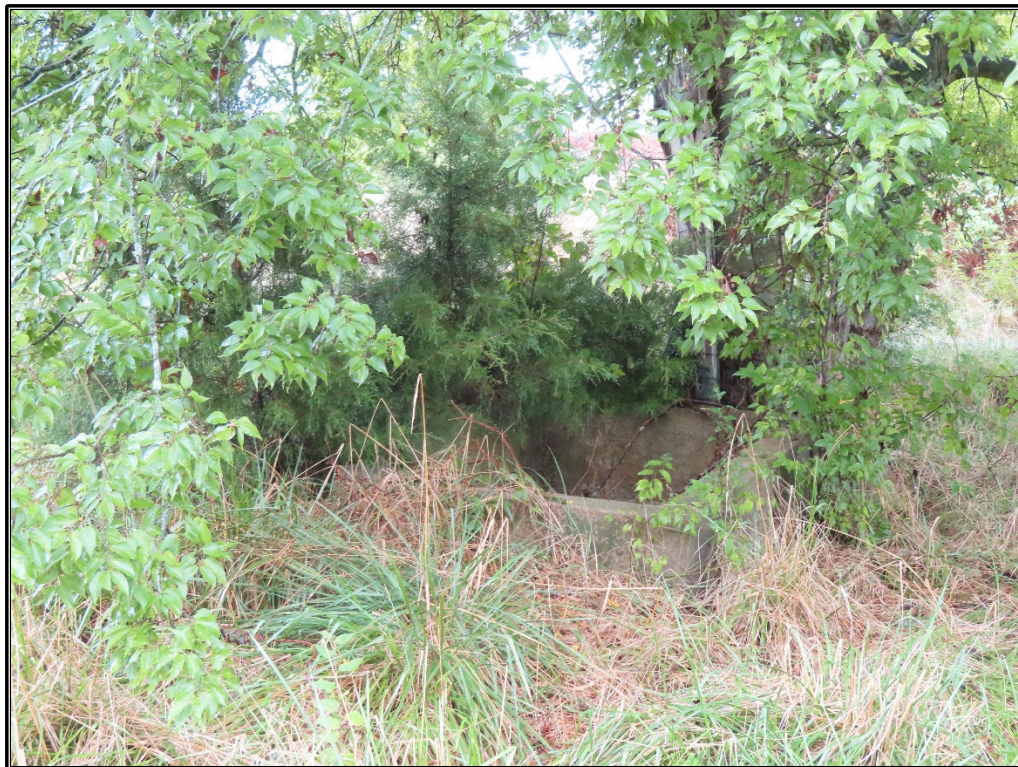
Located approximately 250 ft east of the residence is a concrete structure that either functioned as a livestock trough or was associated with a well or pump house (Resource H) (Figure 29). Based on form and materials, the structure likely dates to the mid-twentieth century.

Figure 29. SP 1: West elevation of concrete structure (Resource H), looking east.

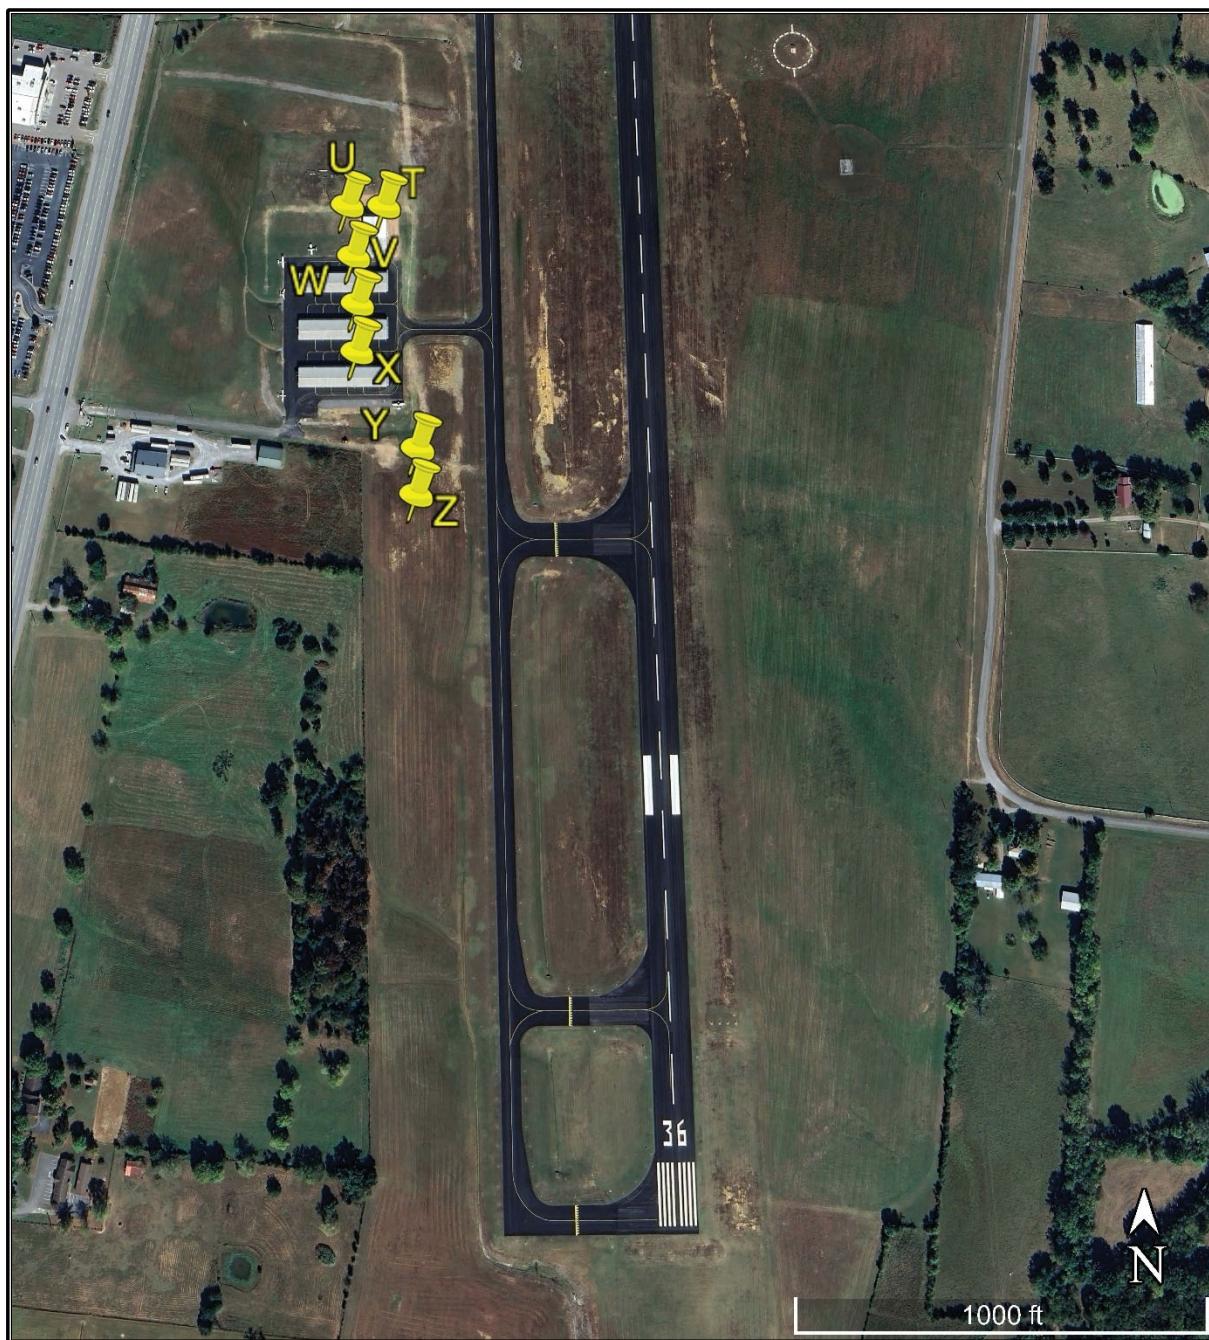
Figure 30b. SP 2: Aerial photograph depicting the locations of surveyed resources in the south half of the Shelbyville Municipal Airport. Resources U, Y, and Z are so recently constructed that they do not appear in available aerial photographs.
