HISTORIC ARCHITECTURAL RESOURCE SURVEY FOR THE PROPOSED DEVELOPMENT NEAR THE SHELBYVILLE MUNICIPAL AIRPORT, BEDFORD COUNTY, TENNESSEE

Cultural Resource Analysts, Inc.
119 West Summit Hill Drive
Knoxville, Tennessee 37902
CRA Project No.: T240252

September 2024

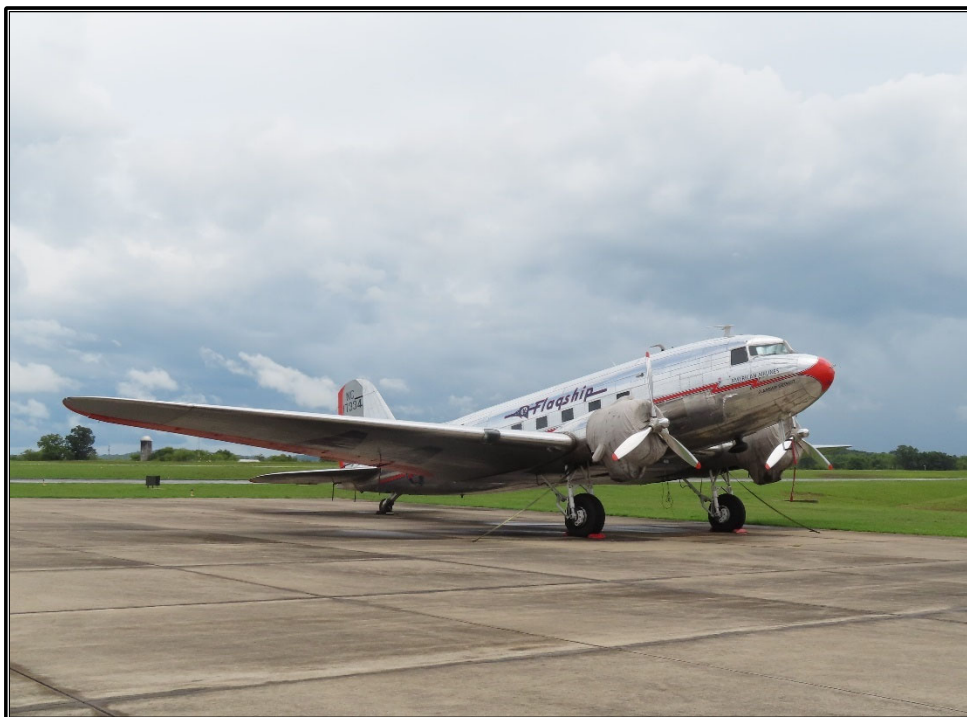
Figure 35. Current photograph of the Flagship Detroit DC-3, housed at the Shelbyville Municipal Airport.

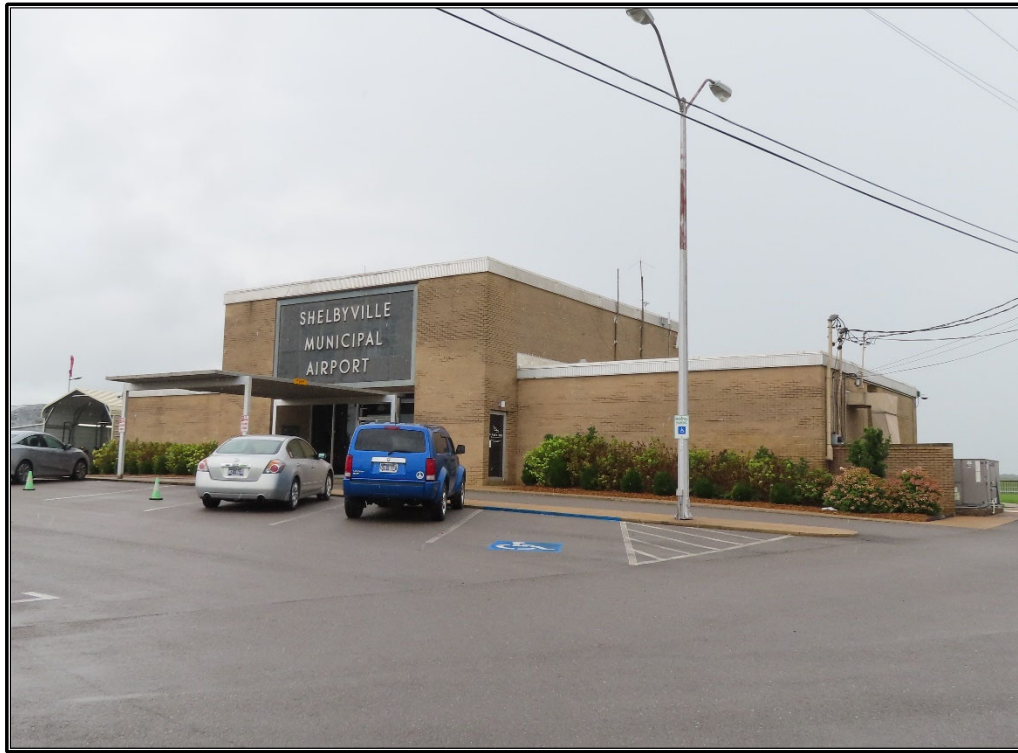
Figure 36. SP 2: Façade (west) and south elevations of the terminal, looking northeast.

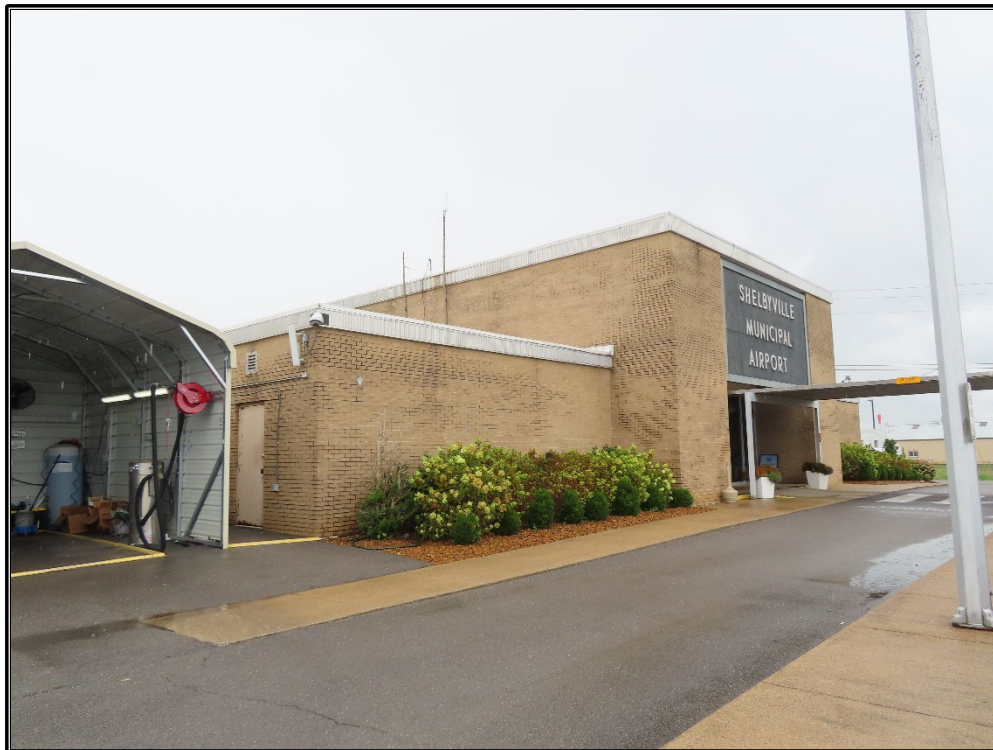
Figure 37. SP 2: North and façade (west) elevations of the terminal, looking southeast.

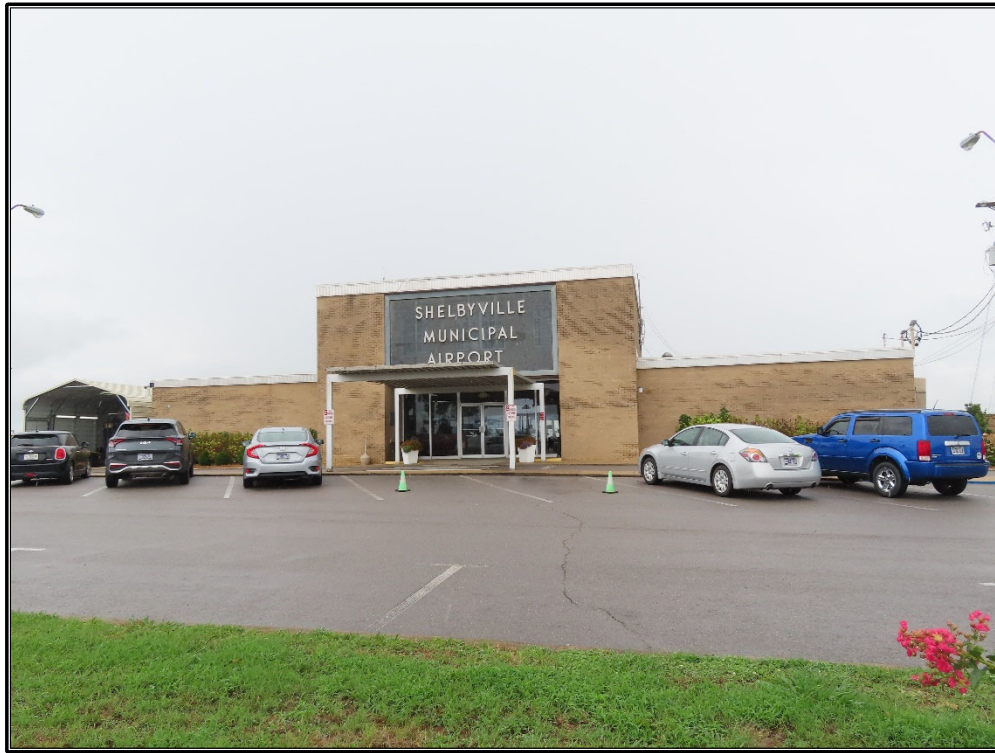
Figure 38. SP 2: Façade (west) elevation of the terminal, looking east.

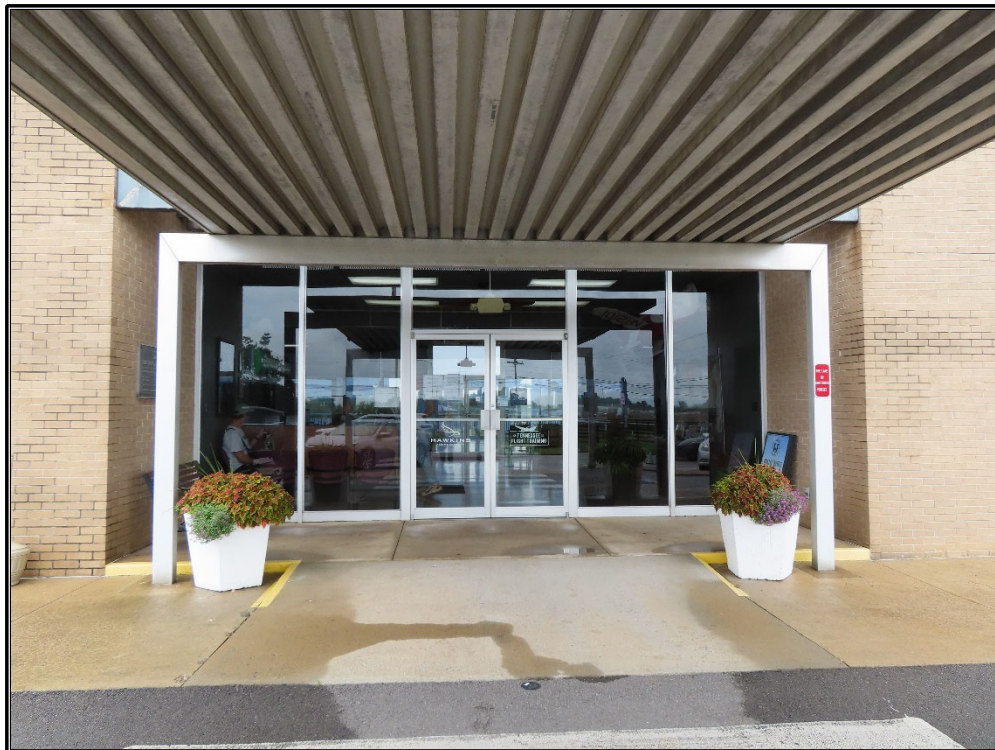
Figure 39. SP 2: Entry on the façade (west) elevation of the terminal, looking east.

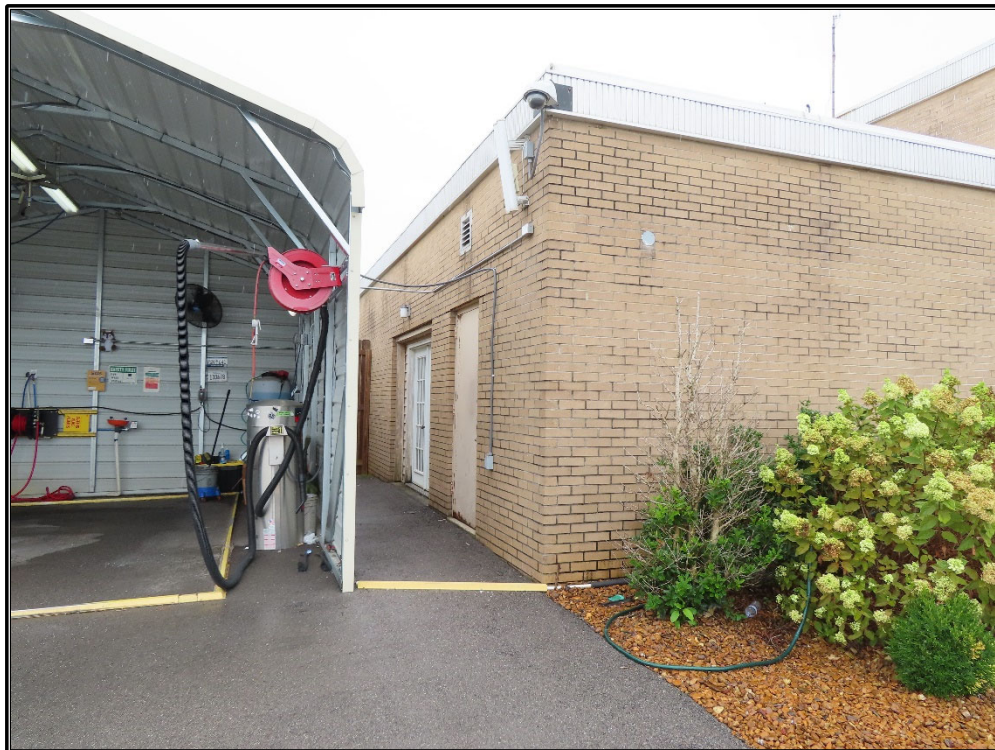
The north elevation of the terminal is pierced by a single-leaf entry filled with a steel door, and a double-leaf entry filled with a set of modern French doors (Figure 41). The south elevation of the central two-story portion of the building is pierced by a single-leaf entry filled with a full-light door. The south elevation of the south wing features a recessed single-leaf entry filled with a full-light door (Figure 42).

Figure 41. SP 2: North elevation of the terminal, looking southeast.

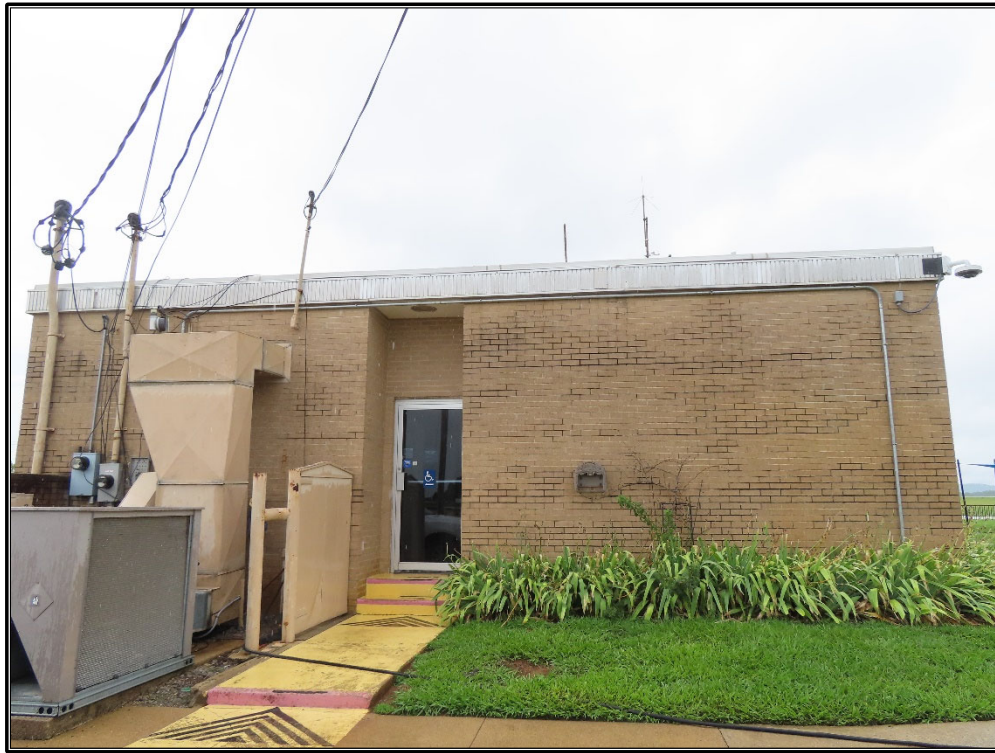
Figure 42. SP 2: South elevation of the south wing of the terminal, looking north.

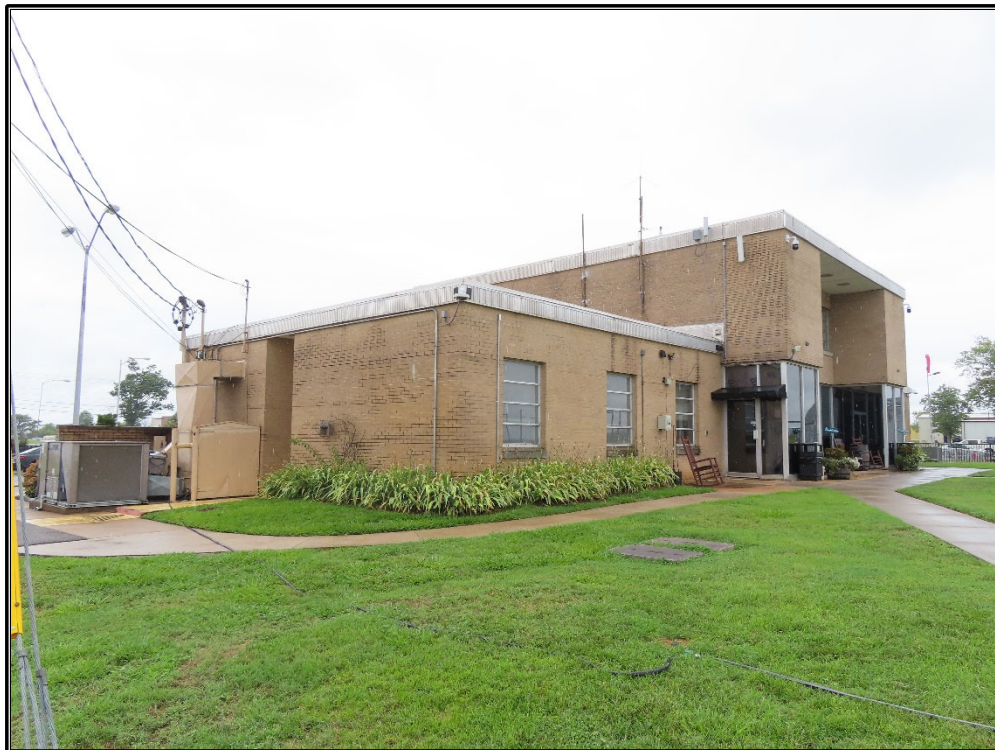
Figure 43. SP 2: South and east elevations of the terminal, looking northwest.

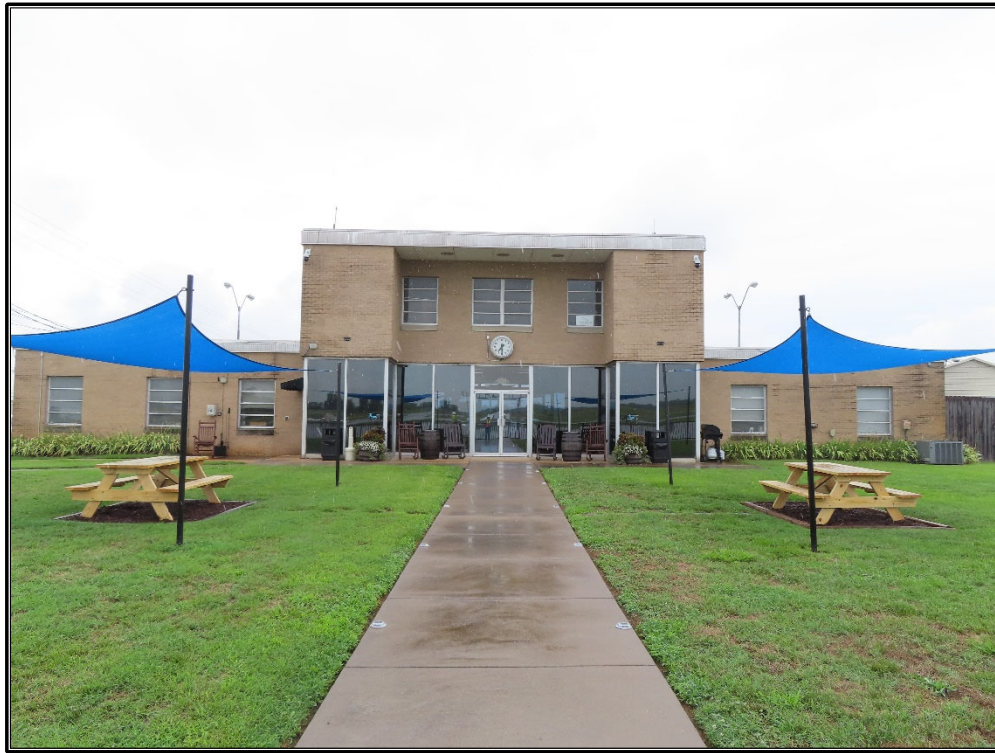
Figure 44. SP 2: East elevation of the terminal, looking west.

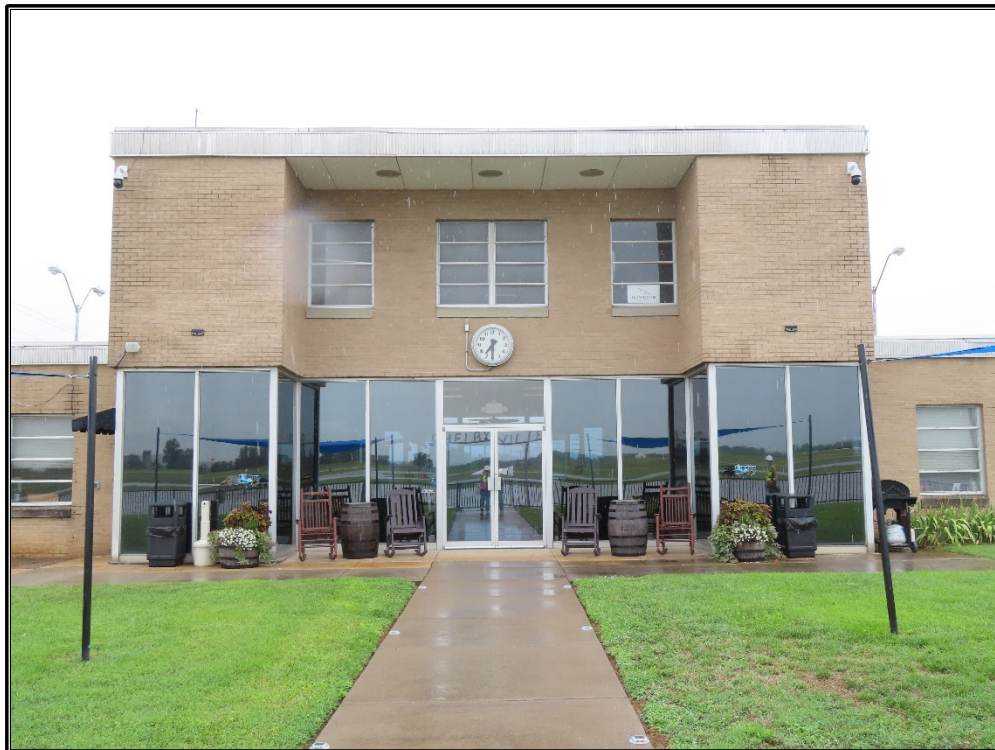
Figure 45. SP 2: Center portion of the east elevation of the terminal, looking west.

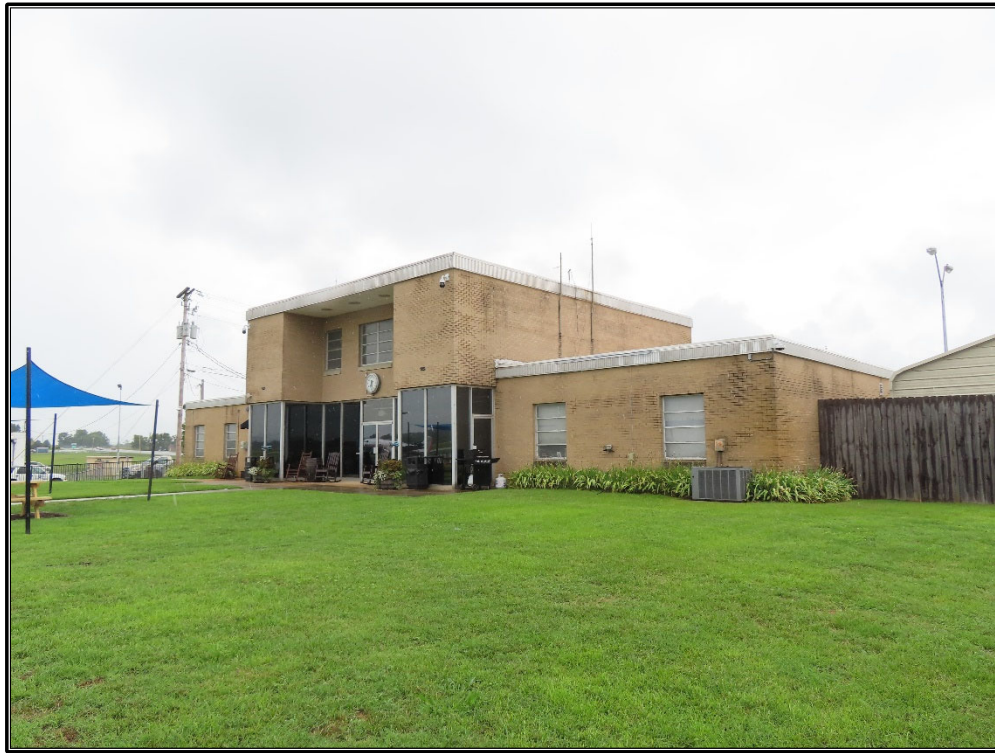
Figure 46. SP 2: East and north elevations of the terminal, looking southwest.

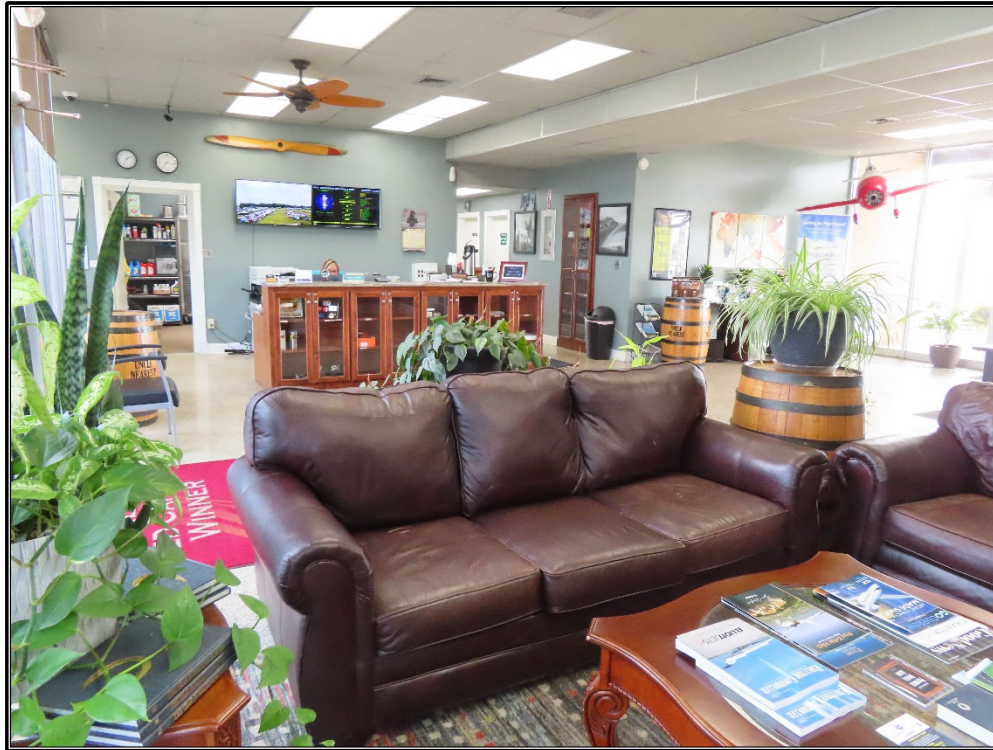
Figure 48. Interior of the first floor of the terminal, looking southwest. At left is the exit to the boarding area; at right is the main entrance.

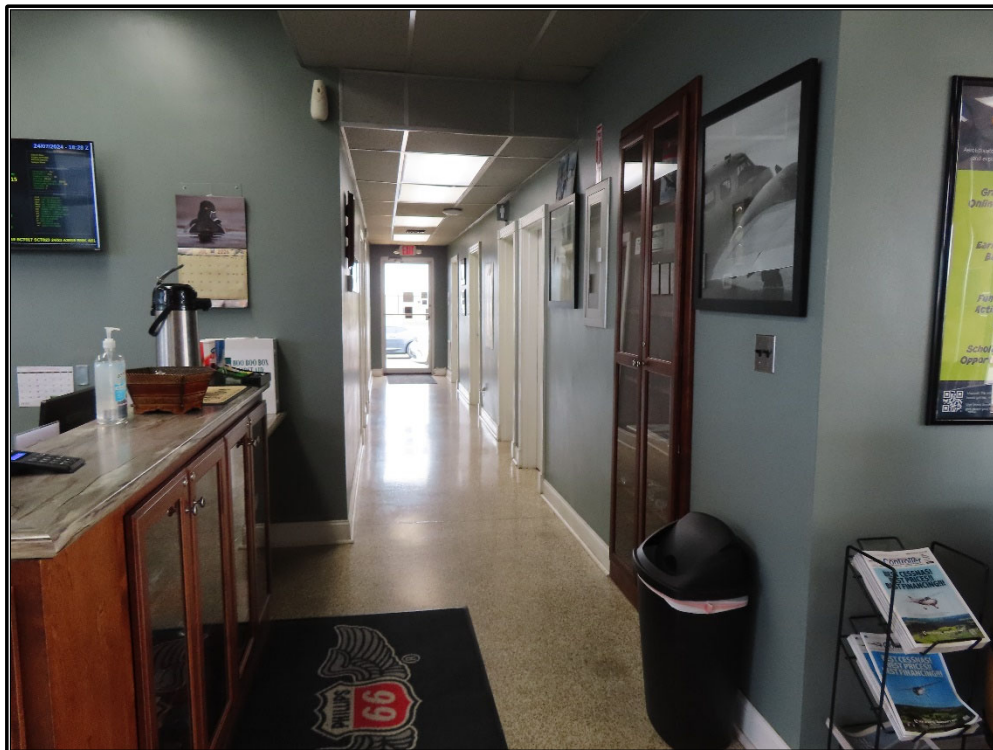
Figure 49. Interior of the first floor of the terminal, looking south toward the south wing.

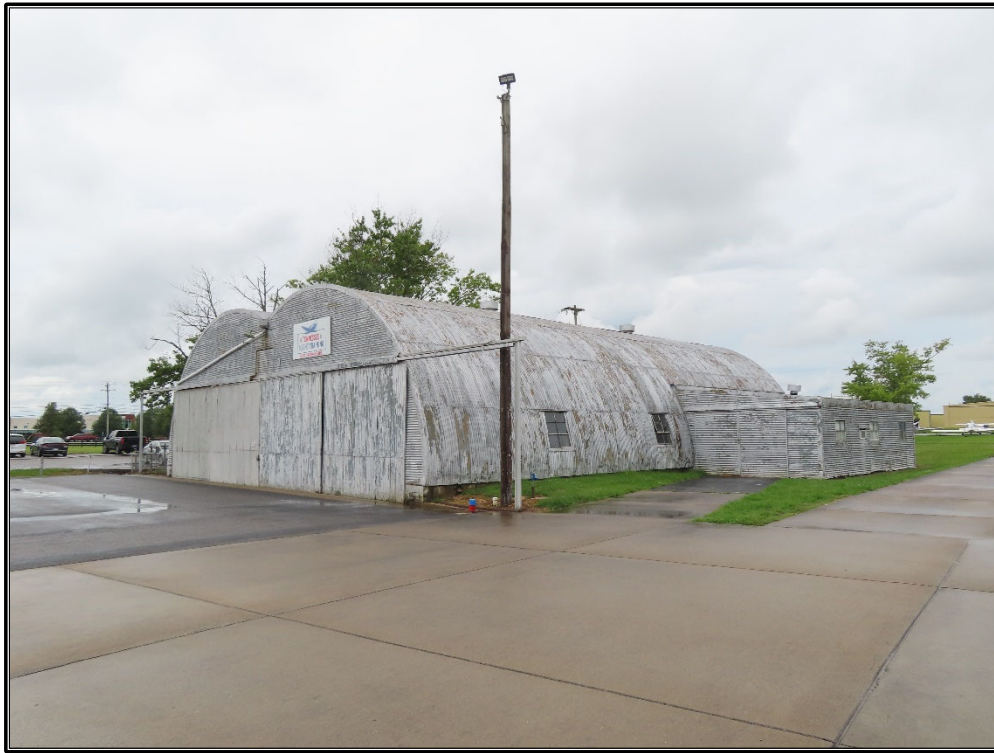
Located approximately 150 ft northeast of the terminal is a one-and-one-half-story Quonset-style airplane hangar (Resource A) (Figure 50). The hangar is set on a concrete-block foundation and is clad in corrugated metal panels. The main portion of the building consists of two Quonset huts joined together at the roof. Attached to the east elevation is a one-story shed-roof addition also clad in corrugated metal that was used as office space (Figure 51). Windows on the main portion of the building exhibit four-over-two, steel-frame, awning-casement sashes; windows on the addition are two-over-two awning casement sashes. The south elevation is pierced by a large vehicular bay covered by two pairs of corrugated-metal doors on sliding tracks; the addition is pierced by a double-leaf entry filled with a pair of corrugated-metal doors. The west elevation is pierced by three double window bays (Figure 52). The north elevation is pierced by two double window bays in the main portion of the building and one single window bay in the addition (Figure 53). The east elevation is pierced by two double window bays in the main portion of the building and three single window bays in the addition. The hangar dates to at least 1946 and was a war-surplus Quonset building. It makes its first map appearance on a 1951 topographic map and was the second hangar used at Bomar Field (see Figure 32).

Figure 50. SP 2: South and east elevations of Quonset hangar (Resource A), looking northwest.

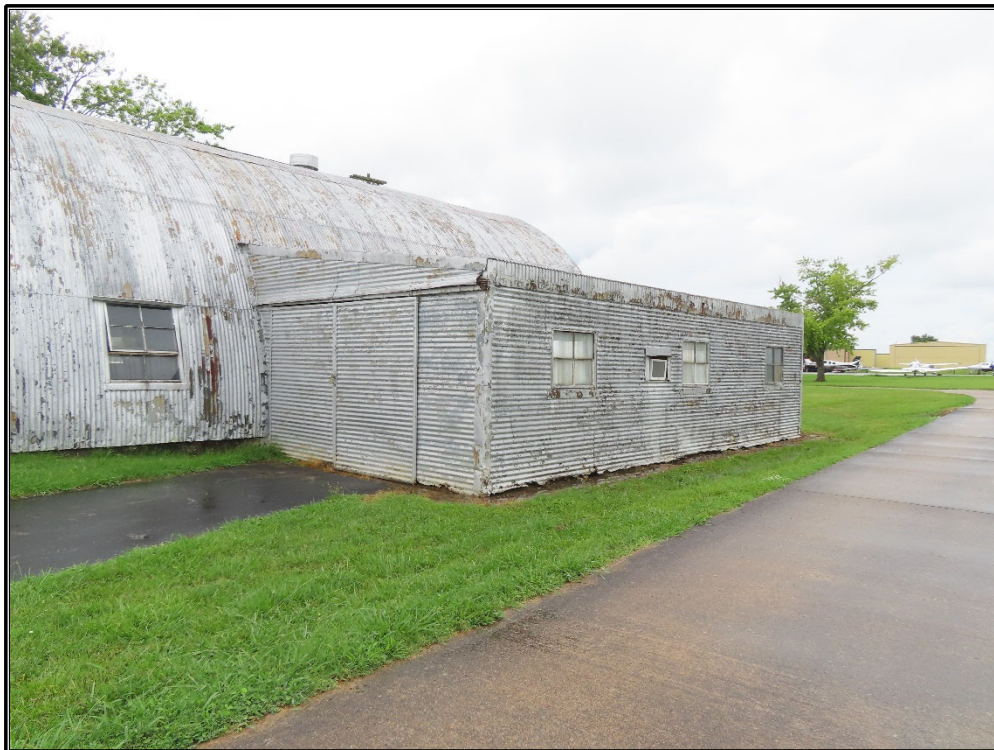
Figure 51. SP 2: South and east elevations of addition on Quonset hangar (Resource A), looking northwest.

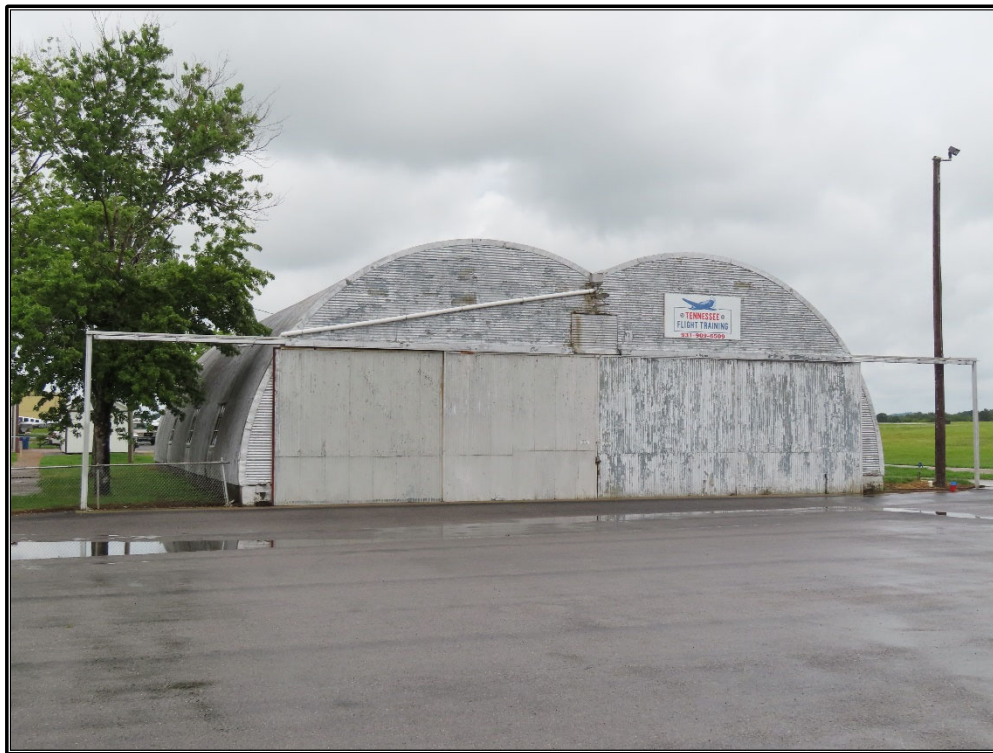
Figure 52. SP 2: West and south elevations of Quonset hangar (Resource A), looking northeast.

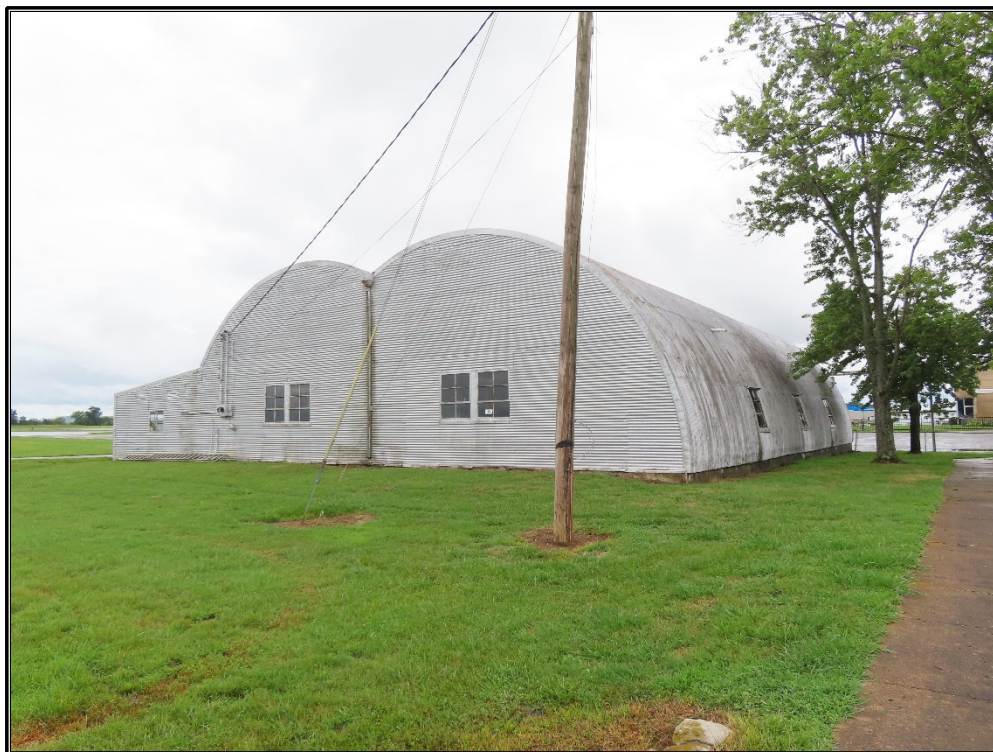
Figure 53. SP 2: North and west elevations of Quonset hangar (Resource A), looking southeast.

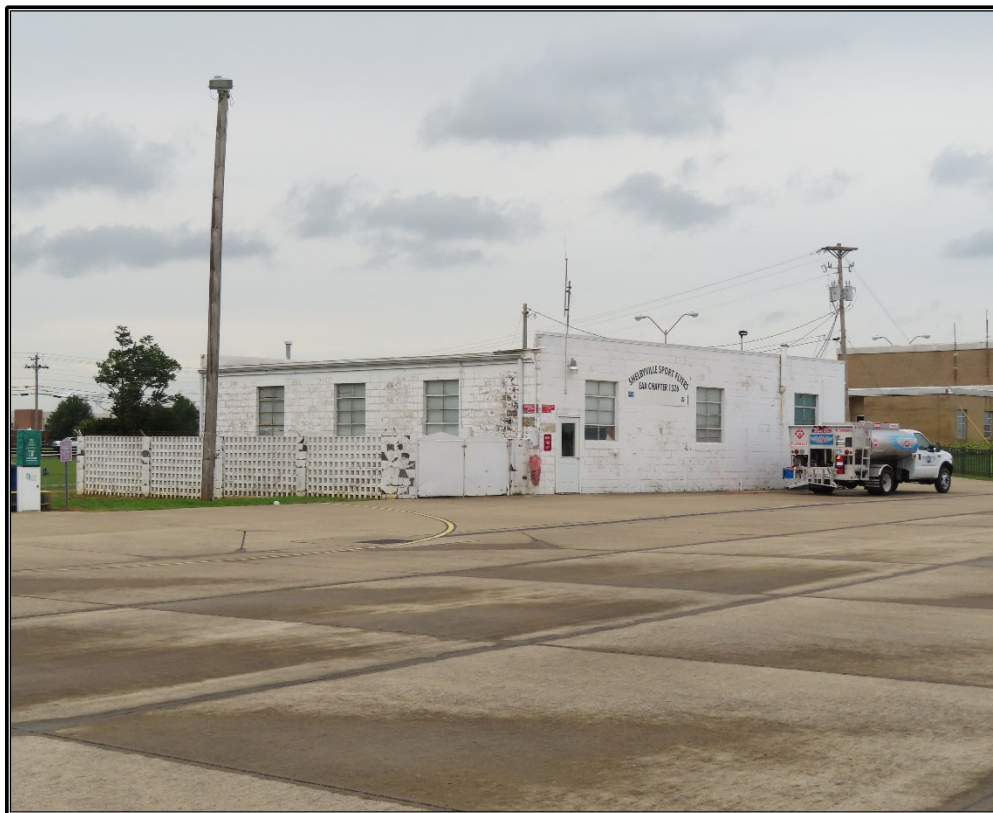
Located approximately 110 ft south of the terminal is a one-story shop building (Resource B) (Figure 54). The building is set on a concrete slab, has concrete-block walls to grade, and rests beneath a flat roof with parapets along the east and west sides. Windows exhibit two-over-four-over-two, steel-frame awning-casement sashes. Attached to the south elevation is a pierced concrete-block screen wall enclosure with concrete-block posts; a double-leaf gate on the east side of the enclosure is supported by a pair of larger concrete-block pillars. The east elevation is pierced by a single-leaf entry filled with a replacement door, and three single window bays. The south and west elevations are each pierced by three single window bays (Figure 55). The north elevation is composed almost entirely of a large vehicular entry filled with a wide bi-fold metal-panel roll-up door (Figure 56). The building originally functioned as a shop but is currently in use by an Experimental Aircraft Association (EAA) Flying Club known as the Shelbyville Sport Flyers, EAA Chapter 1326.

Figure 54. SP 2: South and east elevations of shop building (Resource B), looking northwest.

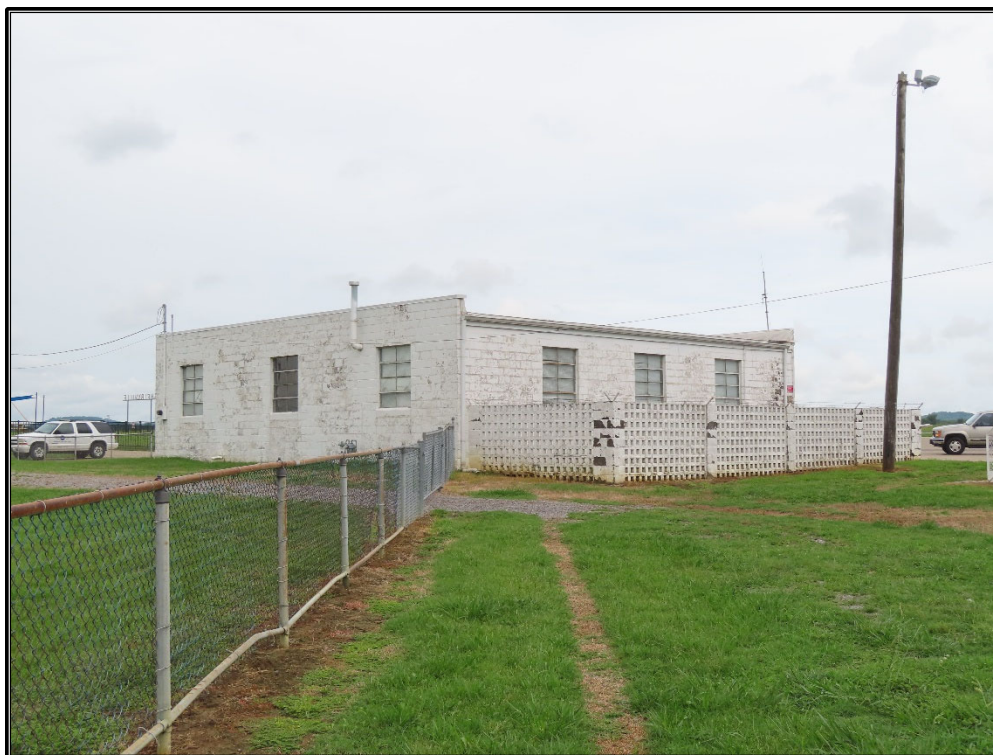
Figure 55. SP 2: West and south elevations of shop building (Resource B), looking northeast.

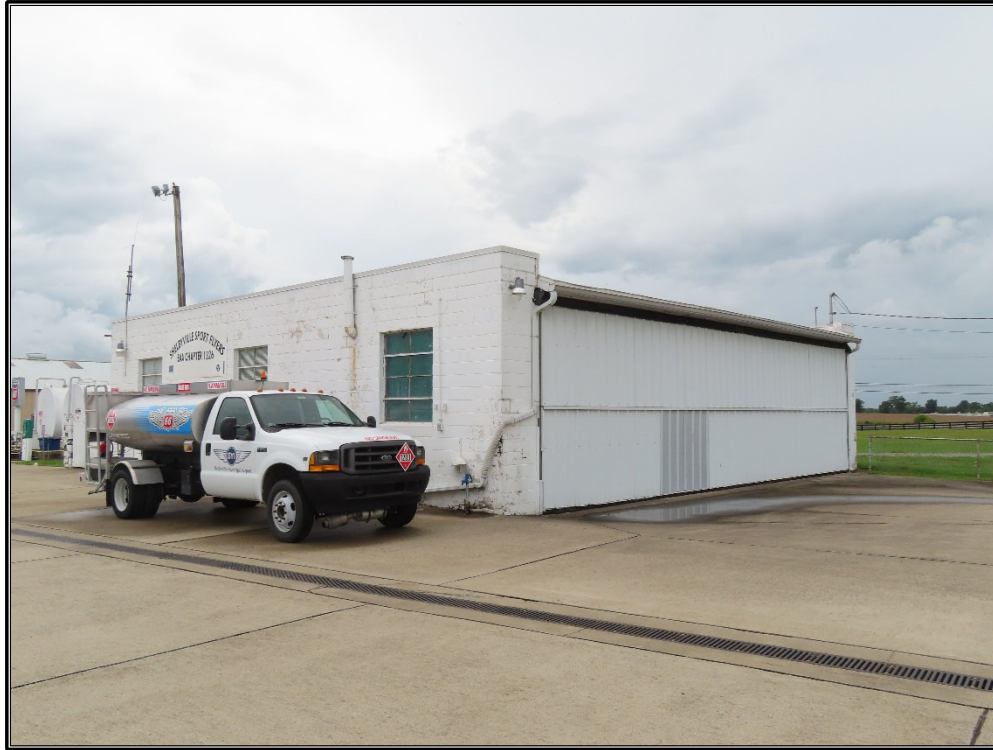
Figure 56. SP 2: East and north elevations of shop building (Resource B), looking southwest.

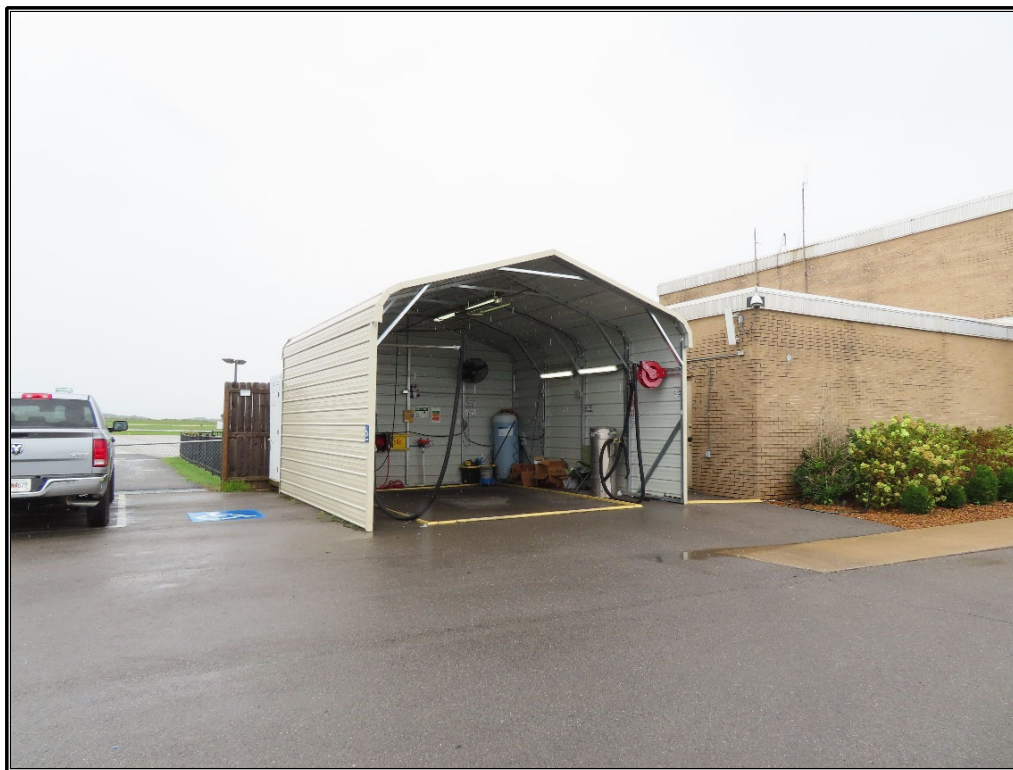
Located approximately 5 ft north of the terminal is a modern front-gable, metal-frame carport (Resource C) (Figure 57). The carport is clad in metal panels and sheltered by a metal-panel roof. The west elevation of the carport is pierced by a full-width opening with no door. The north, south, and east elevations exhibit no fenestration. Based on a review of recent aerial photographs, the carport was constructed between 2010 and 2012.

Figure 57. SP 2: North and west elevations of carport (Resource C), looking southeast.

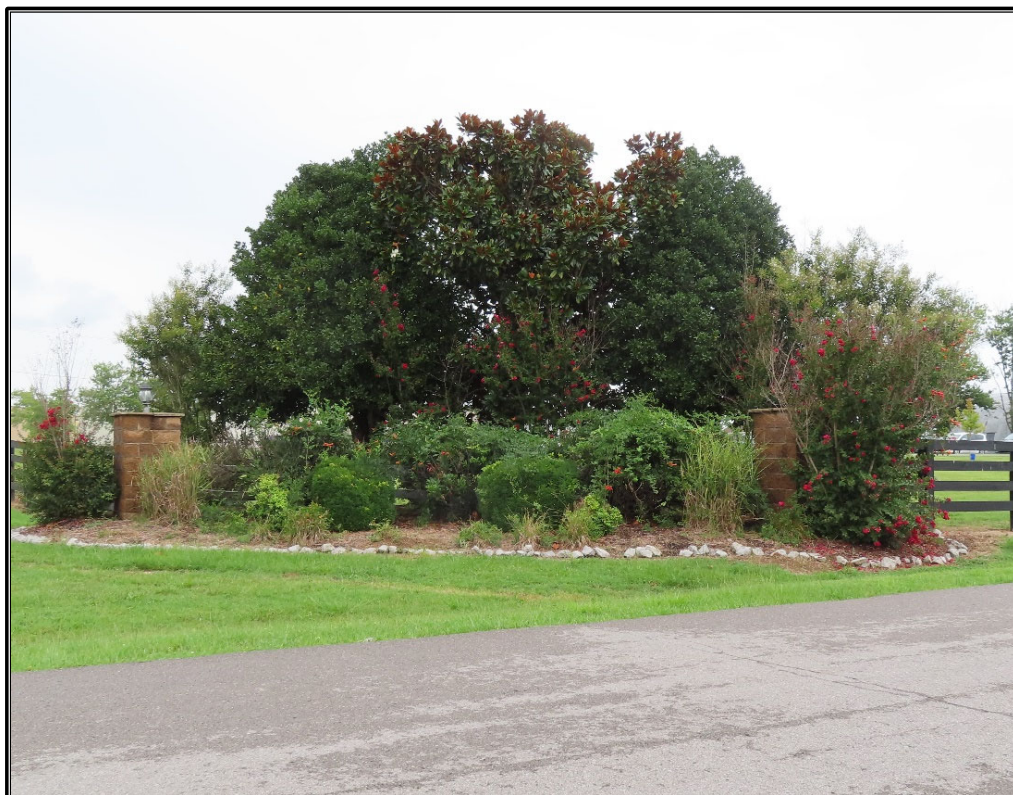
Located approximately 270 ft west of the terminal are pairs of structures (Resource D) flanking the entry drive that are associated with the entrance to the airport (Figure 58). The structures are composed of two pairs of pillars made of rusticated concrete blocks with sandstone caps and light fixtures. Extending between the pairs of pillars is wood fencing. In front of the pillars and fencing are planting beds. Based on a review of recent aerial photographs, the pillars, fencing, and planting beds were installed between 1992 and 2007.

Figure 58. SP 2: Pair of pillars (Resource D), fencing, and planting bed on the south side of the airport entry drive, looking southeast.

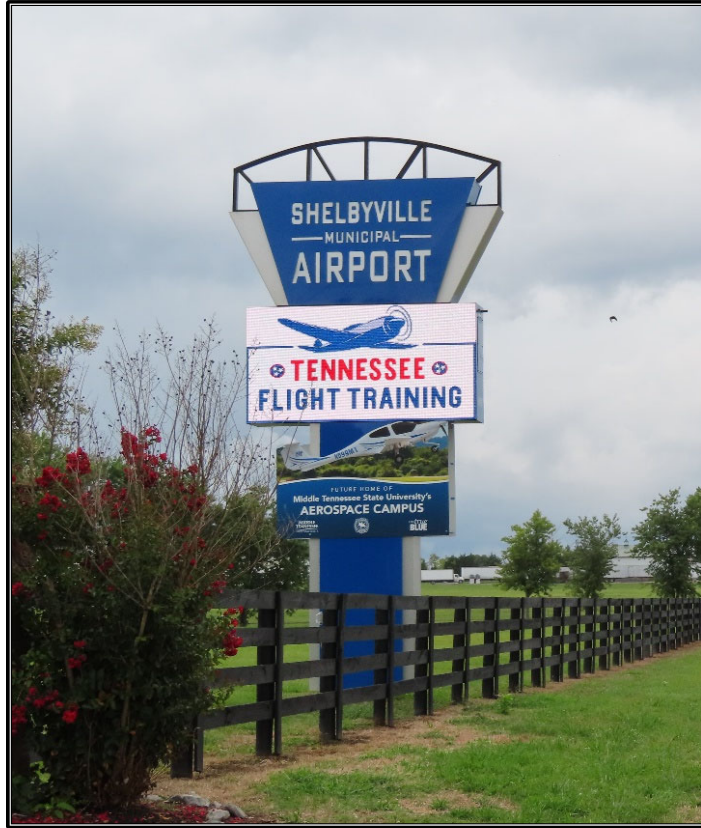
Located approximately 290 ft west of the terminal is an airport sign (Resource E) (Figure 59). The sign is composed of metal panels, with a rectangular base topped with a diamond-shaped section designating the site as the Shelbyville Municipal Airport. Beneath the name are two rectangular sections, one of which is lit, with lettering advertising Tennessee Flight Training. The lowest section announces the airport as the future home of MTSU's Aerospace Campus. Based on a review of recent aerial photographs, the sign was installed between 2010 and 2012.

Figure 59. SP 2: Airport sign (Resource E), located west of the terminal and near US 231 N, looking south.

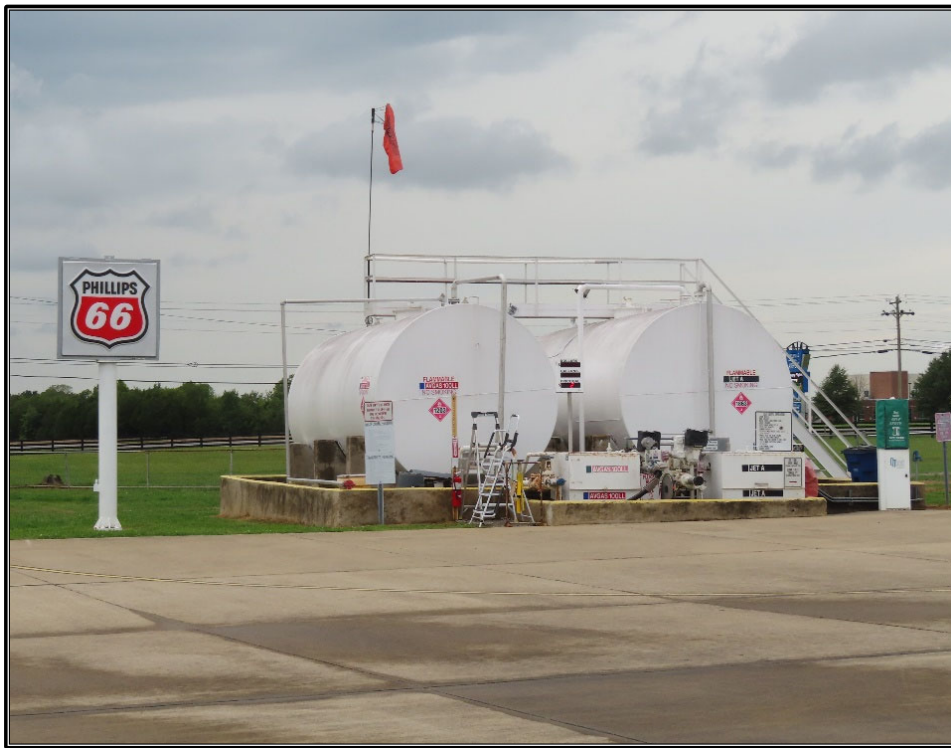
Located approximately 200 ft south of the terminal is a fuel tank facility (Resource F) (Figure 60). The facility consists of two large fuel tanks set within a concrete dike. Attached to the facility on the north side is a set of metal steps that connects to a walkway that extends across the tops of the tanks. Based on a review of aerial photographs, the facility was installed between 1987 and 1992.

Figure 60. SP 2: South and east sides of fuel tank facility (Resource F), looking northwest.

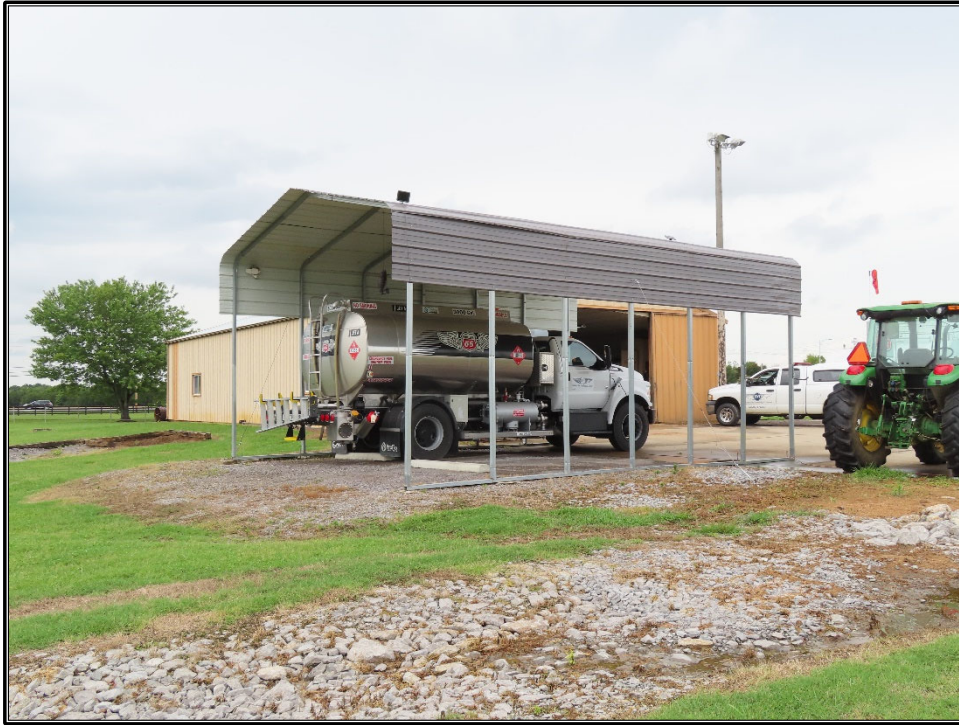
Located approximately 375 ft south of the terminal is a modern front-gable carport (Resource G) (Figure 61). The carport rests beneath a roof sheathed in metal panels and is supported by metal framing. Based on a review of recent aerial photographs, the carport was constructed between 2017 and 2022.

Figure 61. SP 2: South and east elevations of carport (Resource G), looking northwest.

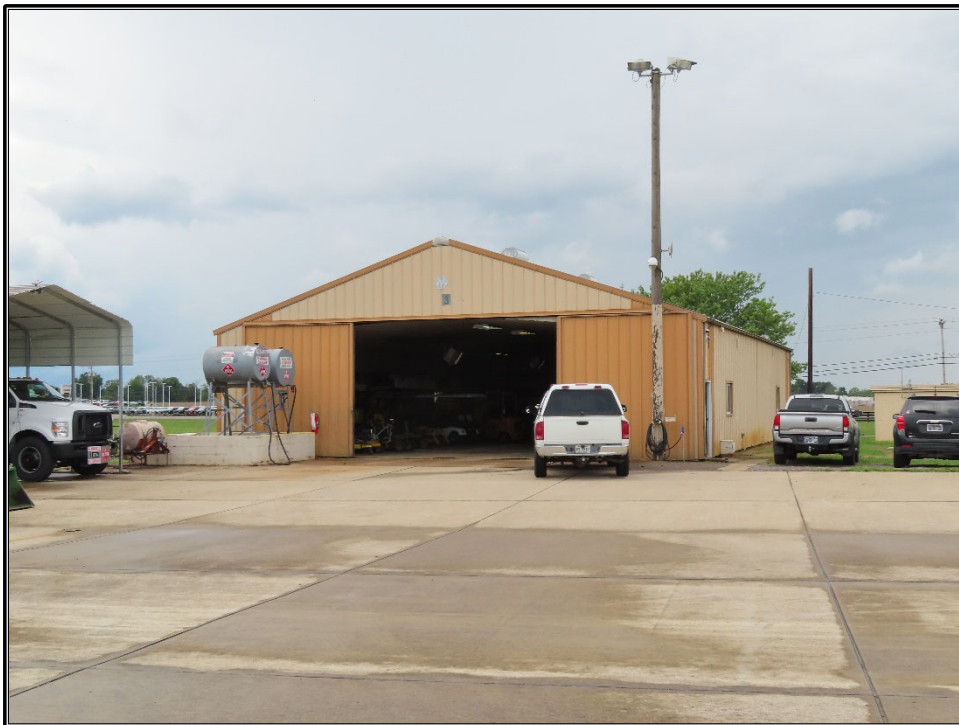
Figure 62. SP 2: East and north elevations of shop/equipment building (Resource H), looking southwest.

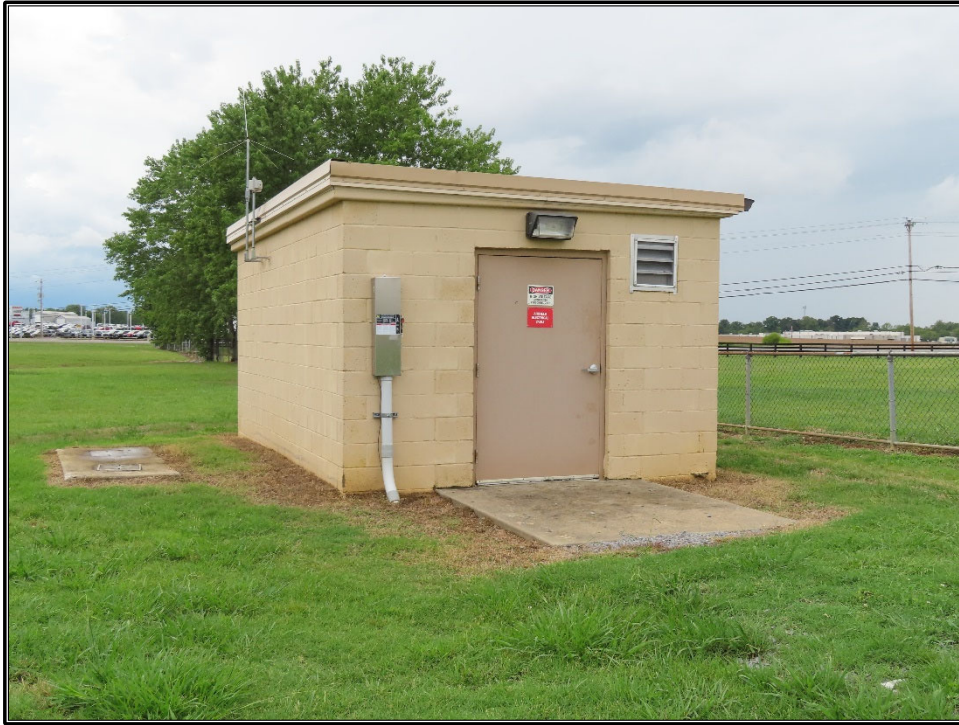
Figure 63. SP 2: Southeast and northeast elevations of utilities building (Resource I), looking west.

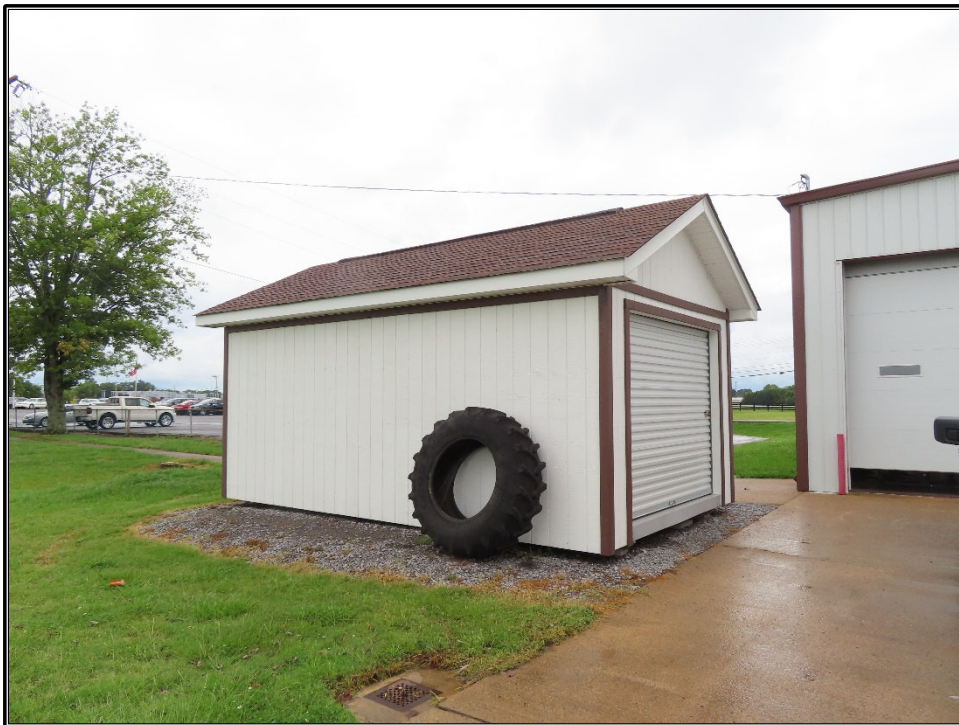
Figure 64. SP 2: East and north elevations of shed (Resource J), looking southwest.
