HISTORIC ARCHITECTURAL RESOURCE SURVEY FOR THE PROPOSED DEVELOPMENT NEAR THE SHELBYVILLE MUNICIPAL AIRPORT, BEDFORD COUNTY, TENNESSEE

Cultural Resource Analysts, Inc.
119 West Summit Hill Drive
Knoxville, Tennessee 37902
CRA Project No.: T240252

September 2024

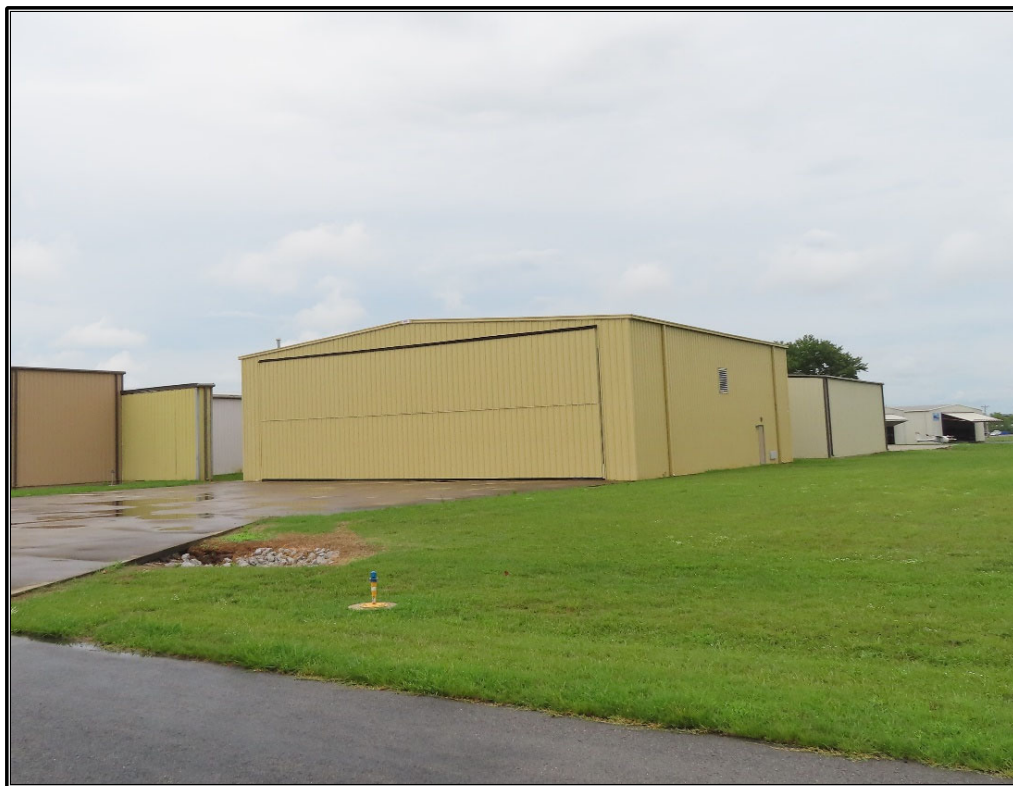
Figure 69. SP 2: South and east elevations of hangar (Resource O), looking northwest.

Located approximately 935 ft northeast of the terminal is an airplane hangar (Resource O) (Figure 69). The hangar is set on a concrete slab, is clad in metal panels, and rests beneath a shallow-pitched gable roof of metal panels. The south elevation is pierced by a large vehicular entry filled with a large metal bi-fold door. Based on a review of recent aerial photographs, the hangar was constructed sometime between 2012 and 2014.

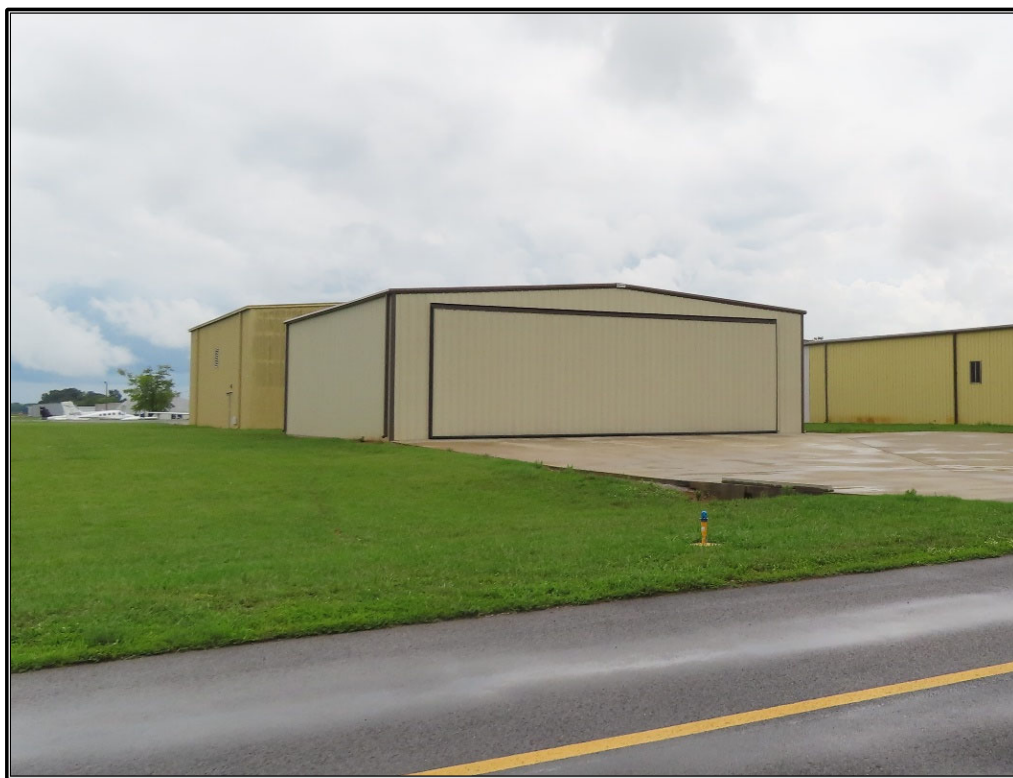
Figure 70. SP 2: East and north elevations of hangar (Resource P), looking southwest.

Located approximately 1,010 ft northeast of the terminal is an airplane hangar (Resource P) (Figure 70). The hangar is set on a concrete slab, is clad in metal panels, and rests beneath a shallow-pitched gable roof of metal panels. The north elevation is pierced by a large vehicular entry filled with a large metal retractable door. Based on a review of recent aerial photographs, the hangar was constructed sometime between 2017 and 2022.

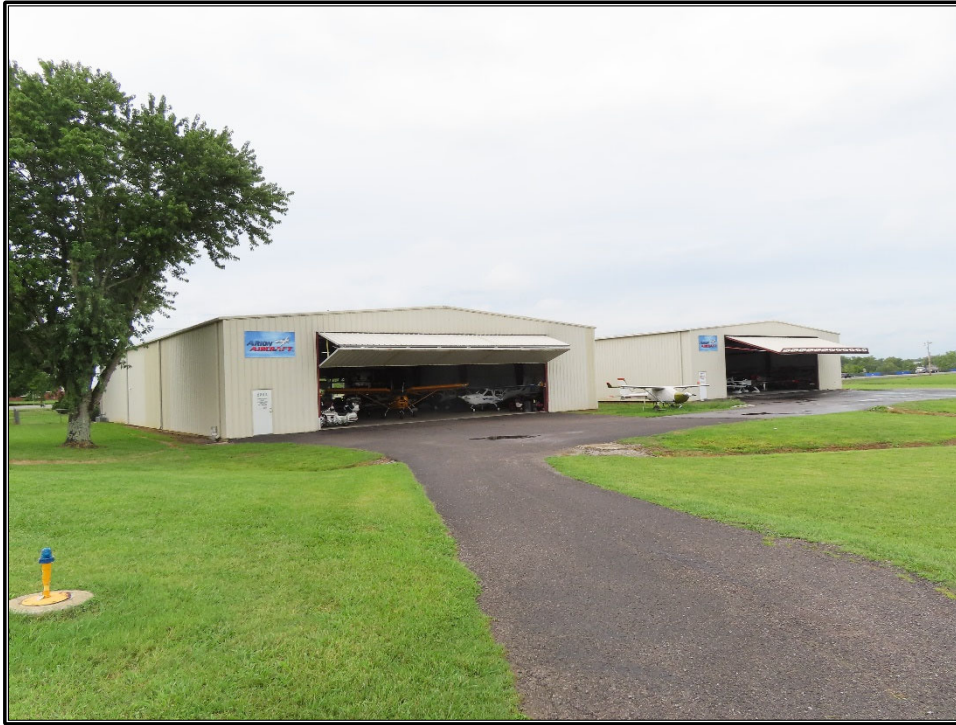
Figure 71. SP 2: South and east elevations of airplane hangars (Resources Q and R), looking northwest.

Located between 1,270 and 1,360 ft north of the terminal is a pair of airplane hangars (Resources Q and R) (Figure 71). The hangars are set on concrete slabs, are clad in metal panels, and rest beneath shallow-pitched gable roofs of metal panels. The east elevations are pierced by vehicular entries filled with metal bi-fold doors. The west portions of the buildings house rooms for offices and other facilities pertaining to a flight school, accessed through single-leaf entries and vehicular entries. Adjacent to the west elevations are parking lots accessed from US 231 N. Based on a review of recent aerial photographs, the hangars were constructed between 1992 and 2007.

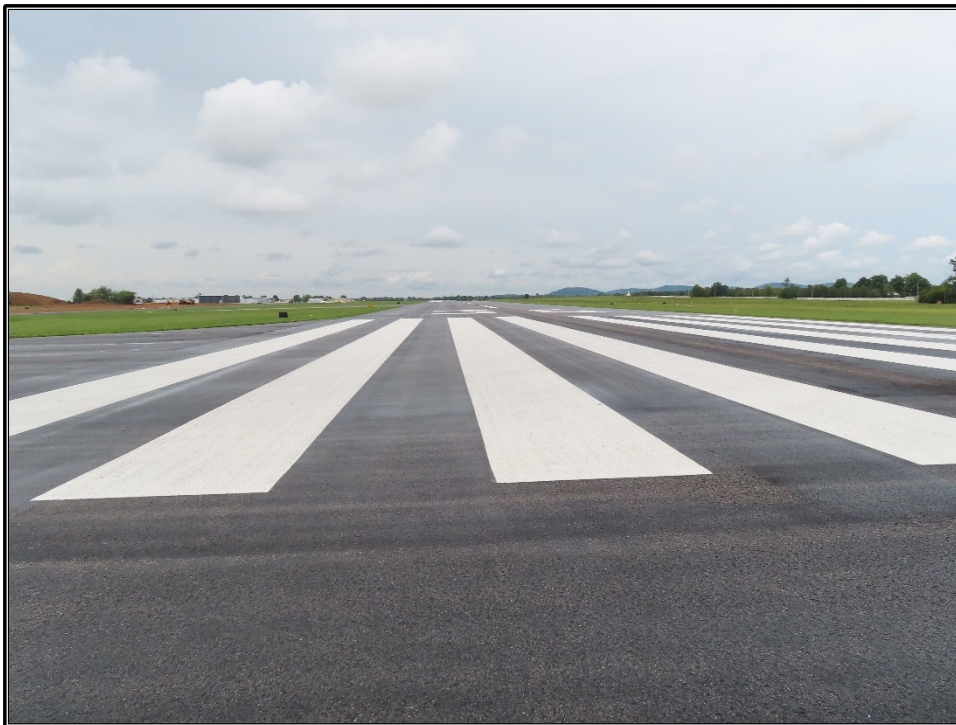
Figure 72. SP 2: Southeast end of runway (Resource S), looking northwest.

Extending northwest–southeast through the approximate center of the airport is the runway (Resource S) (Figure 72). The runway is approximately 5,500 ft long and 100 ft wide, paved in asphalt. Accessing the runway are five connective taxiways approximately 300 ft long, at the northwest and southeast ends of the runway, and at three locations along the runway’s route. Parallel to the runway on its west side, with approximately 325 ft of turf between, is a taxiway approximately 5,500 ft long and 50 ft wide, which is accessed from the various hangars via paved drives and aprons (Figures 73 and 74). Painted markings on the paved areas, lights, and signage offer guidance to incoming and outgoing aircraft (Figure 75). The runways and associated taxiways and aprons have changed in configuration since the airport was laid out in the late 1940s. The majority of the runway in its current route was established by circa 1960, at which point it was 5,000 ft long. By 2007 it had been extended southward to its current length. Taxiways were added and altered as the airport expanded and added hangars north and south of the terminal. A triangular arrangement of two connective taxiways between the terminal and the runway was laid down in the 1950s and persisted until about 2020, when the current configuration was achieved.

The fire station (Resource K), runway (Resource S), and VOR (Resource AA) do not embody the distinctive characteristics of locally important types, periods, or methods of construction, and do not possess additional known architectural significance. Further, the fire station displays diminished integrity due to a large modern addition. The runway has been lengthened and its associated taxiways altered and no longer reflect the entirety of their original layout. Thus, CRA recommends that Resources K, S, and AA are ineligible for listing in the NRHP.

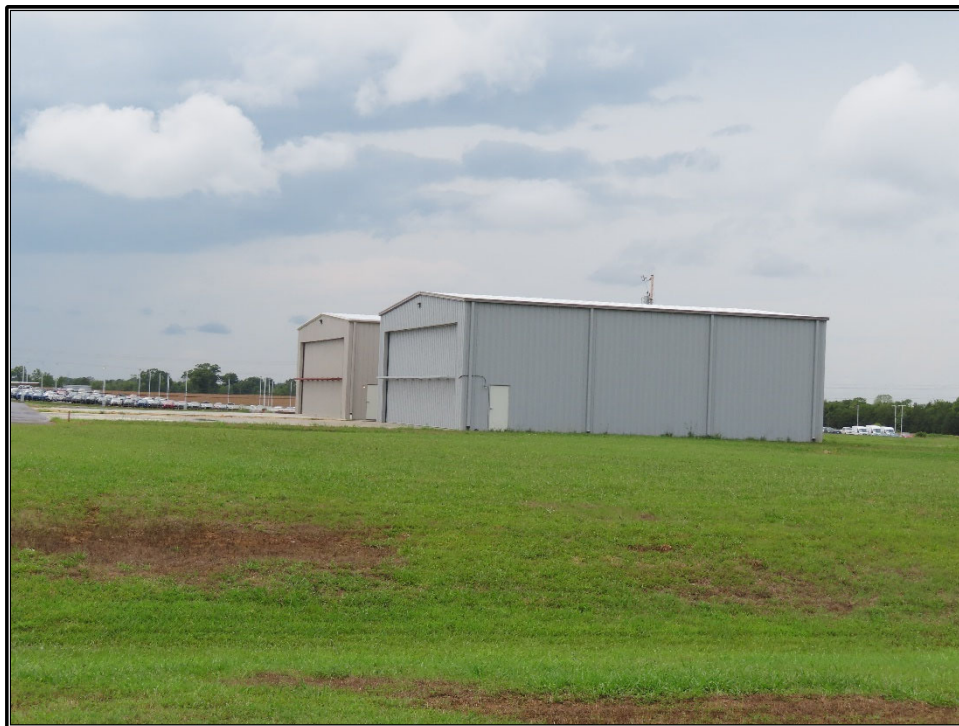
Figure 76. SP 2: Two airplane hangars (Resources U and T) located south of the terminal, looking northwest.

Located approximately 940 ft south and southeast of the terminal are two airplane hangars (Resources T and U) (Figure 76). The hangars are set on concrete slabs, are clad in metal panels, and rest beneath shallow pitched gable roofs of metal panels. The south elevations are pierced by vehicular entries filled with metal bi-fold doors. The east elevations are pierced by single-leaf entries. Based on a review of recent aerial photographs, the hangars were constructed between 2022 and 2024.

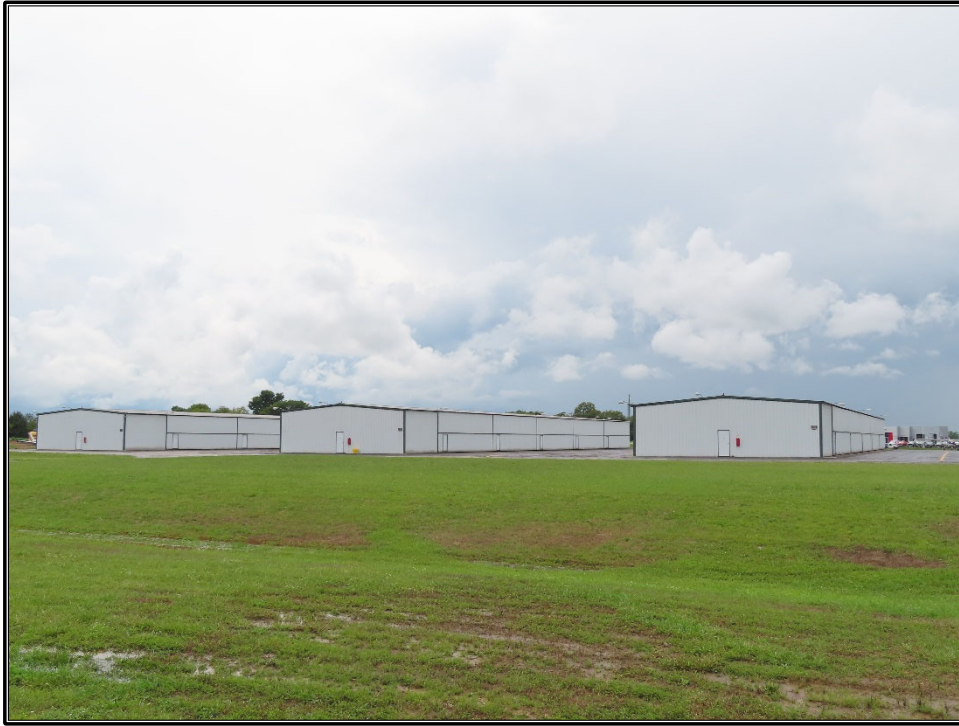
Figure 77. SP 2: Trio of hangars (Resources V, W, and X) located south of the terminal, looking southwest.

Located between approximately 1,100 and 1,350 ft south of the terminal is a trio of airplane hangars (Resources V, W, and X) (Figure 77). The hangars are set on concrete slabs, are clad in metal panels, and rest beneath shallow-pitched gable roofs of metal panels. The north and south elevations of the hangars are pieced by rows of five vehicular entries filled with metal bi-fold doors; each bi-fold door is pierced by a single-leaf entry. The east elevations of the buildings are also pierced by single-leaf entries. Based on a review of recent aerial photographs, the hangars were constructed between 1992 and 2007.

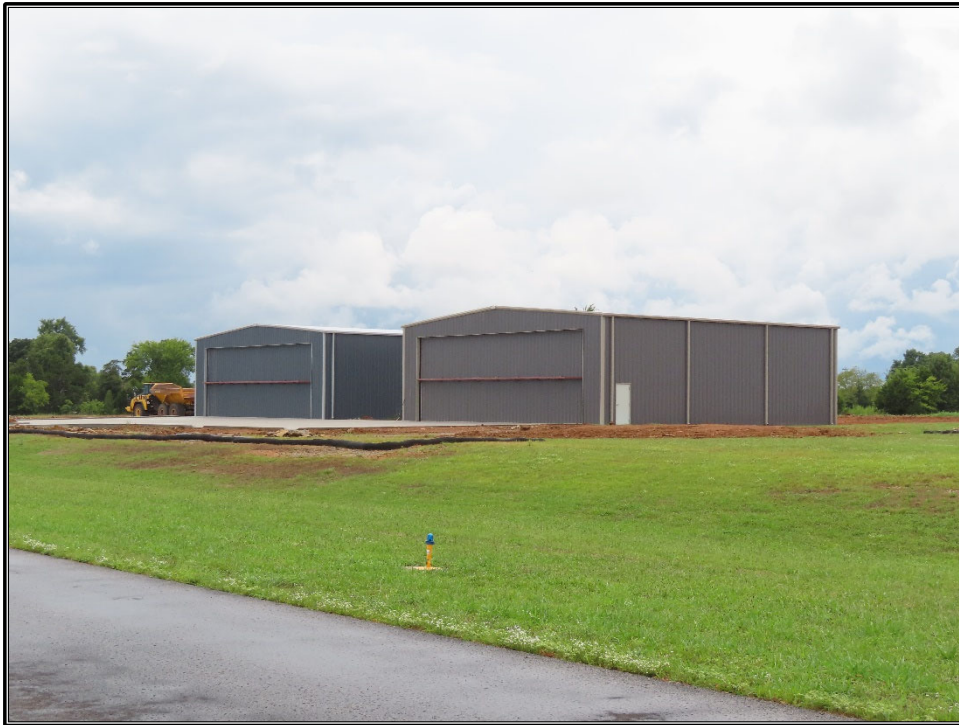
Figure 78. SP 2: Pair of hangars (Resources Y and Z) located south of the terminal, looking southwest.

Located between approximately 1,600 and 1,700 ft southeast of the terminal is a pair of airplane hangars (Resource Y and Z) (Figure 78). The hangars are set on concrete slabs, are clad in metal panels, and rest beneath shallow-pitched gable roofs of metal panels. The east elevations are pierced by large vehicular entries filled with metal bi-fold doors. Single-leaf entries pierce the north elevation of Resource Y and the south elevation of Resource Z. Based on a review of recent aerial photographs, the hangars were constructed between 2023 and 2024.

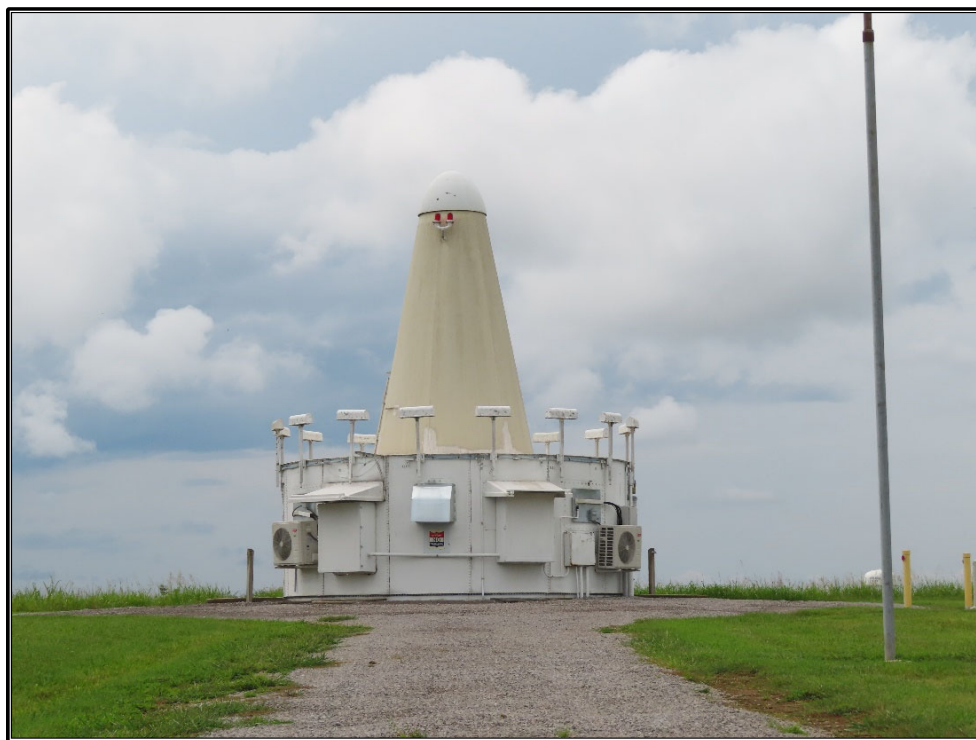
Figure 79. SP 2: East elevation of the VOR, looking west.

Located approximately 0.34 mi east of the terminal, and 0.18 mi east of the runway, is a structure known as a VOR (very high frequency omni-directional range) station (Resource AA) (Figure 79). The VOR is a short-range radio navigation system that assists airplanes in determining their position and maintaining course. The VOR at the Shelbyville airport is composed of a cone-shaped apparatus atop a cylindrical base, to which are attached multiple pieces of equipment. The technology for the VOR was initiated in the late 1930s and developed further during World War II. The first such facility in the U.S. was commissioned in 1946/1947 by the Civil Aeronautics Administration (Federal Aviation Administration [FAA] n.d.). By 1950, the first airways utilizing chains of VORs, called “Victor” airways, were operational (Milbrooke 1998:17). The VOR at the Shelbyville Municipal Airport was installed in the early 1960s and is still in use as an important component of the airport’s operations.

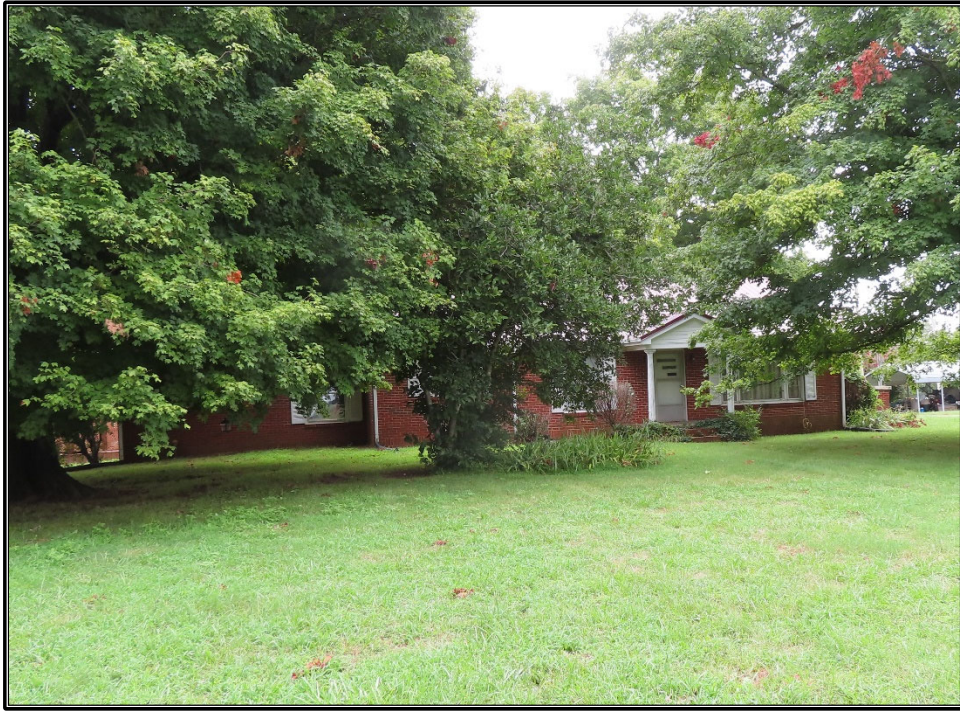
Figure 81. SP 3: Façade (west) elevation of residence, looking east.

Oriented west, the residence at Site 1 is a one-story, six-bay (w/w/ww/w/d/www), side-gable Linear Ranch house; the left two bays are offset (Figure 81). It is set on a concrete-slab foundation, is clad in brick veneer, and rests beneath a roof sheathed in modern metal panels. Just above ground level is a band of brick veneer laid in a basket-weave pattern. The gable fields are clad in vinyl siding. Projecting from the south elevation is an original porch. Attached to the northeast corner of the house is a modern wood deck. Windows exhibit two-over-two, double-hung, wood sashes flanked by inoperable shutters. The façade is characterized by an off-center single-leaf entry filled with an original three-light door, which opens onto a partial-width porch sheltered by a front gable supported by two Tuscan wood columns (Figure 82). To the right of the entry the façade is pierced by a picture window flanked by one-over-one sidelights.

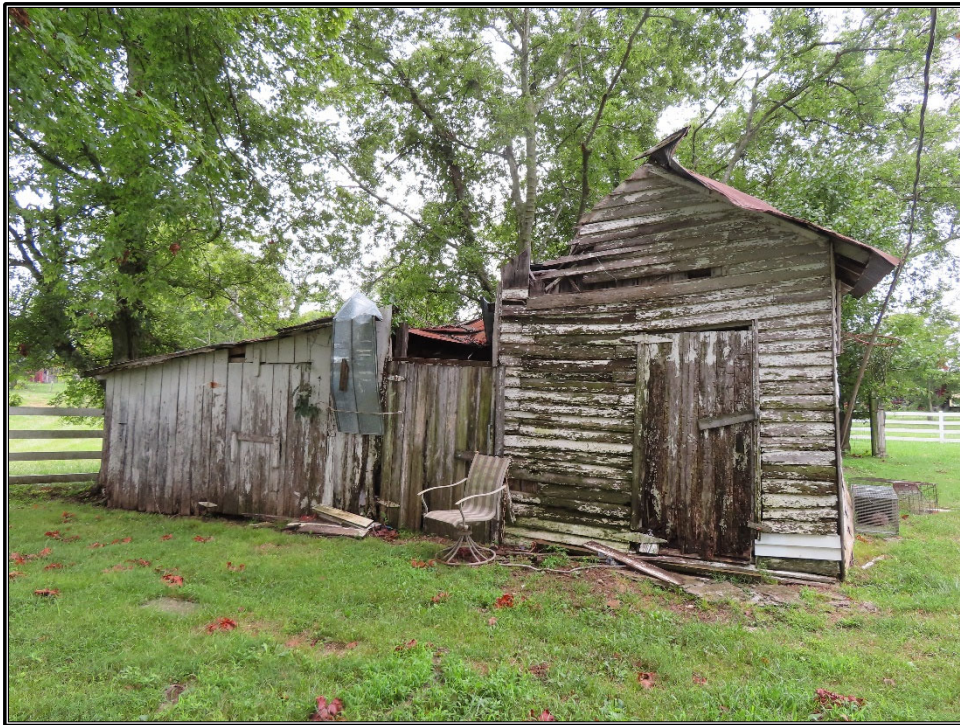
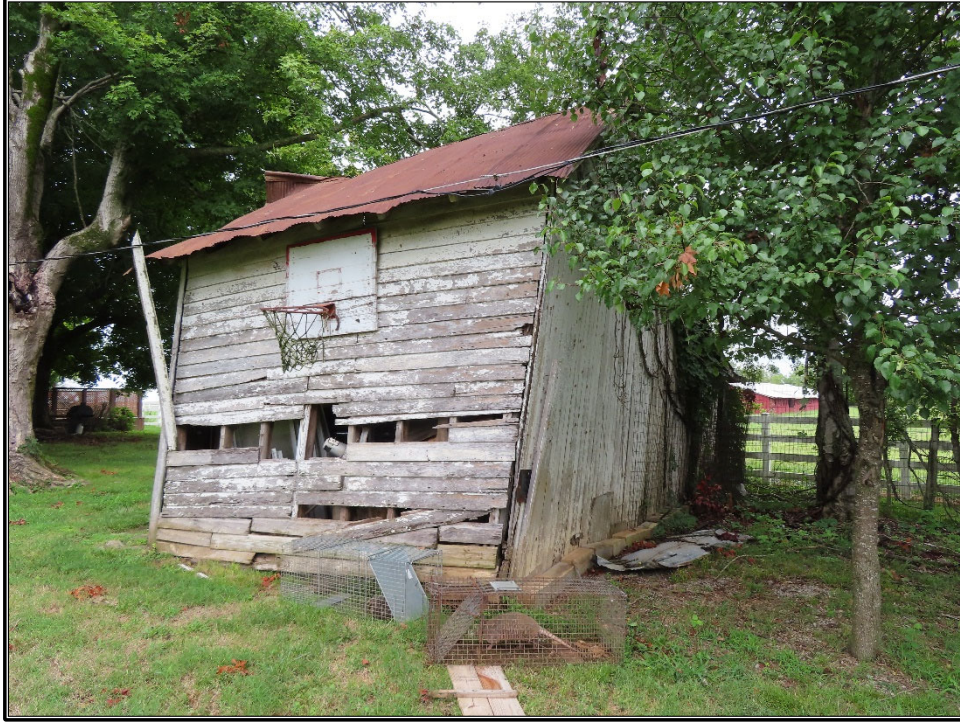
Figure 87. SP 3: Façade (west) elevation of smokehouse (Resource A), looking east.

Located approximately 80 ft east of the residence is a one-story frame smokehouse (Resource A) (Figures 87 and 88). The smokehouse is clad in weatherboard and vertical-board siding, and rests beneath a front-gable roof sheathed in corrugated metal panels. Attached to the north elevation is a shed-roof addition clad in vertical-board siding. The west elevation of the original portion of the building is pierced by a single-leaf entry filled with a vertical-board door. The façade of the addition is pierced by two entries filled with vertical-board doors. During a storm, a tree fell on the building and it suffered damage to the roof. According to the current owners, the smokehouse was associated with the original nineteenth-century house that was on the property. The building has become dilapidated.

Figure 88. SP 3: South and east (rear) elevations of smokehouse (Resource A), looking northwest.

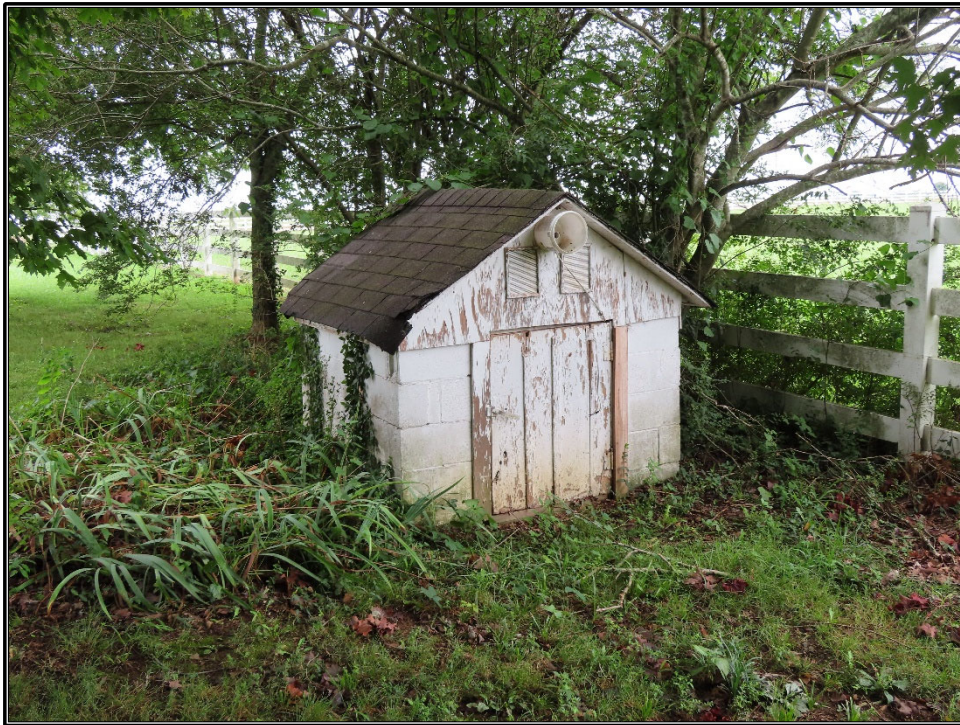
Figure 89. SP 3: South and east elevations of well house (Resource B), looking northwest.

Located approximately 55 ft northwest of the residence is a small well house (Resource B) (Figure 89). The well house has concrete-block walls to grade, is clad in plywood panels in the gable fields, and rests beneath a front-gable roof sheathed in asphalt shingles. The east elevation is pierced by an entry filled with a vertical-board door. Based on form and materials, the well house likely dates to the mid-twentieth century.

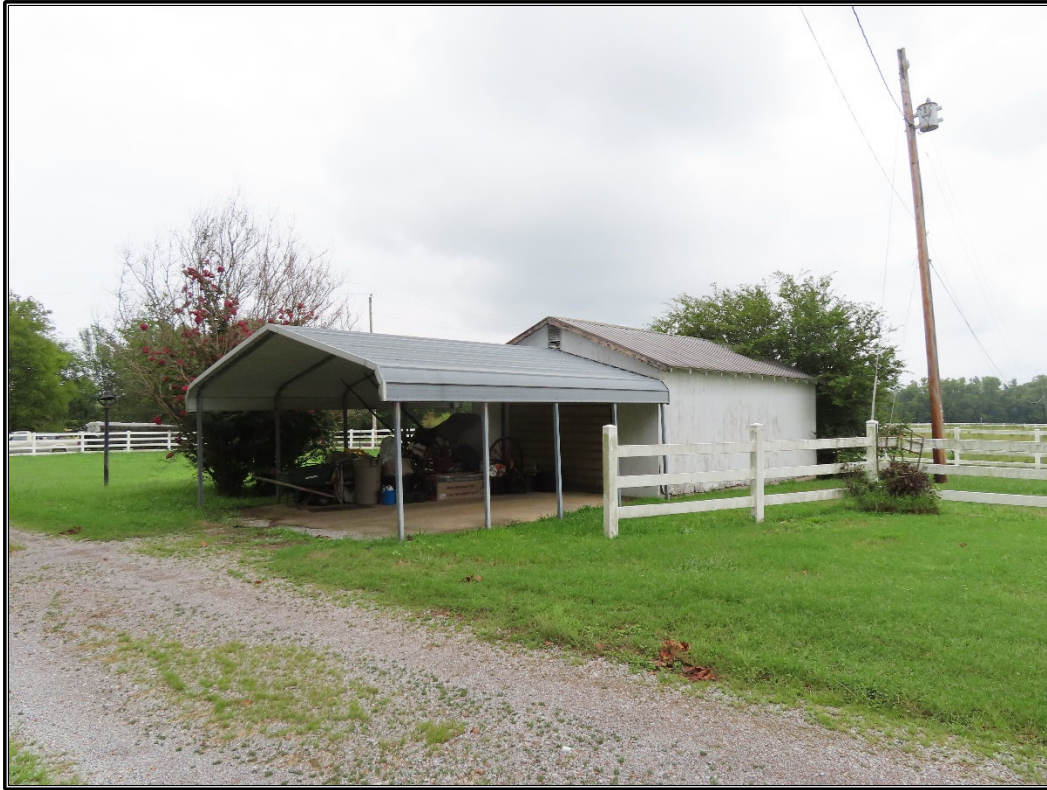
Located approximately 70 ft southeast of the residence is a one-story, frame garage (Resource C) (Figure 90). The garage is set on a concrete-slab foundation, is clad in composite-panel siding, and rests beneath a front-gable roof sheathed in metal panels. Attached to the north elevation is a modern gable-roof metal carport that shelters a concrete parking pad. The north elevation of the garage is pierced by a vehicular entry filled with a metal roll-up door. The east elevation is pierced by a single window bay. Based on map evidence, form, and materials, the garage likely dates to the mid-twentieth century; the attached carport is modern.

Figure 90. SP 3: North and west elevations of garage (Resource C), looking southeast.

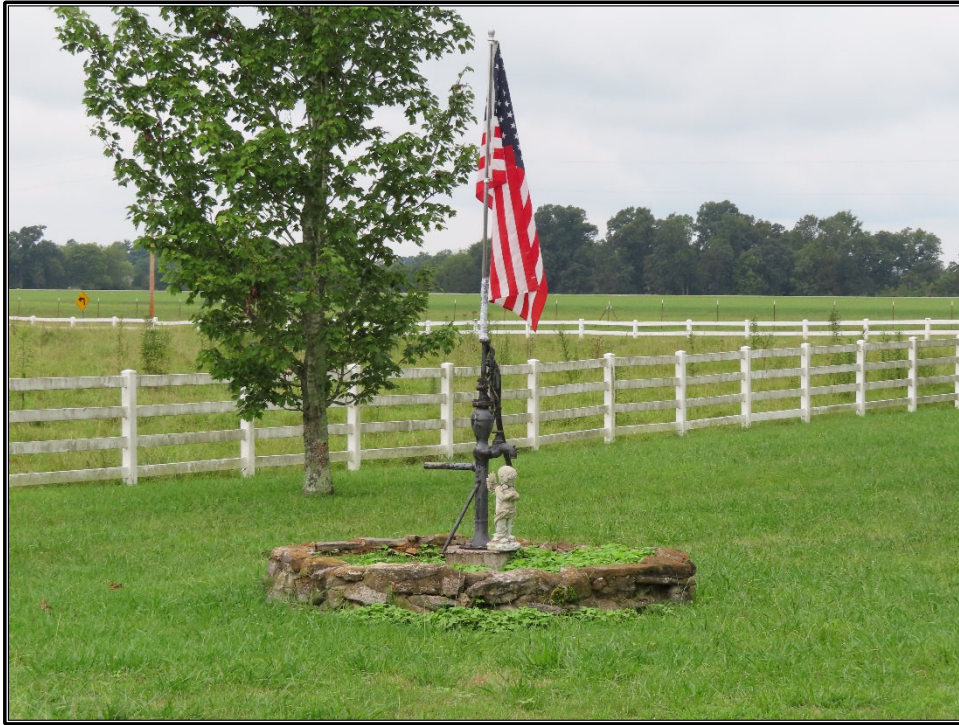
Figure 91. SP 3: Well pump (Resource D) located southwest of the residence, looking southwest.

Located approximately 80 ft southwest of the residence is an old well pump (Resource D) (Figure 91). Based on its form, the pump likely dates to the late nineteenth or early twentieth century. The pump was associated with the original house on the property and was moved to its current spot from its original location east of the garage.

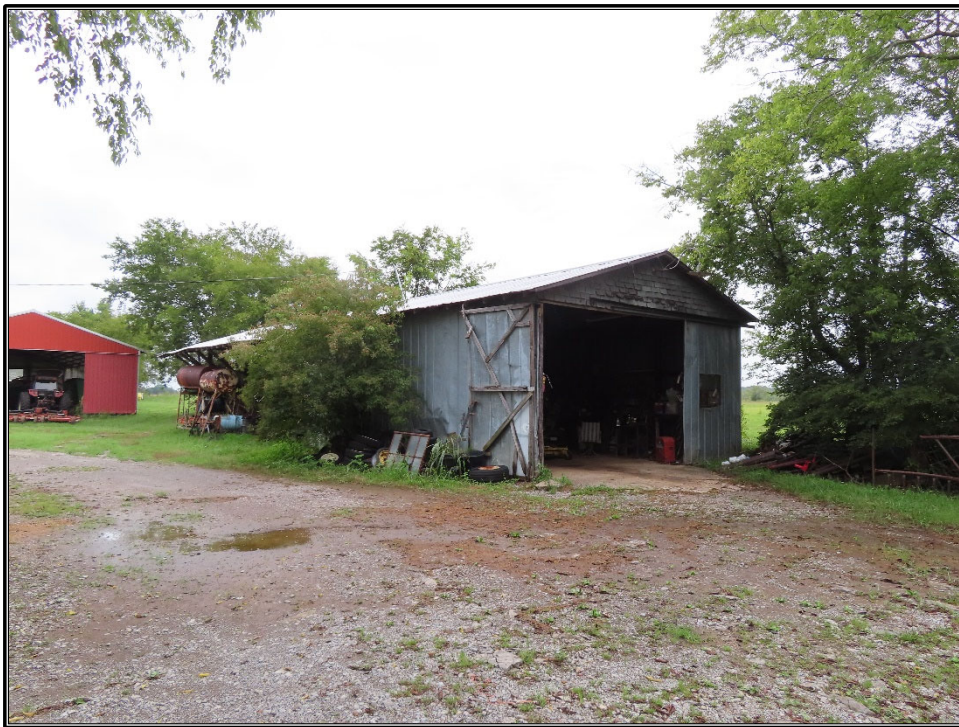
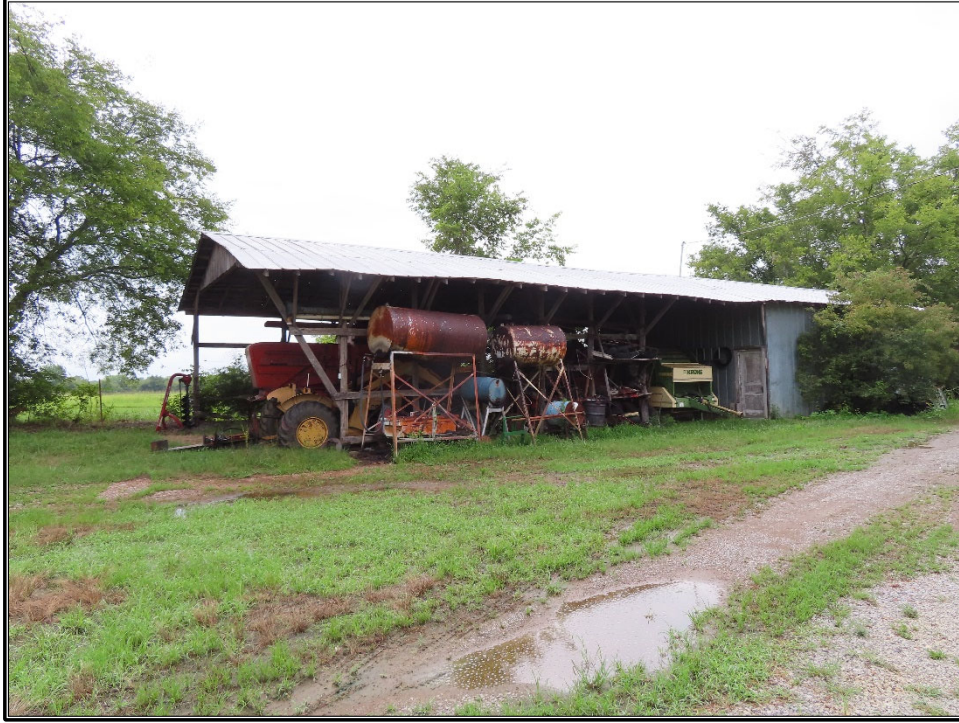
Figure 92. SP 3: West and south elevations of equipment shed (Resource E), looking northwest.

Located approximately 280 ft east of the residence is a one-story, frame equipment shed (Resource E) (Figures 92 and 93). The equipment shed is set on a poured-concrete foundation, is clad in metal panels, and rests beneath a gable roof sheathed in metal panels. The gable field on the south elevation is clad in asphalt shingles. The south portion of the building is enclosed; the north portion is open. The south elevation of the enclosed portion is pierced by a vehicular entry filled with a pair of metal-panel doors; the north elevation is pierced by at least one single-leaf entry filled with a wood door. Based on map evidence, form, and materials, and information from the current owners, the equipment shed was built in the late 1960s.

Figure 93. SP 3: North and west elevations of equipment shed (Resource E), looking southeast.

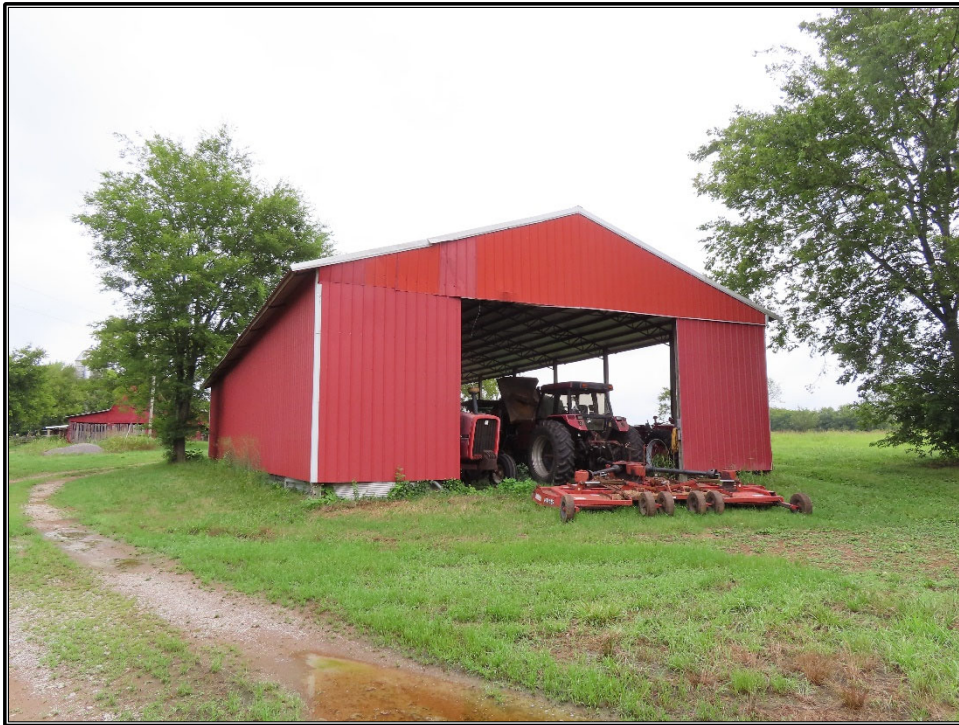
Figure 94. SP 3: South and west elevations of equipment shed (Resource F), looking northeast.

Located approximately 265 ft northeast of the residence is a frame equipment shed (Resource F) (Figures 94 and 95). The shed is clad in modern metal panels and rests beneath a gable roof of metal panels. The south and north elevations are pierced by large vehicular entries. The east elevation is open and presents eight bays. Based on map evidence, form, and materials, and information from the current owners, the equipment shed was built in the 1990s partly on the site of an older barn that was torn down.

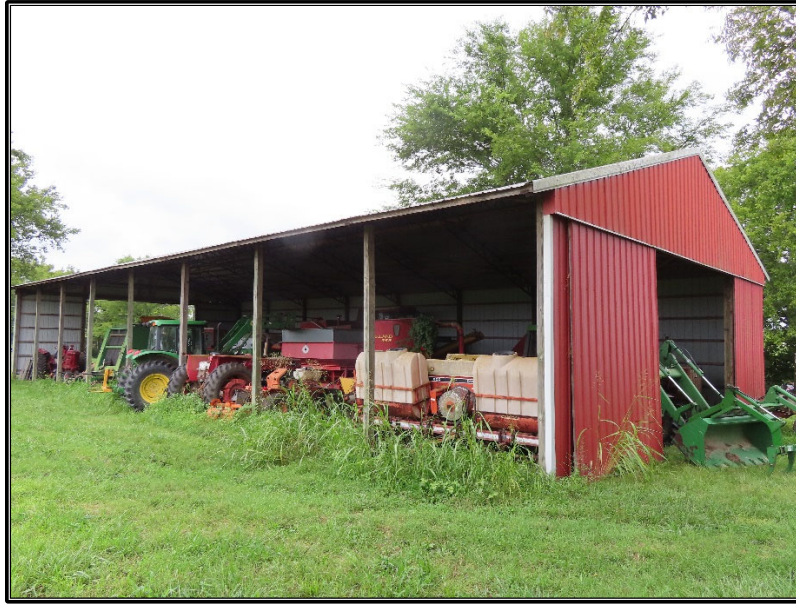
Figure 95. SP 3: East and north elevations of equipment shed (Resource F), looking southwest.

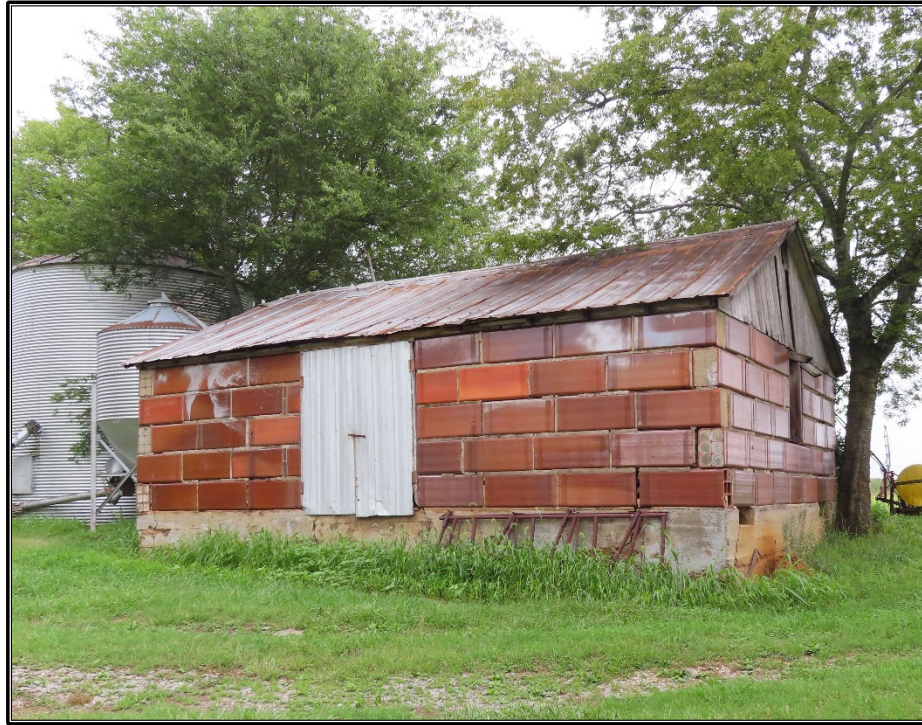
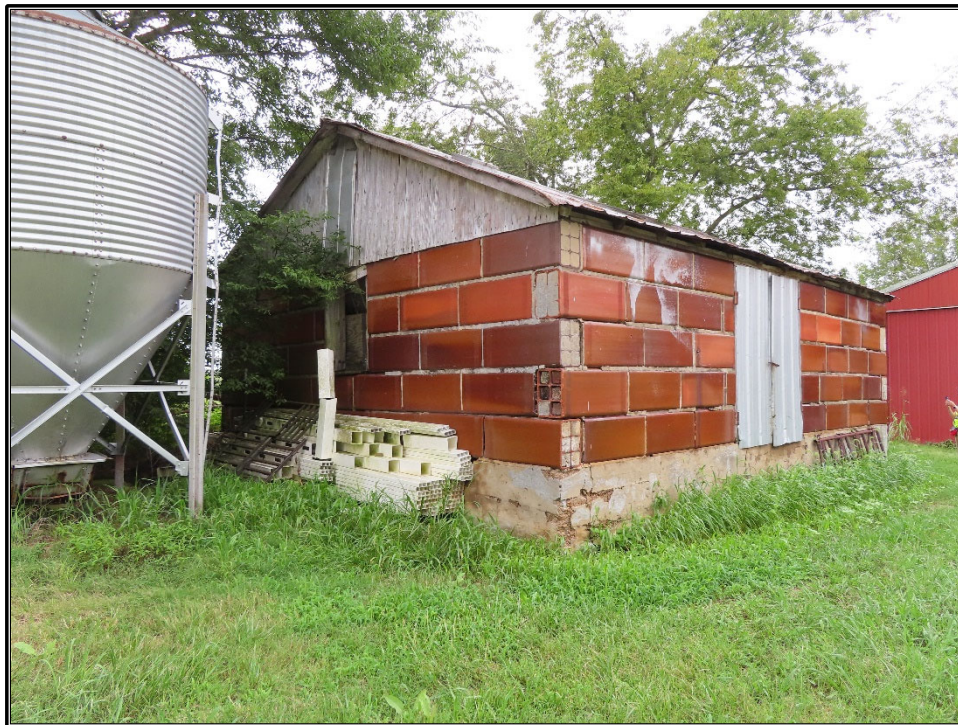
Figure 96. SP 3: West and south elevations of granary (Resource G), looking northeast.

Located approximately 340 ft northeast of the residence is a one-story granary (Resource G) (Figures 96 and 97). The granary is set on a formed-concrete foundation, has masonry walls, and rests beneath a gable roof sheathed in metal panels. The gable fields are clad in vertical-board siding. The masonry blocks used for the walls are repurposed telephone/telegraph tiles, many with the cells filled with concrete, bricks, or stones. The west elevation is pierced by a double-leaf entry covered by a pair of metal-panel doors. The south and north elevations are each pierced by a single window bay. According to the current owner, the granary was associated with the original nineteenth-century house on the property. The granary first appears on a 1951 topographic map; the prior topographic map, which dates to 1936, only depicts dwellings and not outbuildings. Telephone tiles were hollow core, salt-glazed, terra cotta with multiple cells, originally designed as underground conduits for telephone cables in the early twentieth century. Occasionally the tiles were repurposed as building materials, including for foundations and walls, as well as for silos. Based on map evidence, form, and materials, the granary was likely built in the 1910s or 1920s.

Figure 97. SP 3: North and west elevations of granary (Resource G), looking southeast.

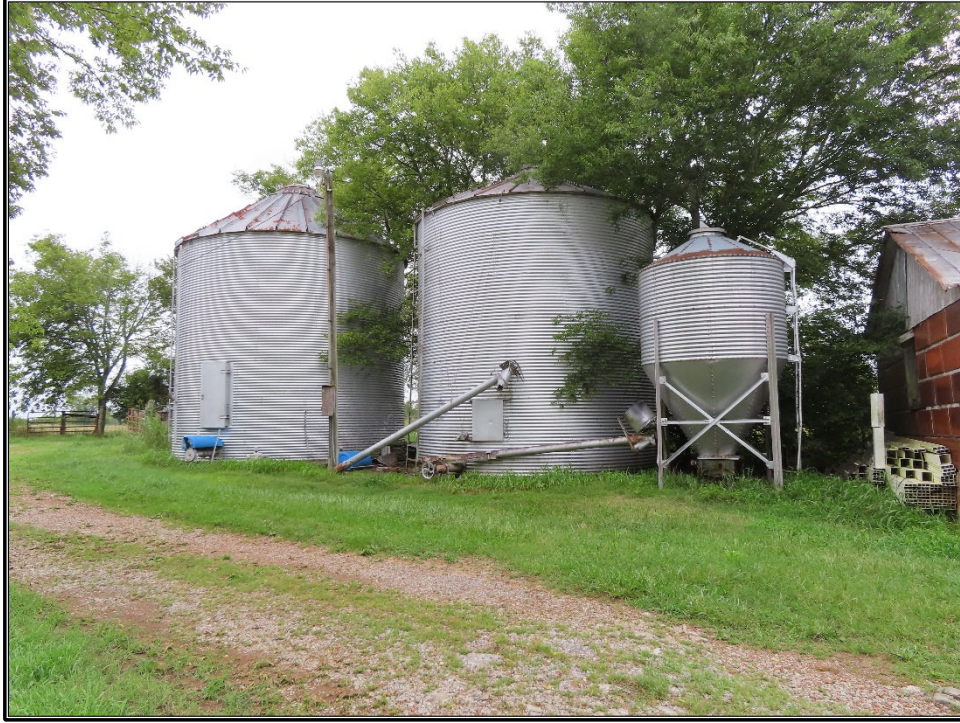
Figure 98. SP 3: West and south sides of three grain storage bins (Resource H), looking northeast.

Located approximately 370 ft northeast of the residence is a group of three grain storage bins (Resource H) (Figure 98). Two of the bins are larger and nearly identical; the third bin is smaller and has a chute on the base. All three bins are cylindrical and clad in metal, with metal caps. Based on map evidence, form, and materials, and information from the current owners, the bins were moved to the property in the late 1970s.

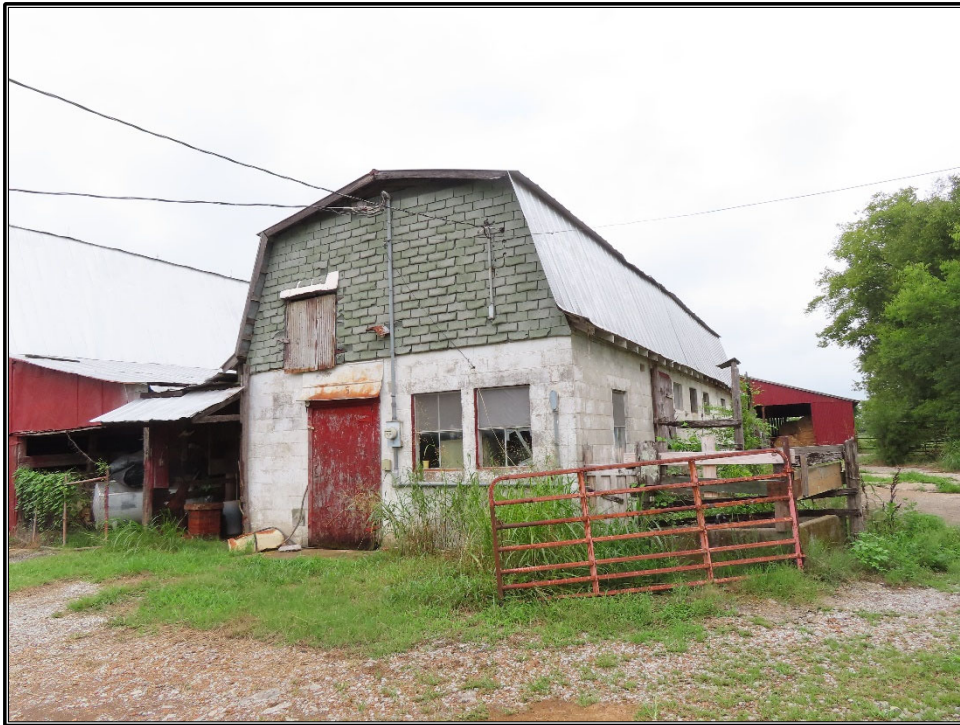
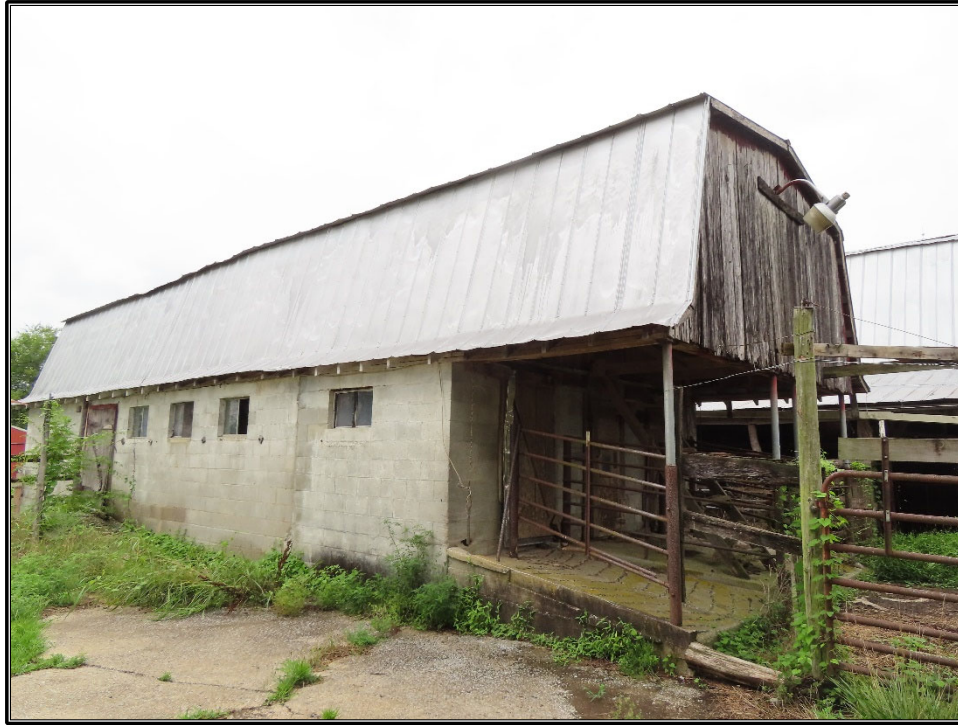
Figure 99. SP 3: South and east elevations of milk house (Resource I), looking northwest.

Located approximately 415 ft northeast of the residence is a two-story milk house (Resource I) (Figures 99 and 100). The milk house is set on a poured-concrete slab, has concrete-block walls to grade, is clad in the gable fields with asphalt shingles and vertical-board siding, and rests beneath a gambrel roof sheathed in metal panels. Attached to the west elevation is a flat-roof addition that connects the building to the adjacent barn. Visible windows exhibit two-over-two, metal-frame, awning-casement sashes and two-light sliding-casement sashes. The south elevation is pierced by a wide single-leaf entry filled with a wood door and two single window bays; at the second story is an opening covered by a metal panel. The east elevation is pierced by five single window bays and a single-leaf entry that opens onto a concrete stoop with a ramp. The north (rear) elevation is pierced by two single-leaf livestock entries that open onto a concrete ramp sheltered by an extension of the roof. Adjacent to the north elevation are livestock pens. Based on map evidence, form, and materials, and information from the current owners, the milk house dates to the mid-twentieth century.

Figure 100. SP 3: East and north elevations of milk house (Resource I), looking southwest.

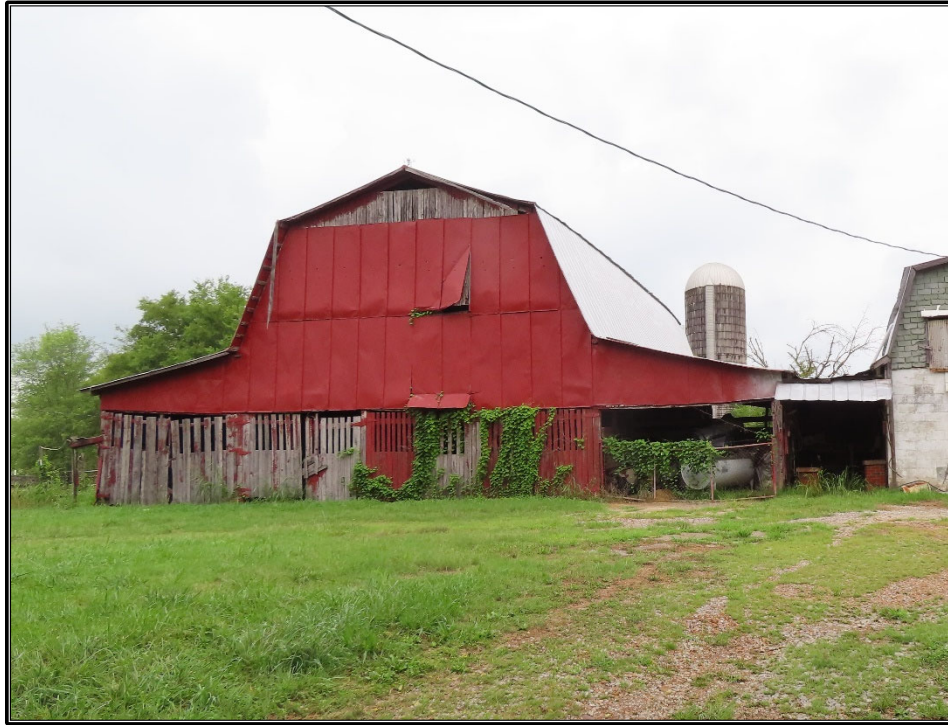
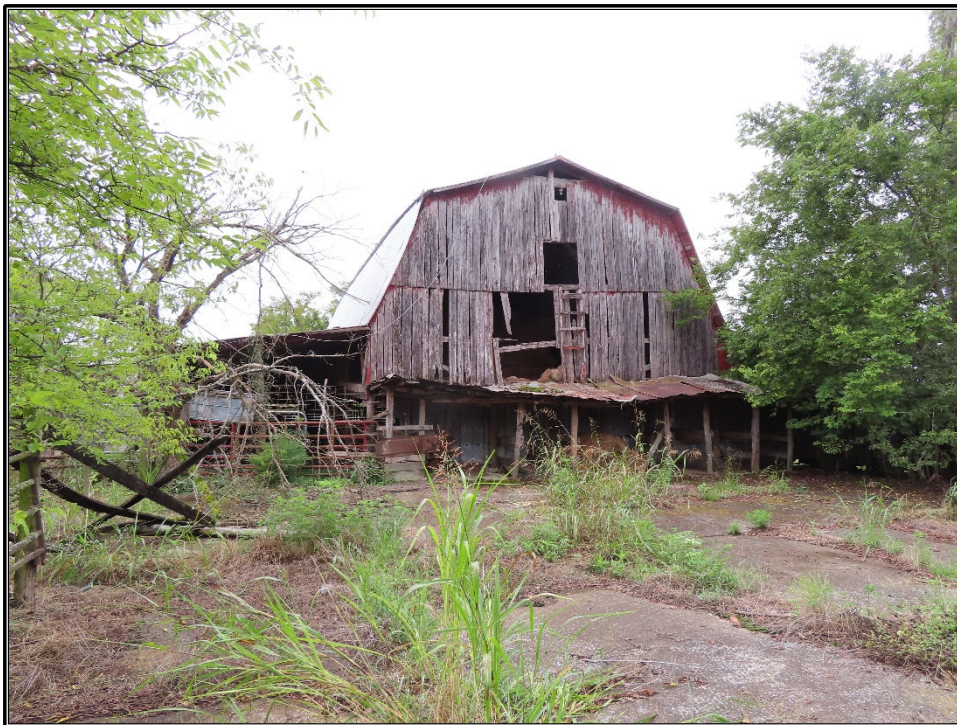
Figure 101. SP 3: South elevation of livestock barn (Resource J), looking northwest.

Located approximately 370 ft northeast of the residence is a two-story, frame livestock barn (Resource J) (Figures 101 and 102). The barn is clad in vertical-board siding and metal panels, and rests beneath a gambrel roof sheathed in modern metal panels. Attached to the east and west elevations are one-story, shed-roof lean-tos; the east lean-to presents an open runway. The south elevation of the barn is pierced by a row of four wide entries filled with pairs of vertical-board doors. Attached to the north elevation is a one-story, shed roof supported by wood posts that form a row of livestock pens or feeding stations. At the second-story, the north elevation is pierced by a hayloft entry. The barn is in a state of disrepair. A barn at this location first appears on a 1951 topographic map; the prior 1936 topographic map does not indicate the locations of barns. Based on map evidence, form, and materials, and information from the current owners, the barn dates to the mid-twentieth century.

Figure 102. SP 3: North elevation of livestock barn (Resource J), looking south.
