HISTORIC ARCHITECTURAL RESOURCE SURVEY FOR THE PROPOSED DEVELOPMENT NEAR THE SHELBYVILLE MUNICIPAL AIRPORT, BEDFORD COUNTY, TENNESSEE

Cultural Resource Analysts, Inc.
119 West Summit Hill Drive
Knoxville, Tennessee 37902
CRA Project No.: T240252

September 2024

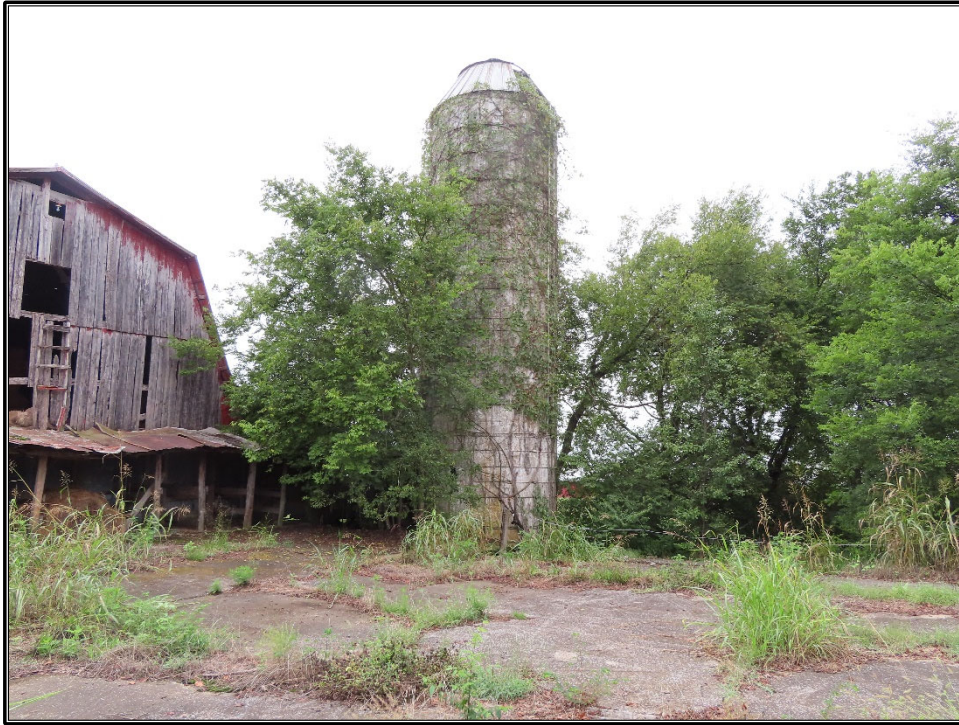
Figure 103. SP 3: North side of silo (Resource K), looking southwest.

Located approximately 420 ft northeast of the residence, and associated with the gambrel-roof barn (Resource J), is a silo (Resource K) (Figure 103). The silo is clad in metal panels and has a metal cap. Based on map evidence, form, and materials, and information from the current owners, the silo, like its associated barn, dates to the mid-twentieth century.

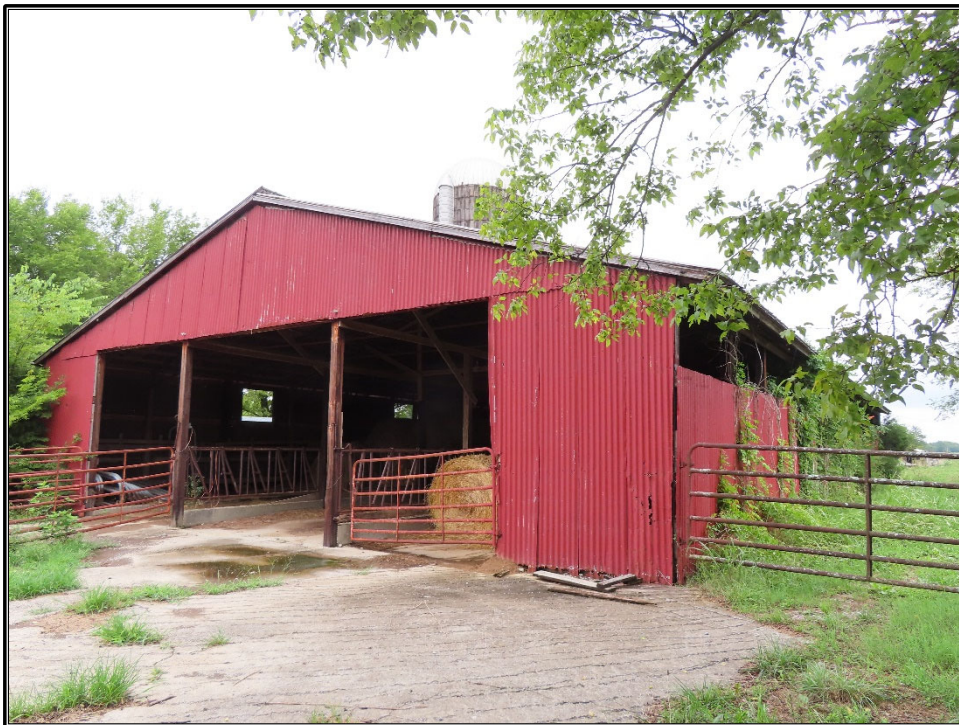
Figure 104. SP 3: South and east elevations of barn (Resource L), looking northwest.

Located approximately 510 ft northeast of the residence is a one-story, frame barn (Resource L) (Figure 104). The barn is set on a concrete-slab foundation, is clad in metal panels, and rests beneath a gable roof sheathed in metal panels. Inside the barn is a central runway, flanked by aisles for livestock. Currently the building is in use for hay storage. The north and south elevations are pierced by large openings for livestock and vehicles. Based on map evidence, form, and materials, the barn was constructed between 1987 and 1992.

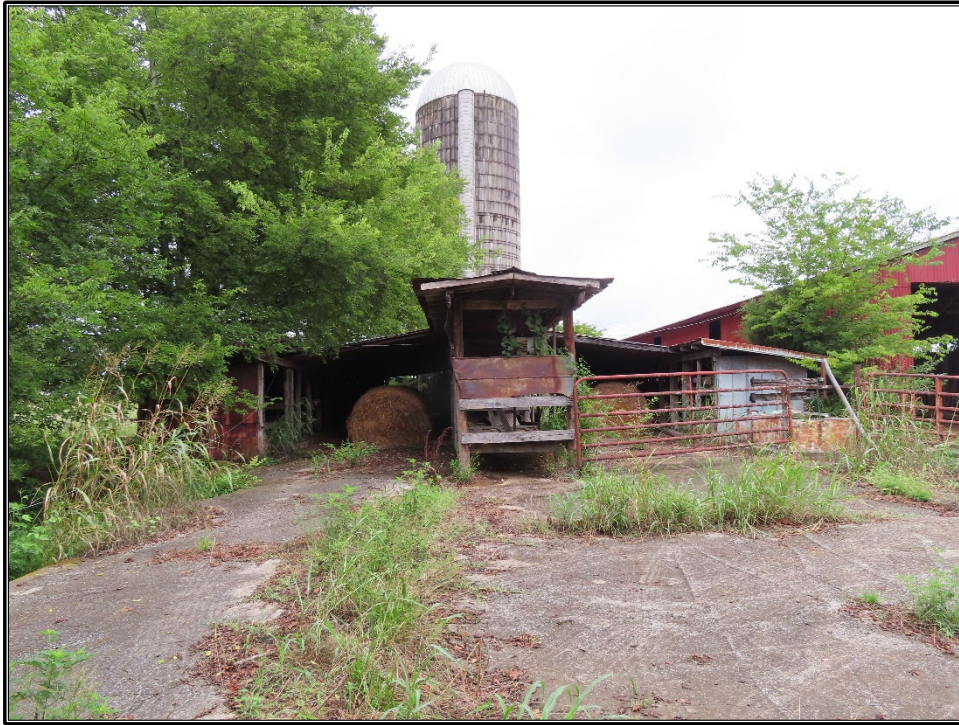
Figure 105. SP 3: South elevation of feeder building (Resource M), looking north.

Located approximately 500 ft northeast of the residence is a one-story frame feeder building or silo shed (Resource M) (Figure 105). The building is set on a concrete slab, is clad in metal panels, and rests beneath a gabled roof of metal panels. Down the center of the building is a narrow elevated platform that projects beyond the plane of the building on the south elevation, which supports a feeder apparatus with a motor at the south end attached to which is a feed belt running the length of the platform. At the north end of the building is an auger that pulls silage out of the associated silo, which is pulled via the feeder apparatus through the building to feed the cows after milking. Flanking the platform are runways. Along the east and west sides of the building are multiple small livestock pens. The building opens into a paved area that connects to the livestock barn and milk house. Based on a review of aerial photographs and information from the current owners, the building was constructed in the mid-twentieth century.

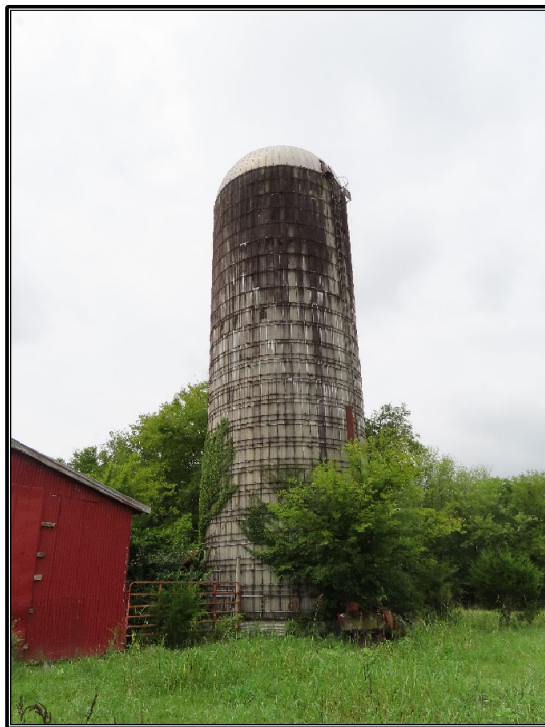
Figure 106. SP 3: Northeast side of silo (Resource N), looking southwest.

Located approximately at the north end of the feeder building is a silo (Resource N) (Figure 106). The silo is clad in metal panels and has a domed metal cap. Based on map evidence, form, and materials, and information from the current owners, the silo was constructed in the mid-twentieth century.

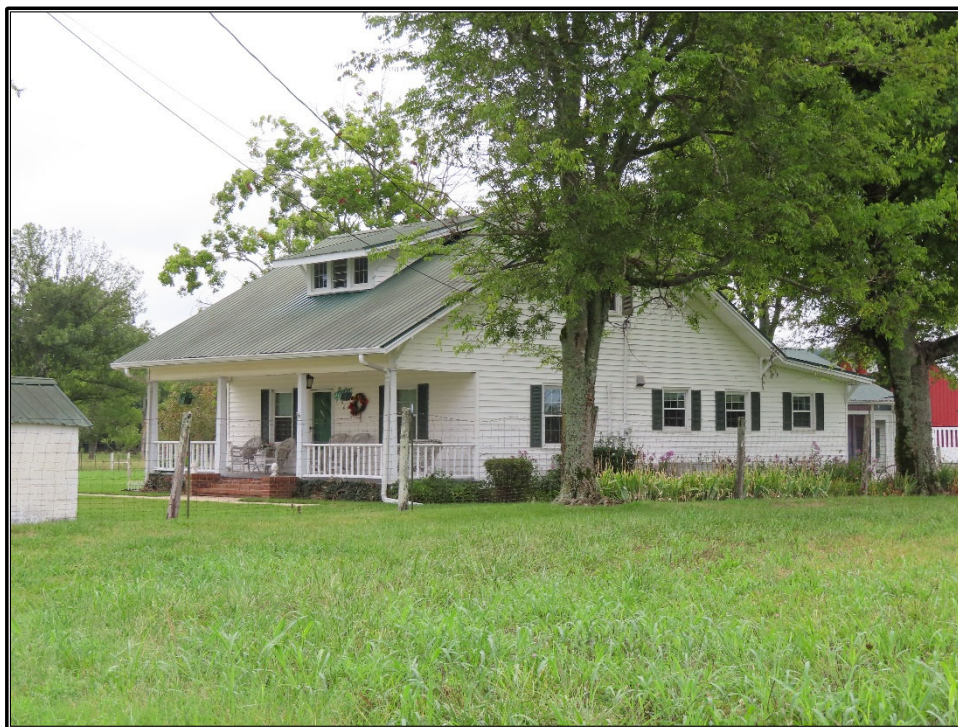
Oriented north, the residence is a one-and-one-half-story, three-bay (w/d/w), side-gable, American Bungalow house (Figure 112). Set on a concrete-block foundation, the residence is clad in vinyl siding, and rests beneath a roof sheathed in metal panels. Unless otherwise noted, observable windows exhibit one-over-one, double-hung sashes with faux six-over-six grids. The Tennessee Property Viewer lists the construction date as 1945; however, a house at this location appears on the 1936 topographic map. Based on available evidence, the residence was likely built in the early 1900s.

Figure 112. SP 4: Façade (north) and west elevations of residence, looking southeast.

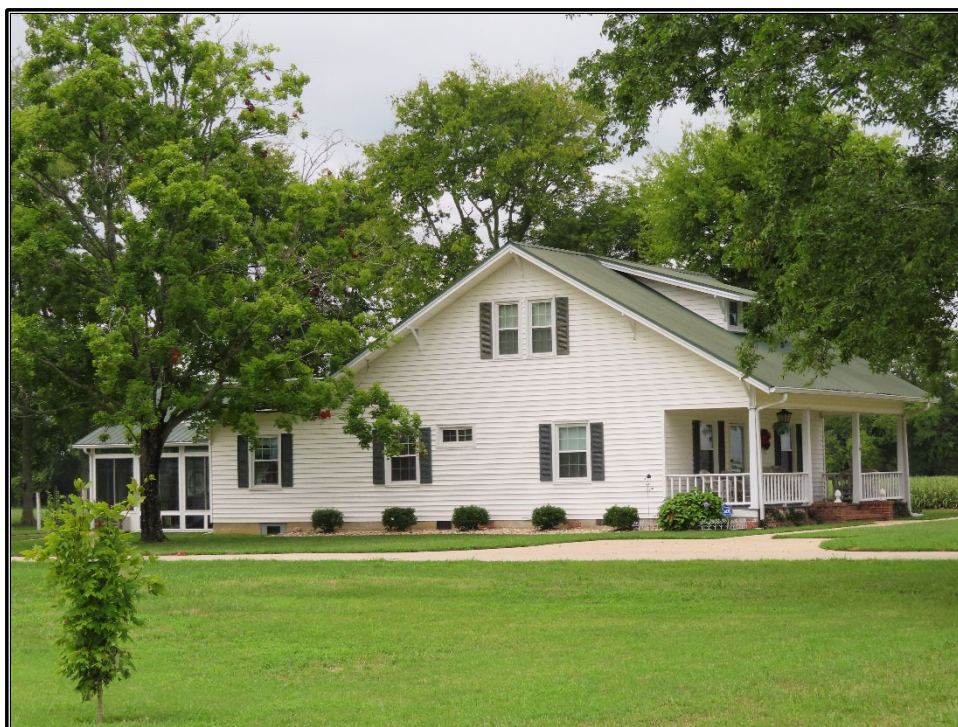
The east elevation of the residence is pierced by three single window bays and one rectangular two-light window (Figure 113). The half-story is pierced by a double window bay. From the east elevation an addition to the south elevation is visible, containing a covered sun porch. The west elevation is pierced by four single window bays in the first story and a double window bay at the half-story.

Figure 113. SP 4: East and façade (north) elevations of residence, looking southwest.

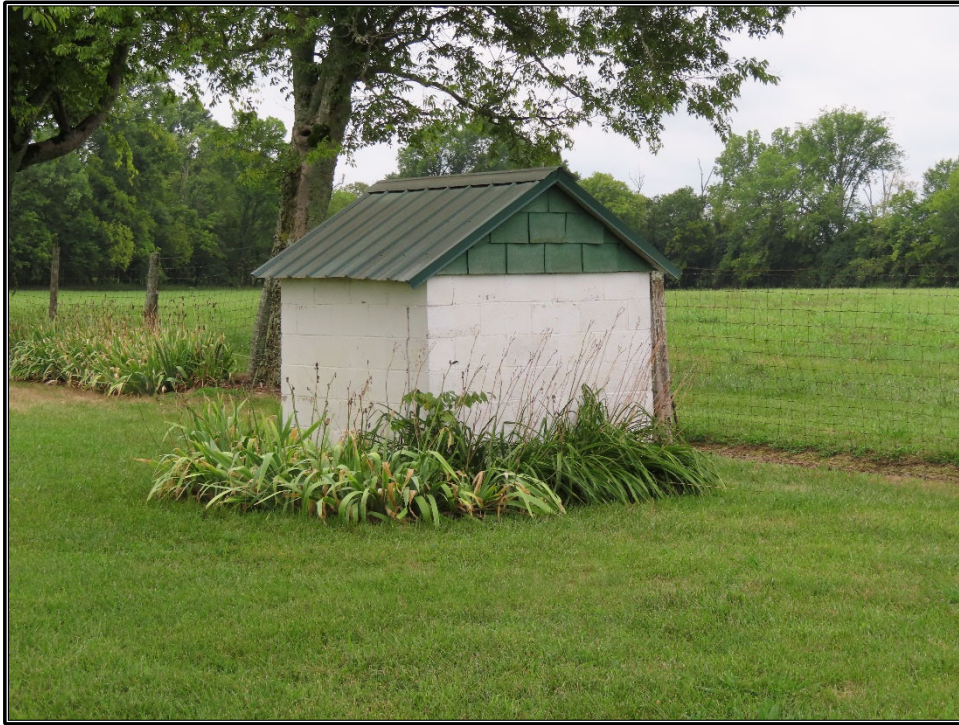
Located approximately 70 ft north of the residence is a well house (Resource A) (Figure 114). The well house has concrete-block walls to grade and rests beneath a front-gable roof sheathed in metal panels. The north, east, and west elevations exhibit no fenestration. The south elevation was not visible from the ROW. Based on form and materials, the well house was likely constructed concurrent with the residence.

Figure 114. SP 4: East and north elevation of well house (Resource A), looking southwest.

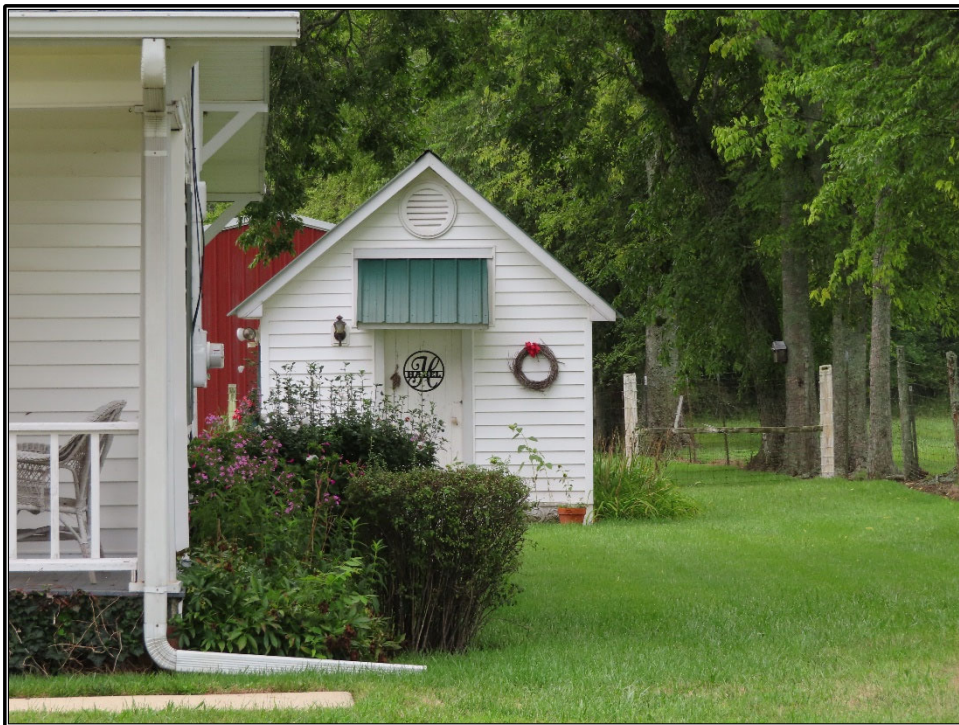
Located approximately 30 ft southwest of the residence is a shed (Resource B) (Figure 115). The shed is set on a concrete-block foundation, is clad in weatherboard siding, and rests beneath a front-gable roof sheathed in modern metal panels. The north elevation is pierced by a single-leaf entry filled with a vertical-board door, sheltered by a metal awning. The west elevation features no fenestration. The south and east elevations were not visible from the ROW. Based on available evidence, the shed was likely constructed concurrent with the residence.

Figure 115. SP 4: North elevation of shed (Resource B), looking south.

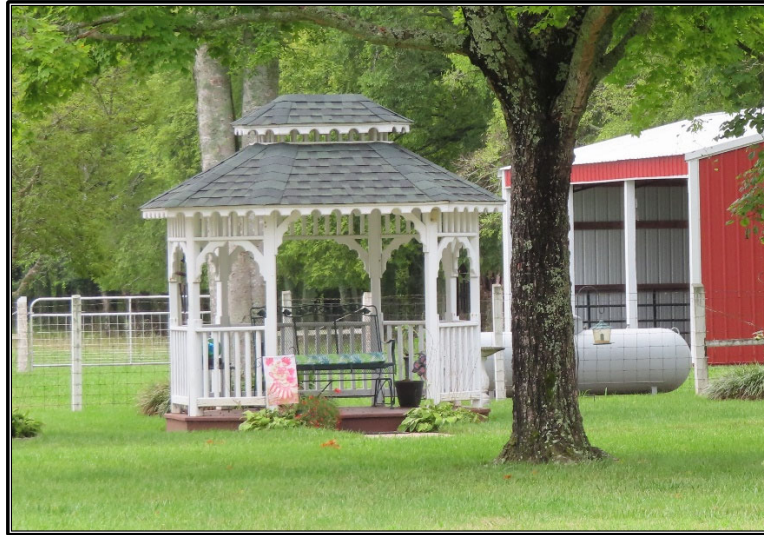
Located approximately 45 ft southeast of the residence is a gazebo (Resource C) (Figure 116). The gazebo is constructed of prefabricated materials. The gazebo is octagonal in shape and is covered by an octagonal roof sheathed in asphalt shingles. Based on a review of recent aerial photographs, the gazebo was constructed or moved to the property between 1992 and 2012.

Figure 116. SP 4: North elevation of gazebo (Resource C), looking south.

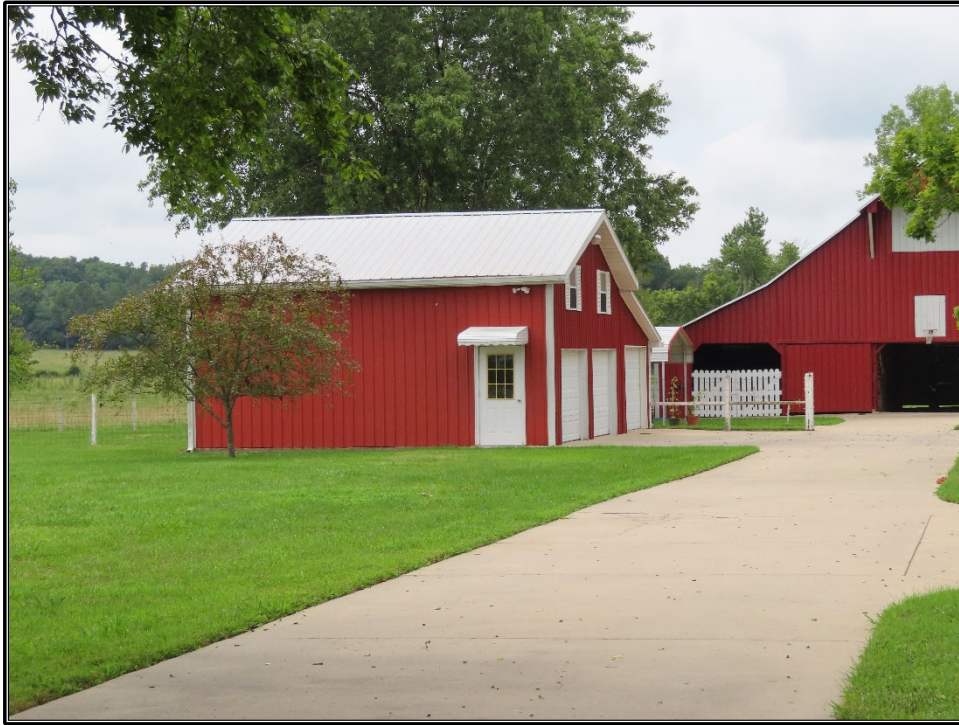
Located approximately 90 ft southeast of the residence is a detached one-and-one-half-story garage (Resource D) (Figure 117). The garage is set on a concrete slab, is clad in modern metal panels, and rests beneath a front-gable roof sheathed in modern metal panels. The north elevation is pierced by a single-leaf entry filled with a solid wood door with a nine-light window. An awning is centered above the doorway. The west elevation is pierced on the first story by three garage bays filled with metal overhead doors. The upper story is pierced by two window bays filled with one-over-one vinyl sashes. The south elevation is pierced by five window bays filled with one-over-one vinyl sashes, three on the first floor and two on the second story. The east elevation was not visible from the ROW. Based on a review of aerial photographs, the garage was likely built between 1958 and 1980.

Figure 117. SP 4: North and west elevations of garage and carport (Resources D and E), looking southeast.

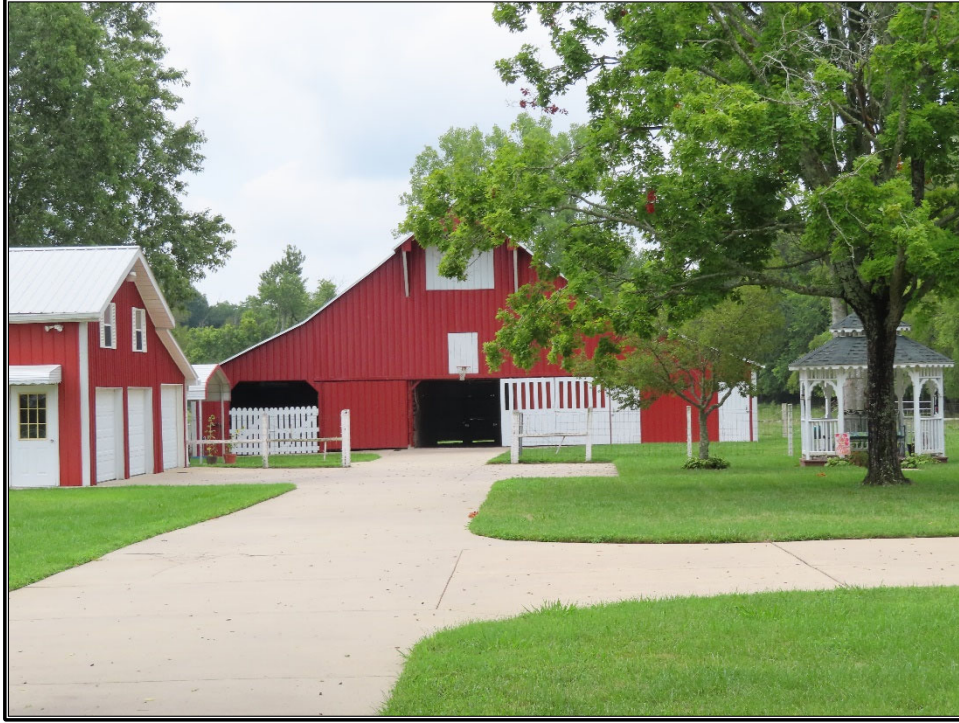
Located approximately 145 ft south of the residence is a two-story barn (Resource G) (Figure 119). The barn is set on a concrete slab, is clad in modern metal panels, and rests beneath a front-gable roof sheathed in modern metal panels. A hay hood extends from the front gable, and shed-roof lean-to additions span the side elevations. The central and eastern bays of the north elevation feature wide openings with sliding doors, while the western portion of the north elevation is pierced by two single-leaf entries. The barn appears on a 1951 topographic map; the previous 1936 topographic map does not depict the locations of barns. Based on available evidence, the barn was likely built between 1945 and 1951.

Figure 119. SP 4: North elevation of barn (Resource G), looking south.

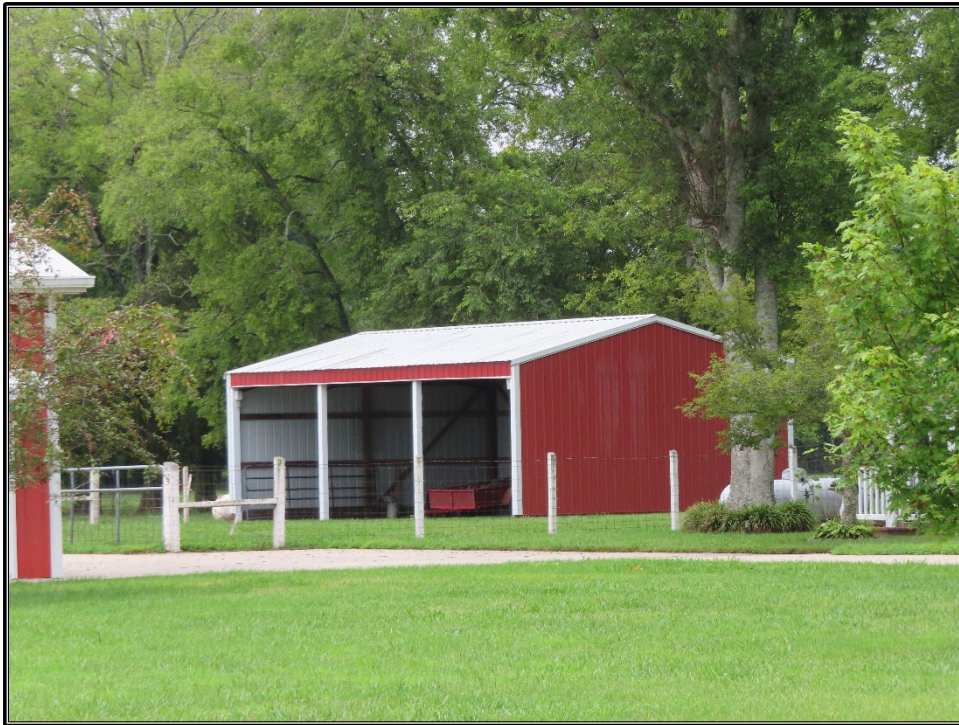
Located approximately 140 ft south of the residence is an equipment shed (Resource H) (Figure 120). The shed rests on an unknown foundation, is clad in modern metal panels, and rests beneath a side-gable roof sheathed in modern metal panels. The north, south, and west elevations exhibit no fenestration. The east elevation displays three open bays. Based on a review of recent aerial photographs, the equipment shed was constructed between 1987 and 1992.

Figure 120. SP 4: East and north elevations of equipment shed (Resource H), looking southwest.

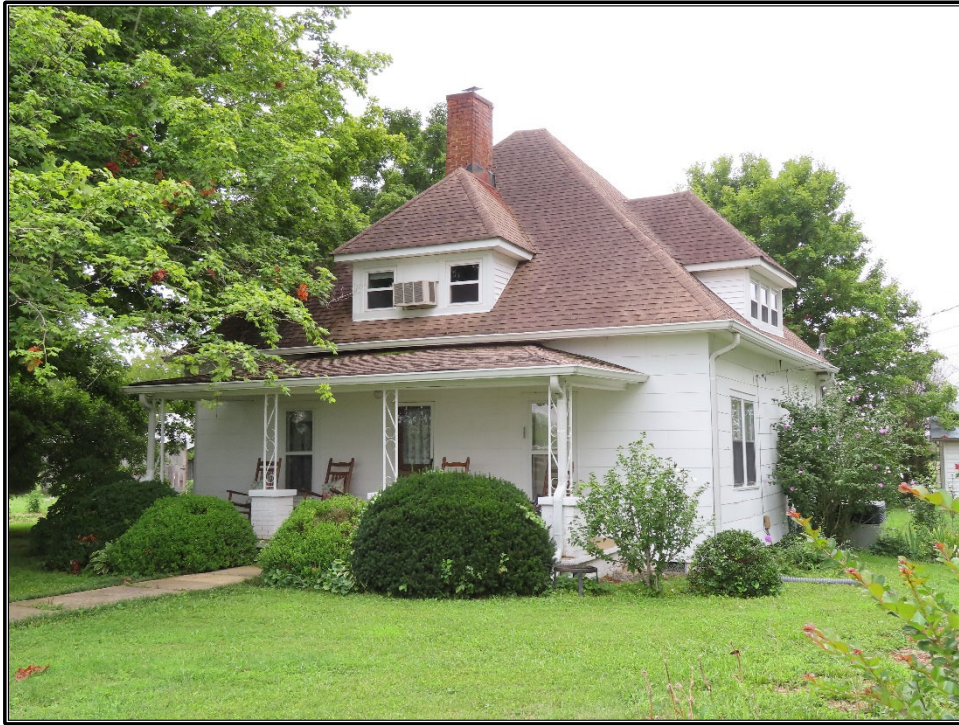
Oriented north, the one-and-one-half-story, three-bay (w/d/w) residence rests on a foundation of brick piers infilled with concrete blocks, is clad in asbestos siding, and is sheltered beneath a pyramidal roof sheathed in asphalt shingles (Figure 121). Attached to the rear (south) elevation is a one-story, gable-roof addition that extends beyond the plane of the east elevation. The roof is pierced by a single interior brick chimney on the front slope. The roof slopes of the north, east, and west elevations feature central hip-roof dormers, each pierced by a triple window bay with one-over-one, double-hung vinyl sashes. Unless noted otherwise, observable windows exhibit one-over-one, double-hung vinyl sashes. According to the Tennessee Property Viewer, the residence was constructed in 1910. Based on a review of aerial photographs, the rear addition was constructed sometime between 1958 and 1980.

The façade features a central single-leaf entry filled with an original three-light wood door. The entry opens onto a partial-width porch sheltered by a hip roof, supported by mid-century metal posts atop brick piers, set on a concrete deck. The entry is flanked by single window bays.

Figure 121. SP 5: Façade (north) and west elevations of residence, looking southeast.

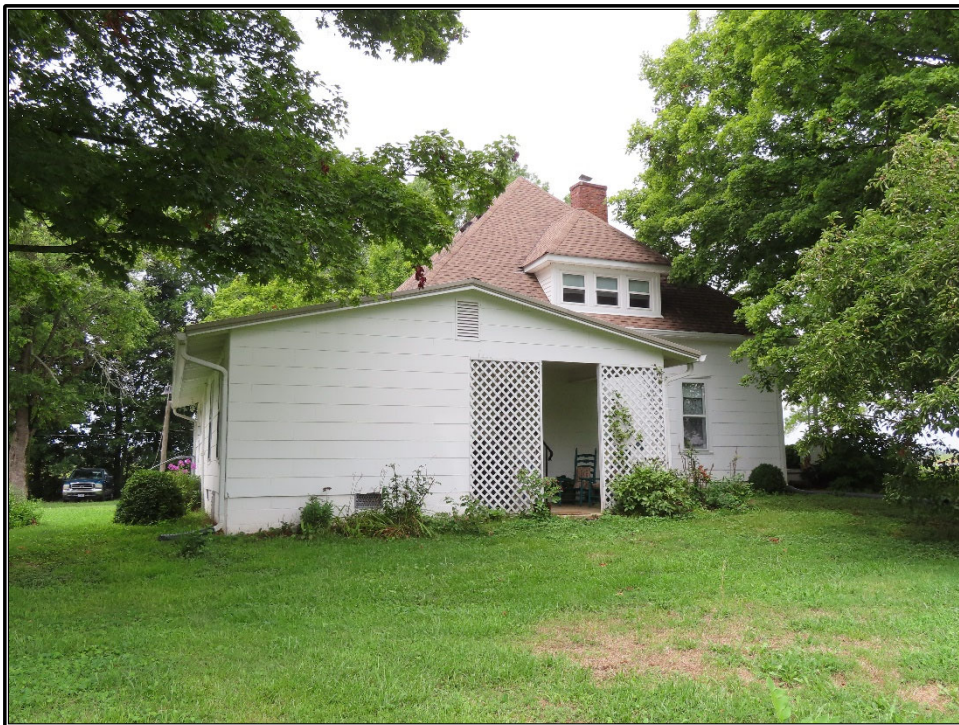
The east elevation is pierced by a single-leaf entry that opens onto a small porch sheltered by the roof of the rear addition, and a single window bay (Figure 122). A second entry opens onto the porch from the north elevation of the addition's ell.

Figure 122. SP 5: East elevation of residence, looking west.

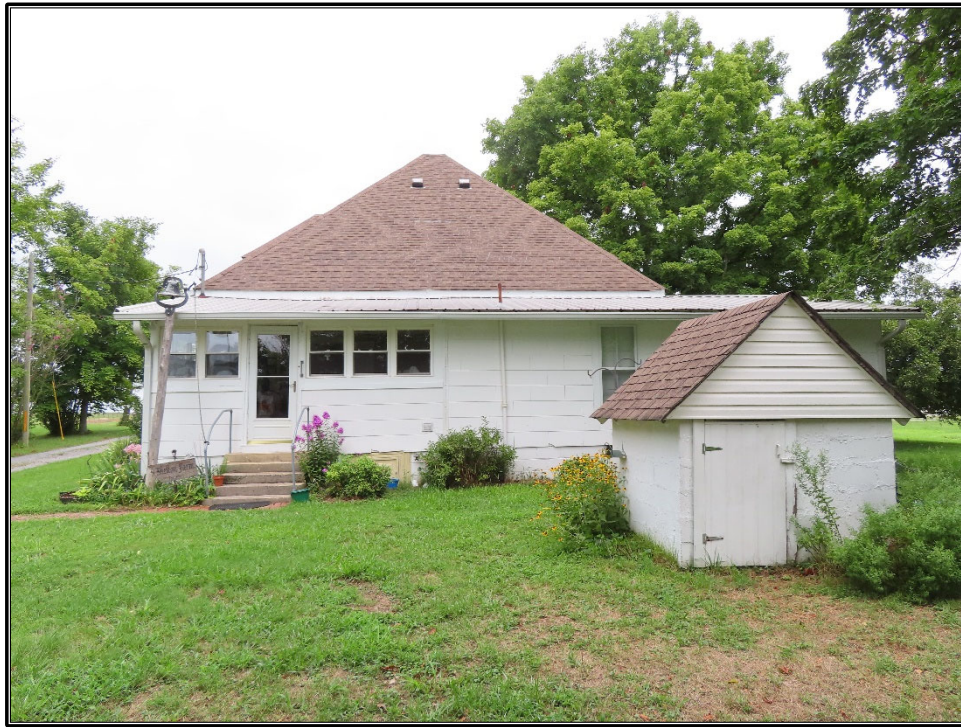
The south (rear) elevation of the addition is pierced by a single-leaf entry flanked by double and triple window bays filled with double-hung vinyl sashes (Figure 123). The west elevation of the residence is pierced by a double window bay and a triple window bay in the main block and a triple window bay in the addition (Figure 124).

Figure 123. SP 5: South elevation of residence, looking north.

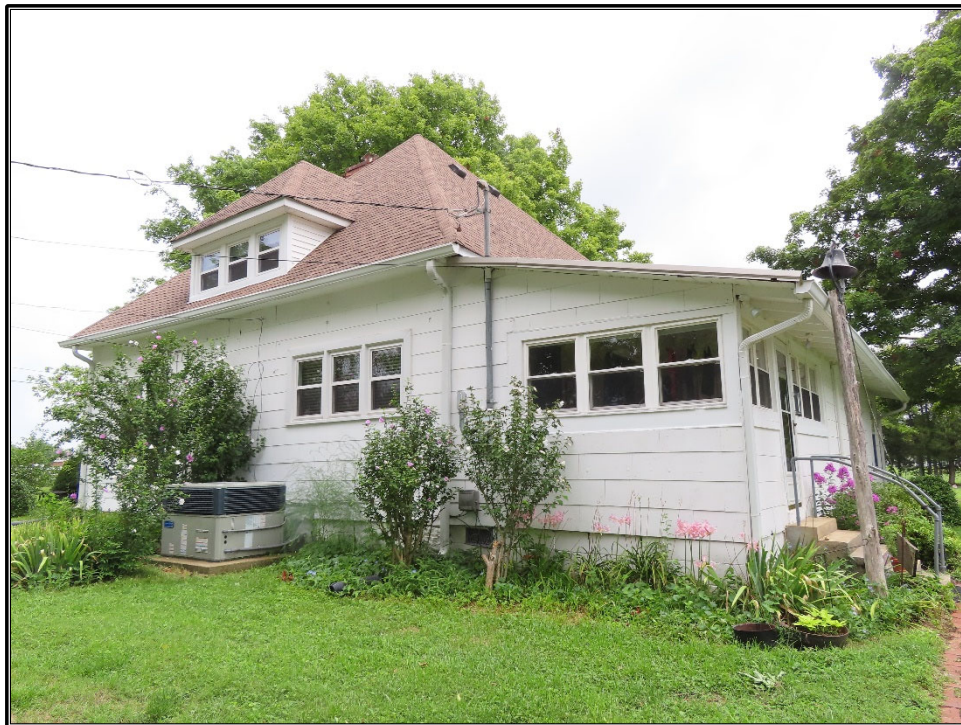
Figure 124. SP 5: West and south elevations of residence, looking northeast.

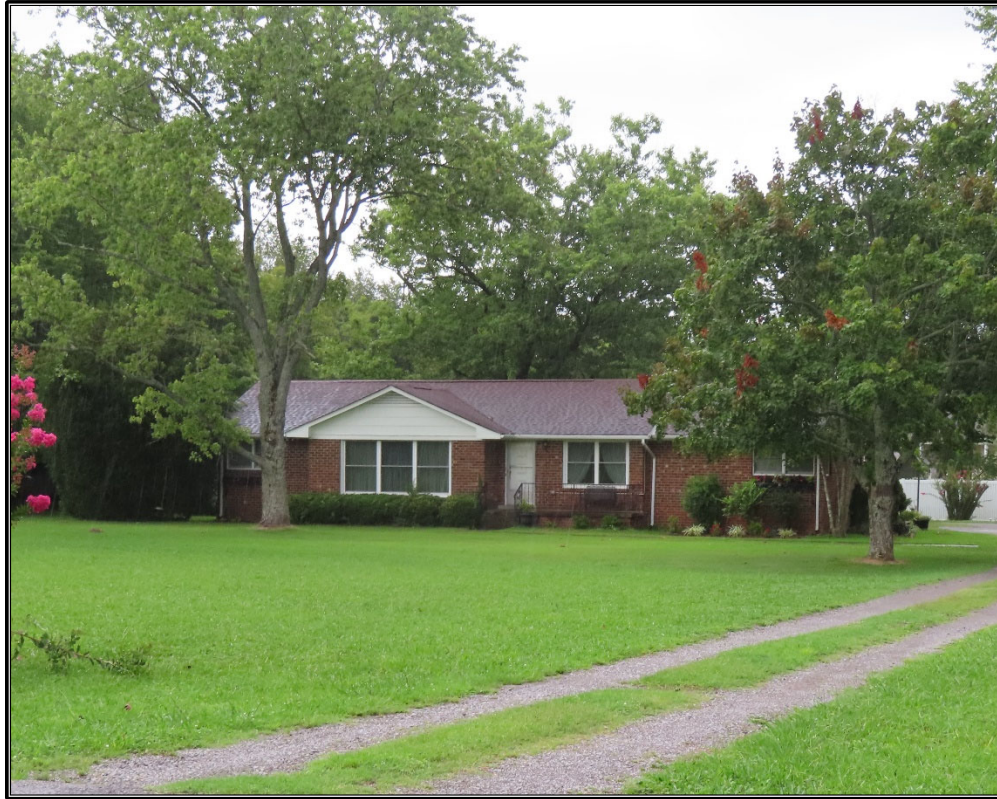
Description: SP 6 consists of a residence dating to the 1970s and multiple outbuildings. Oriented west, the residence is a one story, five-bay (ww/www/d/ww/ww) Linear Ranch house, set on a concrete-slab foundation, clad in brick veneer, and resting beneath a side-gable roof sheathed in asphalt shingles (Figure 131). A one-bay, front-gable projection intersects with the side-gable roof. Unless otherwise noted, windows exhibit one-over-one, double-hung vinyl sashes. The Tennessee Property Viewer lists a construction date for the residence of 1971.

Figure 131. SP 6: Façade (west) and south elevations of residence, looking northeast.

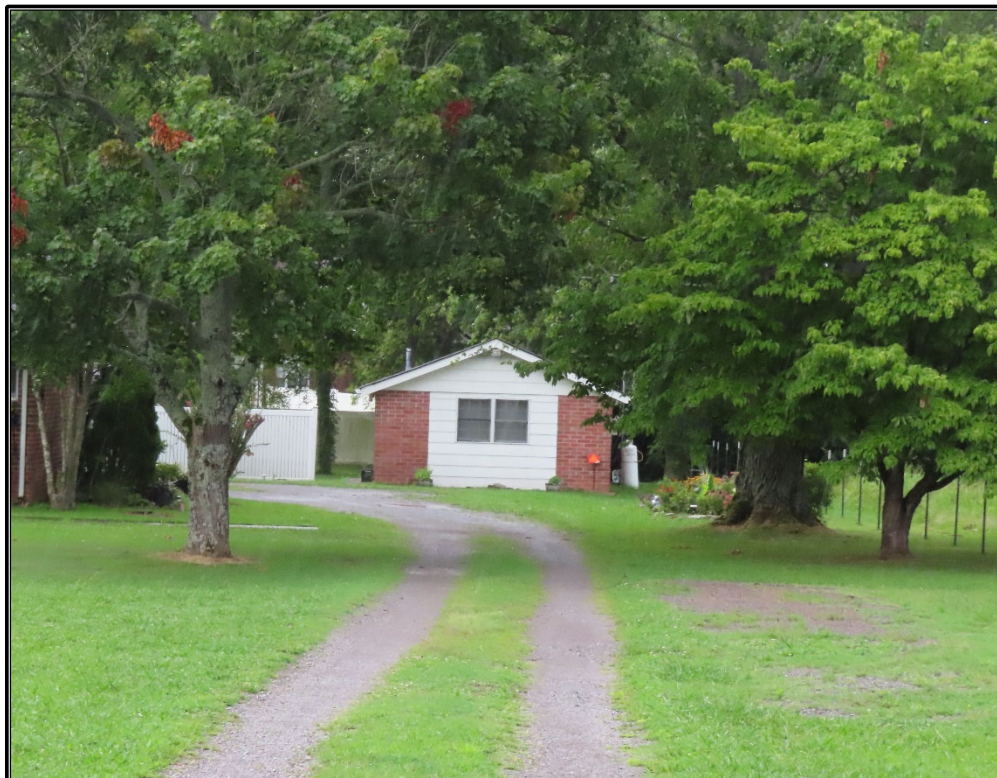
Located approximately 45 ft southeast of the residence is a side-gable garage (Resource A), clad in asbestos siding and brick veneer, and sheltered beneath a roof sheathed in asphalt shingles (Figure 132). The west and south elevations are pierced by windows filled with one-over-one, double-hung vinyl sashes. The east and north elevations were not visible from the ROW. Based on a review of aerial photographs, the garage was constructed between 1987 and 1992.

Figure 132. SP 6: West elevation of garage (Resource A), looking east.

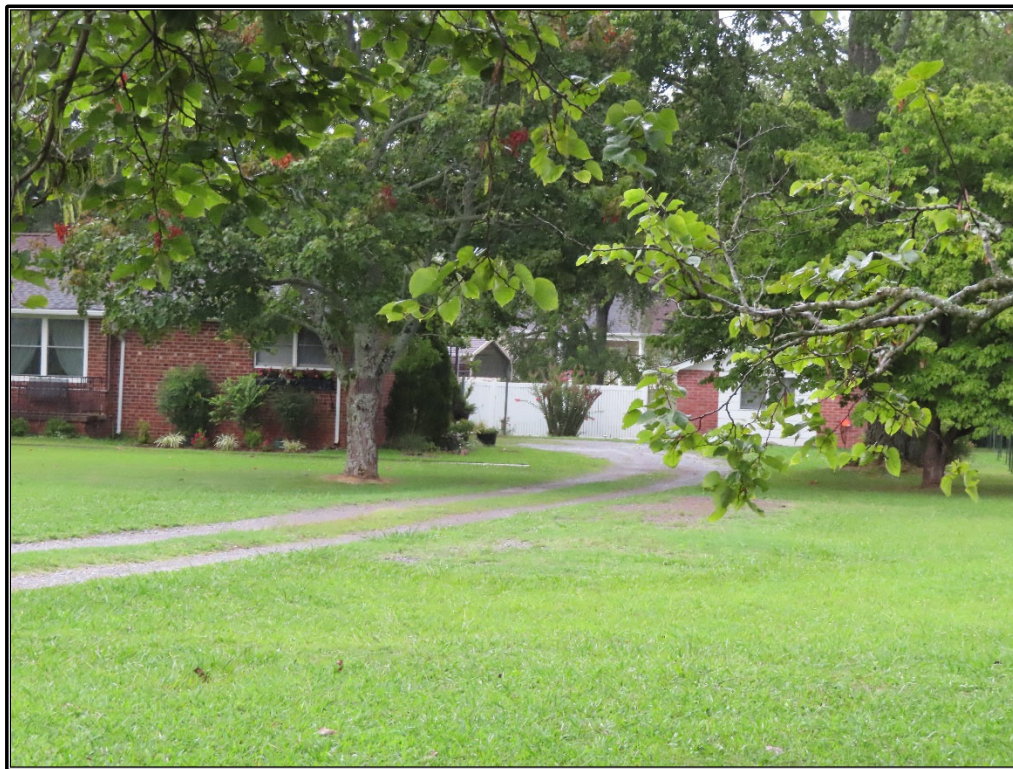
Located approximately 30 ft east of the residence is a metal frame carport (Resource B), sheltered beneath a metal-panel roof (Figure 133). Views of the carport from the ROW were largely blocked by the house. Based on a review of recent aerial photographs, the garage was constructed between 2006 and 2007.

Figure 133. SP 6: West and south elevations of carport (Resource B) (at center of frame), looking east.

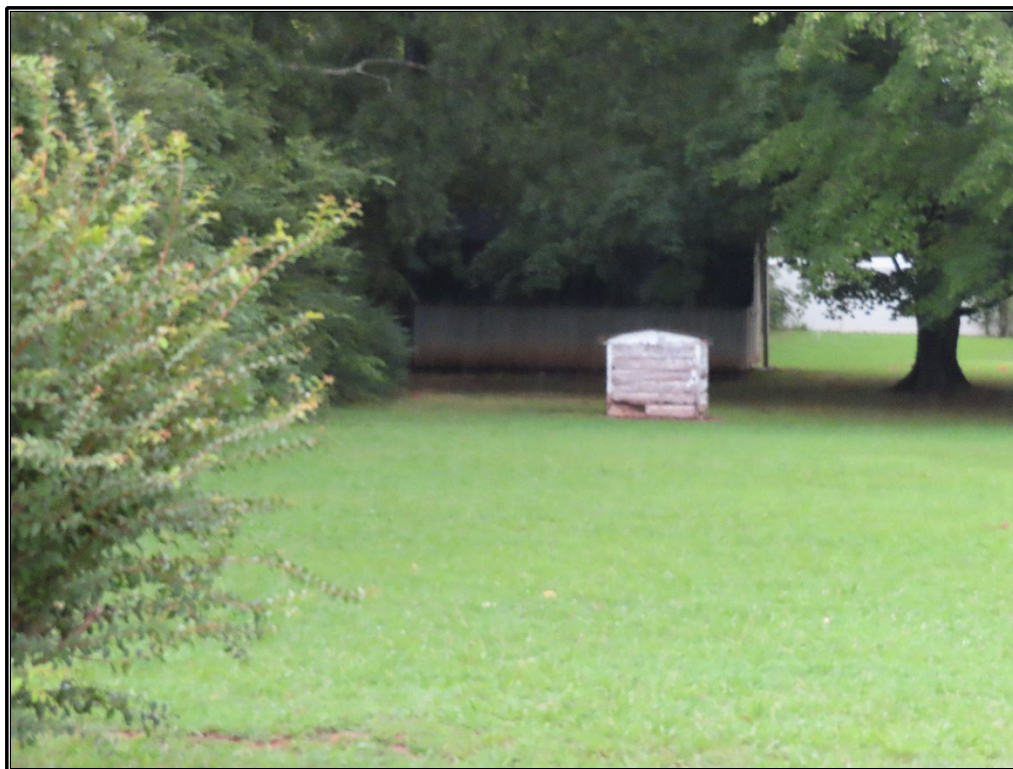
Located approximately 90 ft north of the residence is a well house (Resource C) (Figure 134). The well house is constructed of concrete block and rests beneath an asphalt-shingle roof. The north, south, and east elevations of the well house were not visible from the ROW. Based on a review of aerial photographs, the well house was constructed between 1981 and 1987.

Figure 134. SP 6: West elevation of well house (Resource C), looking east.

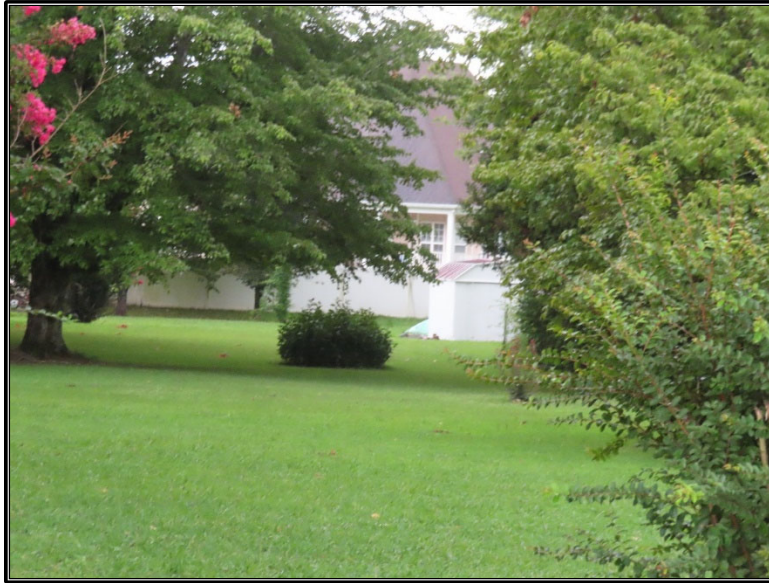
Located approximately 125 ft northeast of the residence is a prefabricated shed (Resource D), clad in metal panels and sheltered by a gambrel roof sheathed in metal panels (Figure 135). The west and north elevations exhibit no fenestration. The east and south elevations were not visible from the ROW. Based on a review of recent aerial photographs, the shed was constructed or moved to the site between 2010 and 2012.

Figure 135. SP 6: North and west elevations of shed (Resource D), looking southeast.

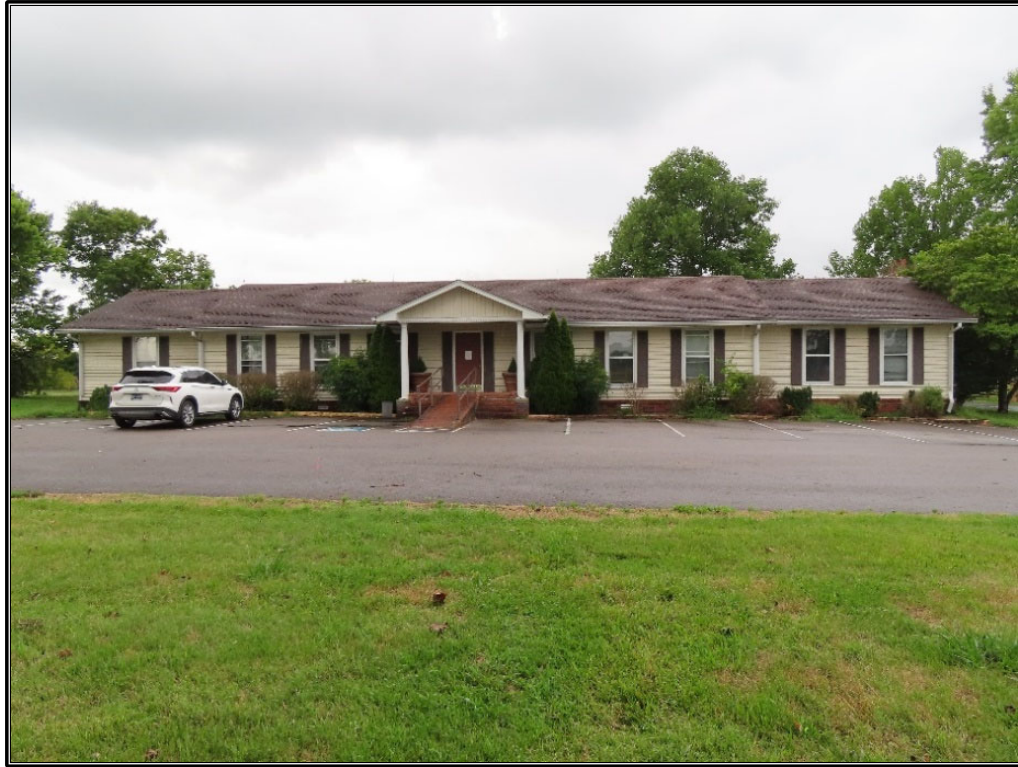
Oriented west, the residence is a one-story, 10-bay (w/w/w/w/d/w/w/w/w/w), side-gable, frame Linear Ranch house with side-gable wings (Figure 136). Projecting from the east elevation is a shallow cross-gable wing. A single exterior brick chimney pierces the roof on the east elevation. The building is set on a continuous concrete foundation, is clad in vinyl siding above a brick veneer water table, and is sheltered beneath a roof sheathed in asphalt shingles. Unless otherwise noted, observable windows exhibit one-over-one, double-hung vinyl sashes. A previous residence and barn resided on the property prior to construction of the current building. Based on aerial photographs, the original residence and barn were demolished sometime between 1958 and 1980. The Tennessee Property Viewer lists the construction date for the current residence as 1977.

Figure 136. SP 7: Façade (west) elevation of residence, looking east.

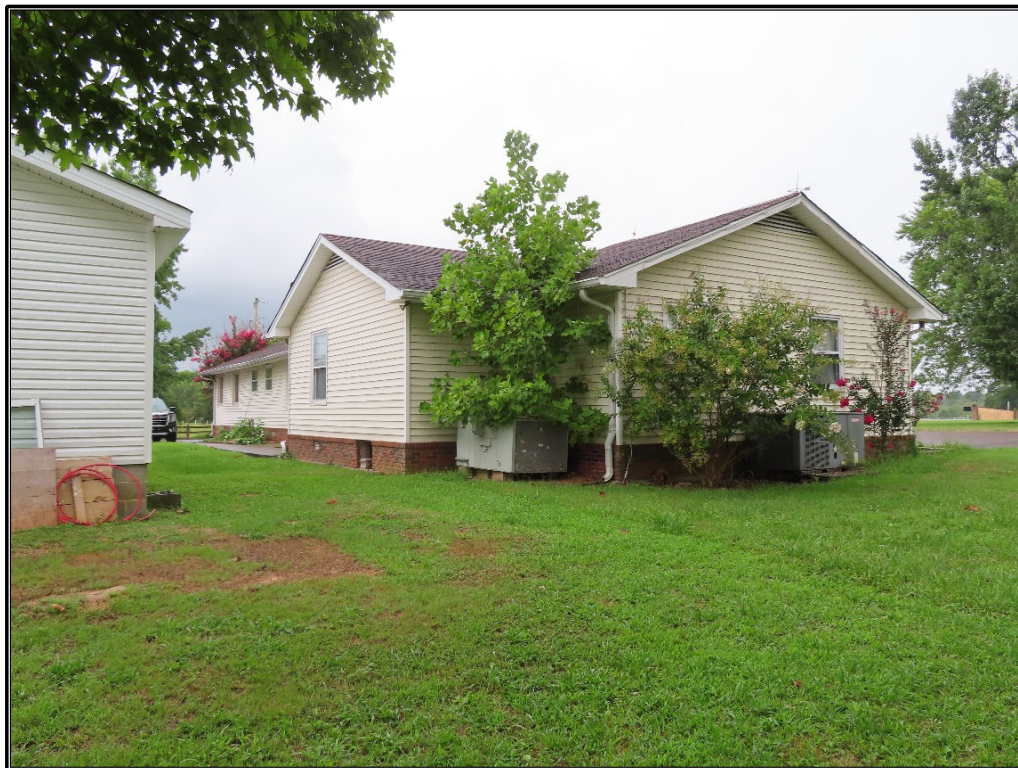
The façade of the residence is pierced by a single-leaf entry and nine single window bays. The entry opens onto a partial-width porch sheltered by a front-gable roof supported by fluted columns set on a brick deck. The north elevation is pierced by two single window bays (Figure 137). The east elevation is pierced by a single-leaf entry and six single window bays windows (Figure 138). The entry opens onto an uncovered brick porch. The south elevation is pierced by at least one window bay.

Figure 137. SP 7: East and north elevations of residence, looking southwest.

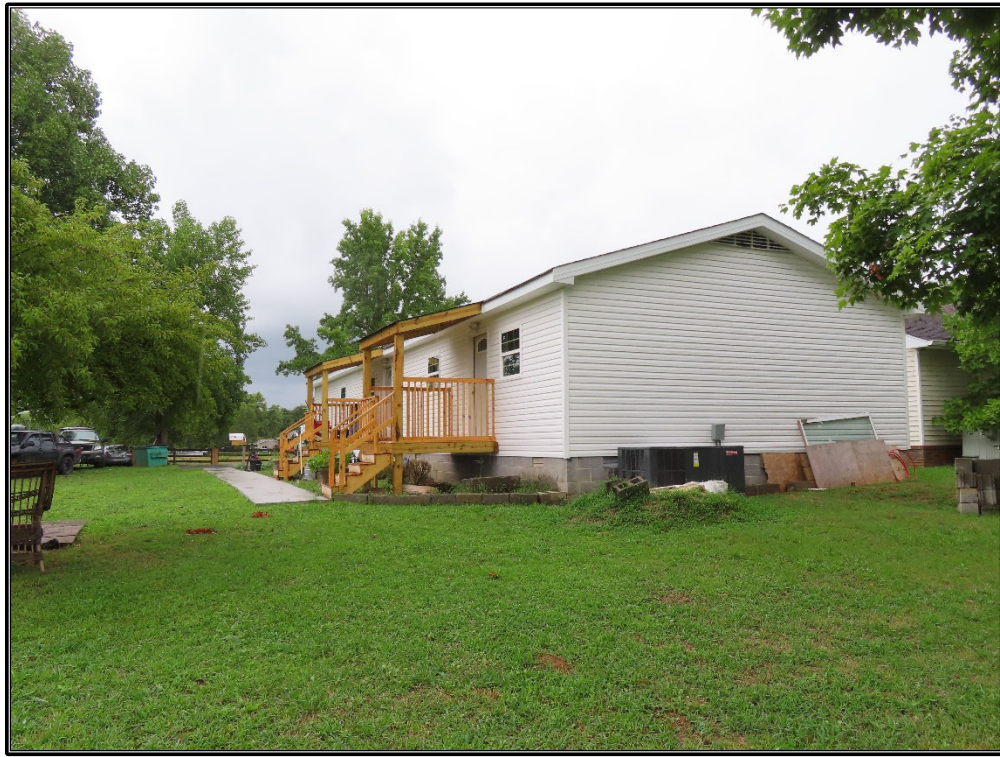
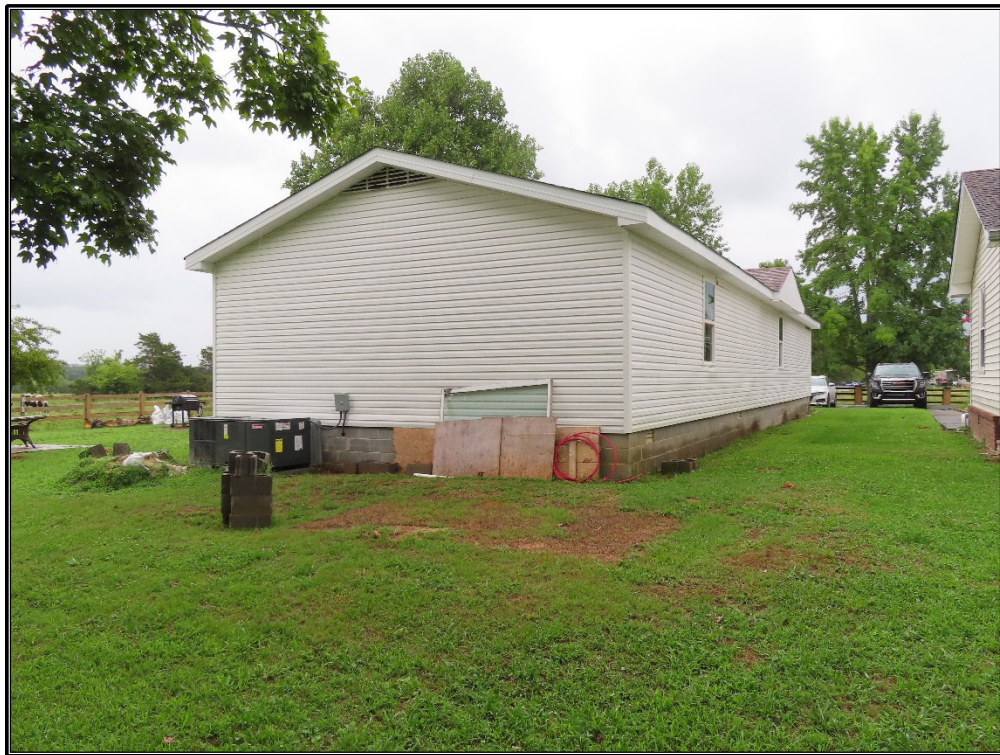
Located approximately 50 ft east of the facility is a second residence (Resource A) (Figures 139–140). The residence is a one-story, seven bay (w/w/w/d/w/d/w), side-gable, frame, multi-unit, Linear Ranch house. The residence is set on a continuous concrete-block foundation, is clad in vinyl siding, and sheltered beneath a roof sheathed in asphalt shingles. Unless otherwise noted, observable windows exhibit one-over-one, double hung vinyl sashes. The façade features two single-leaf doors flanked by single window bays. The entries open onto covered porches constructed of wood. The east elevation is pierced by two single window bays. The north and south elevations exhibit no fenestration. The Tennessee Property Viewer lists a date of 2000, but a review of recent aerial photographs suggests the residence was built sometime between 2014 and 2016.

Figure 139. SP 7: Façade (east) and north elevations of second residence (Resource A), facing southwest.

Figure 140. SP 7: North and west elevations of second residence (Resource A), facing southeast.

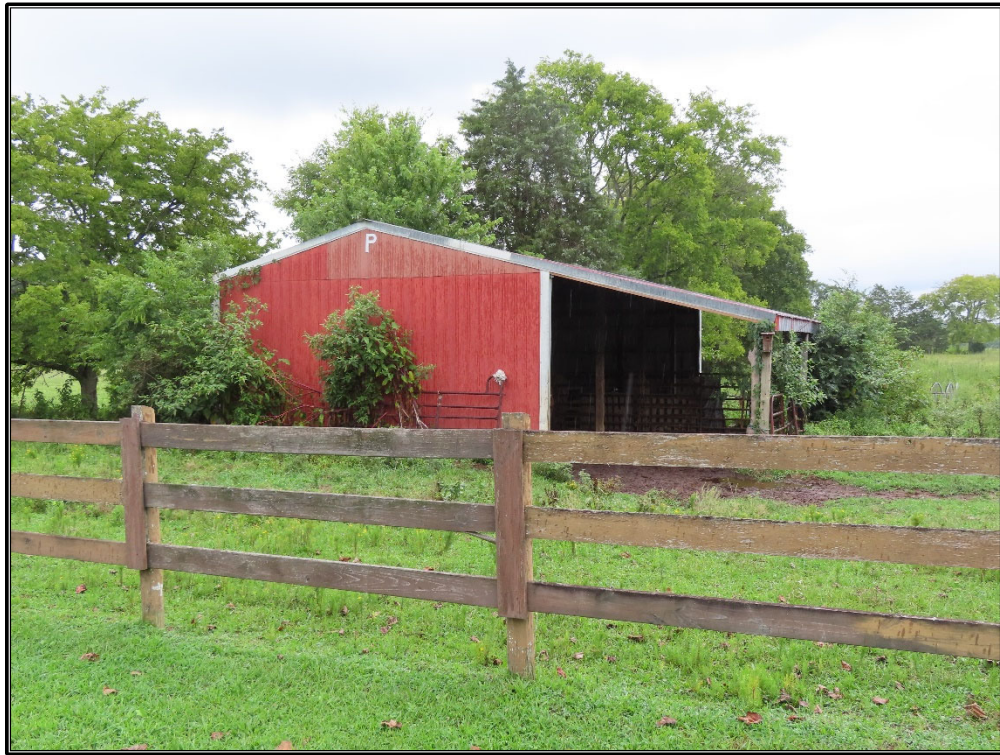
Located approximately 145 ft east of the residence is a one-story, side-gable, frame barn (Resource B) (Figure 141). The barn is clad in metal panels and sheltered beneath a metal-panel roof. The south elevation is open to a covered shelter created by an extension of the roof supported by wooden posts. The west and east elevations exhibit no fenestration. The north elevation was not visible from the ROW. Based on a review of recent aerial photographs, the barn was constructed sometime between 1981 and 1987.

Figure 141. SP 7: West and south elevations of barn (Resource B), facing northeast.
