HISTORIC ARCHITECTURAL RESOURCE SURVEY FOR THE PROPOSED DEVELOPMENT NEAR THE SHELBYVILLE MUNICIPAL AIRPORT, BEDFORD COUNTY, TENNESSEE

Cultural Resource Analysts, Inc.
119 West Summit Hill Drive
Knoxville, Tennessee 37902
CRA Project No.: T240252

September 2024

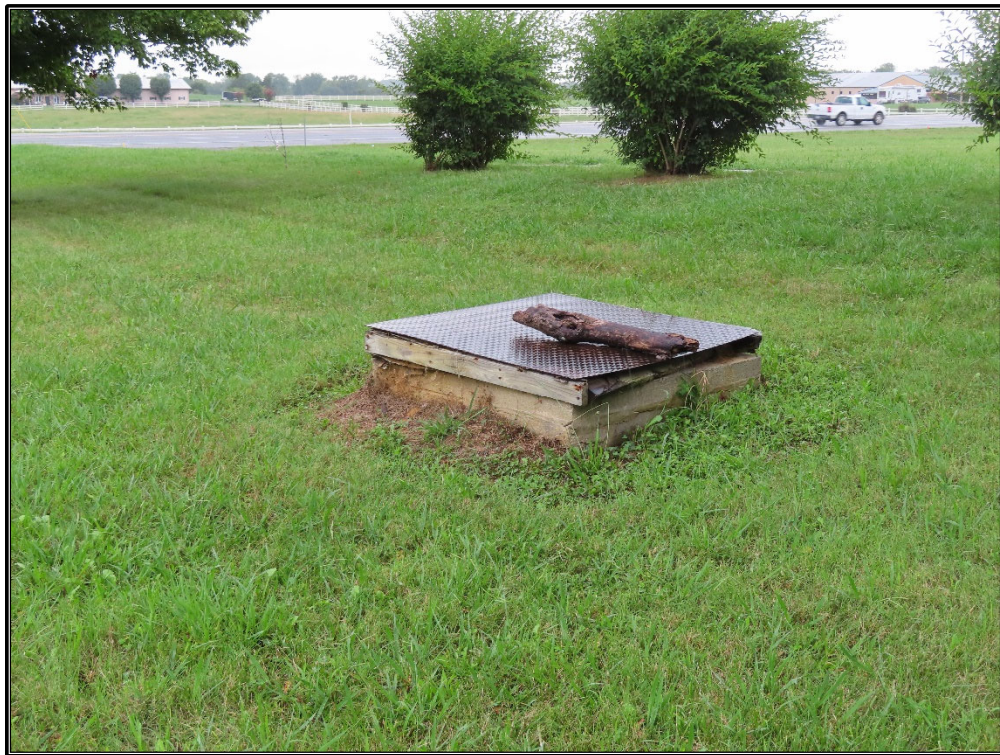
Located approximately 220 ft west of the residence is a low well structure (Resource C) (Figure 142). The well is constructed with concrete topped with a wooden board and covered by a metal panel. Based on available evidence, the well likely dates to the early to mid-twentieth century and was associated with the previous residence on the property.

Figure 142. SP 7: South and east elevations of well (Resource C), facing northwest.

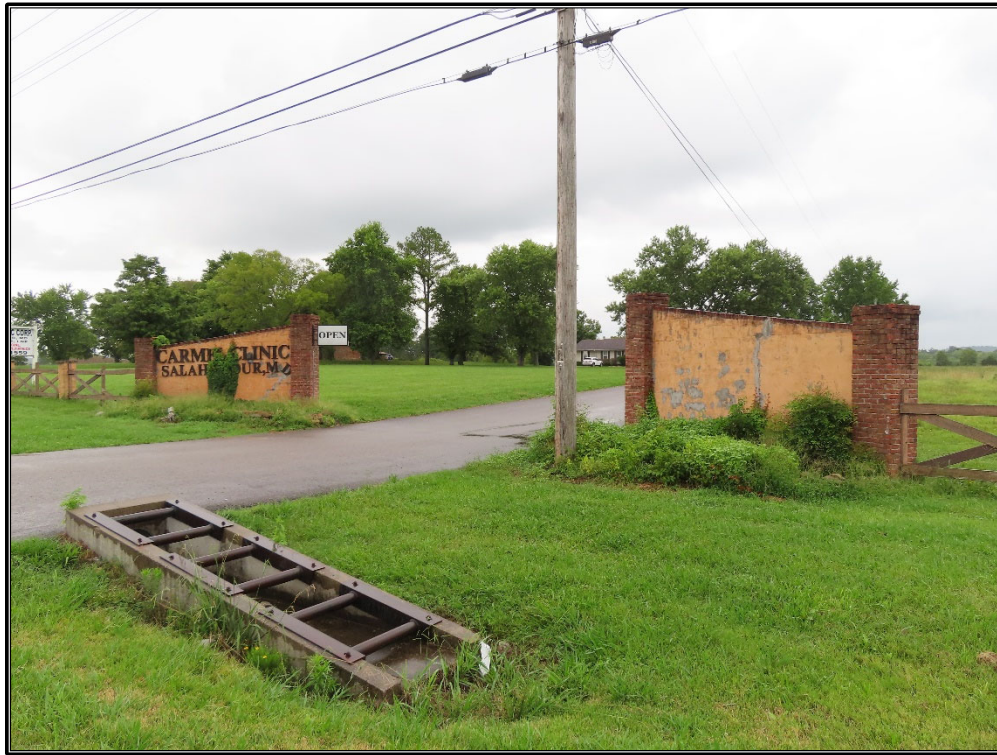
Located along the west property boundary, adjacent to the highway, and in a line south of the driveway are fences, which connect to entry walls on the west end of the drive (Resource D). The entry walls are constructed of concrete block and brick (Figure 143). The entry walls are sloped and at an angle flanking each side of the driveway. The fence is constructed of rows of concrete-block posts with concrete caps, between which is fencing of wooden boards (Figure 144). Based on a review of recent aerial photographs, the entry walls and fence were built in the early 2000s.

Figure 143. SP 7: West elevation of entry walls (Resource D), facing northeast.

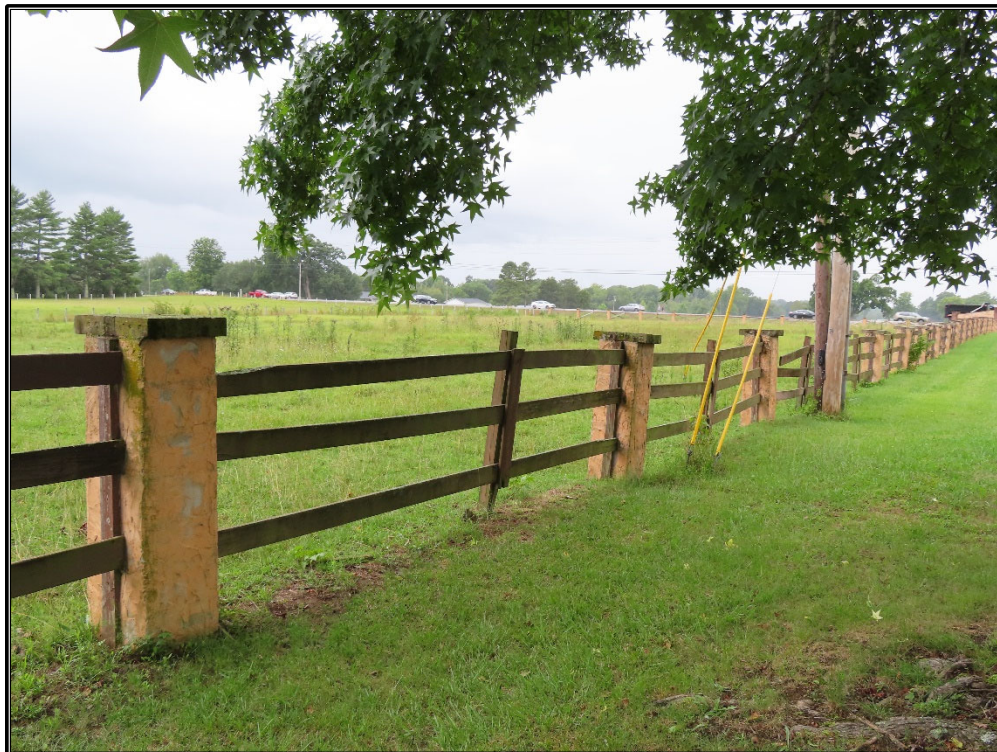
Figure 144. SP 7: North elevation of fence (Resource D) along the south side of the driveway, looking southwest.

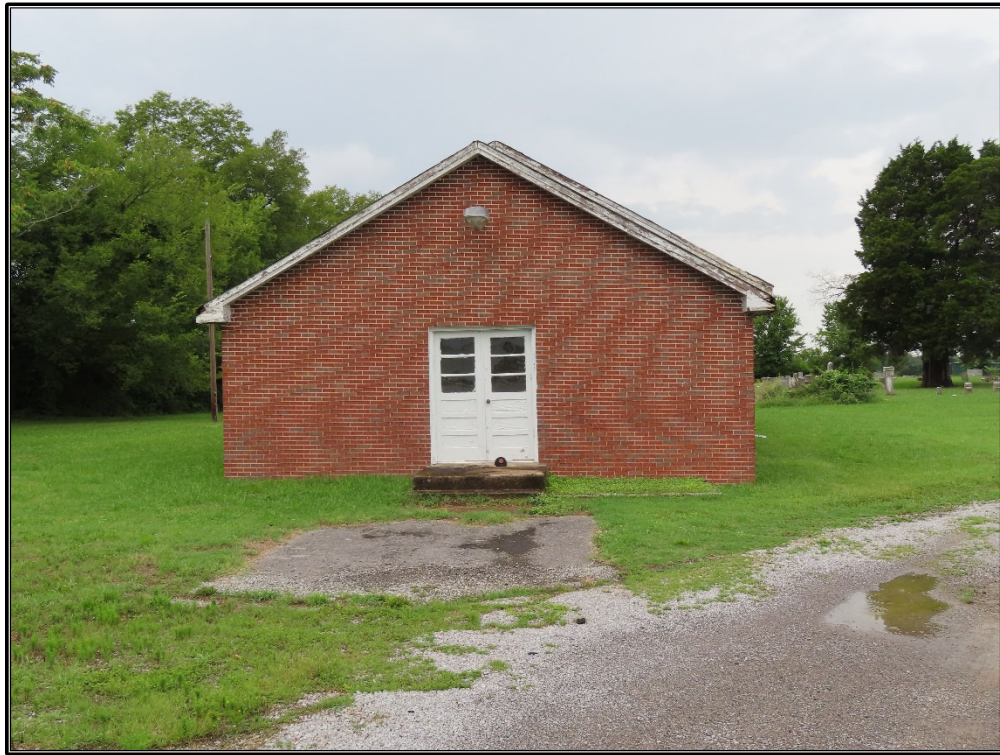
Description: SP 8 consists of a church, the Harts Chapel Cemetery, and a well house. Oriented east, the church is a one-story, one-bay, front-gable, frame building clad in brick veneer and sheltered beneath a roof sheathed in asphalt shingles (Figure 145). Originally the church was clad in weatherboard siding, which is visible along the roofline on the east elevation where the brick has fallen off (Figure 146). The foundation could not be determined. Unless otherwise noted, windows exhibit three-by-three, steel-frame casement sashes beneath two-light transoms; the window glazing consists of frosted blue glass (Figure 147). A front-gable vestibule projects from the façade that is pierced by a double-leaf entry filled with a pair of three-light, wood-panel doors. The doors open onto a concrete stoop. The north wall of the vestibule is pierced by a single window bay, and the south wall is pierced by two small windows with two-light sashes.

Figure 145. SP 8: Façade (east) elevation of church, looking west.

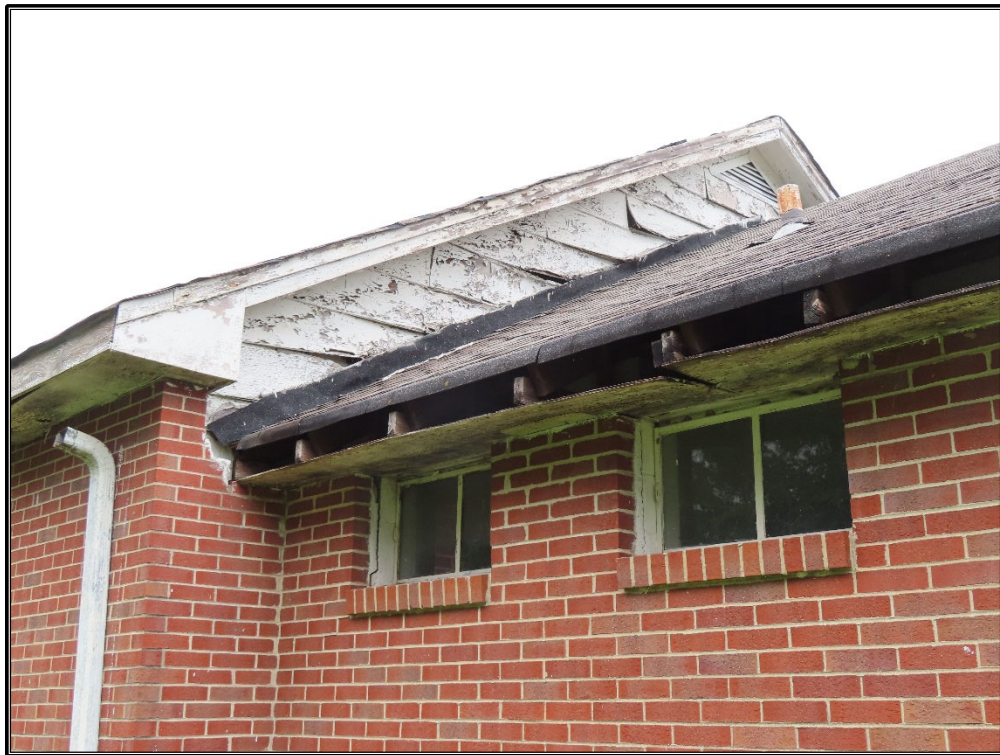
Figure 146. SP 8: Façade detail of church showing original weatherboard siding.

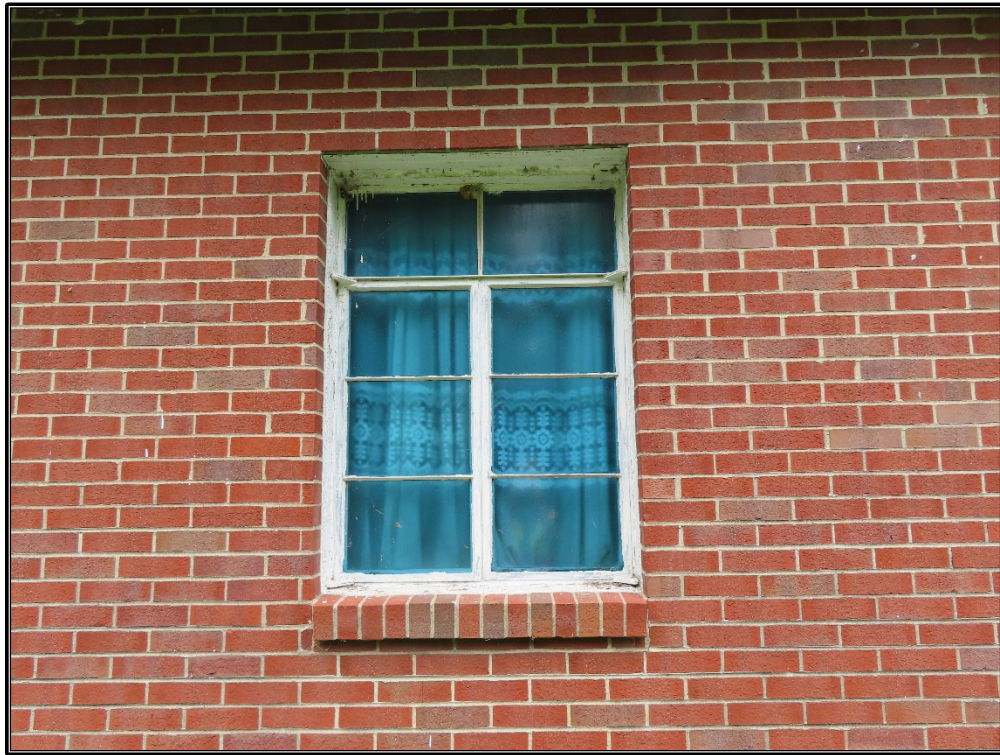
Figure 147. SP 8: Window detail of church.

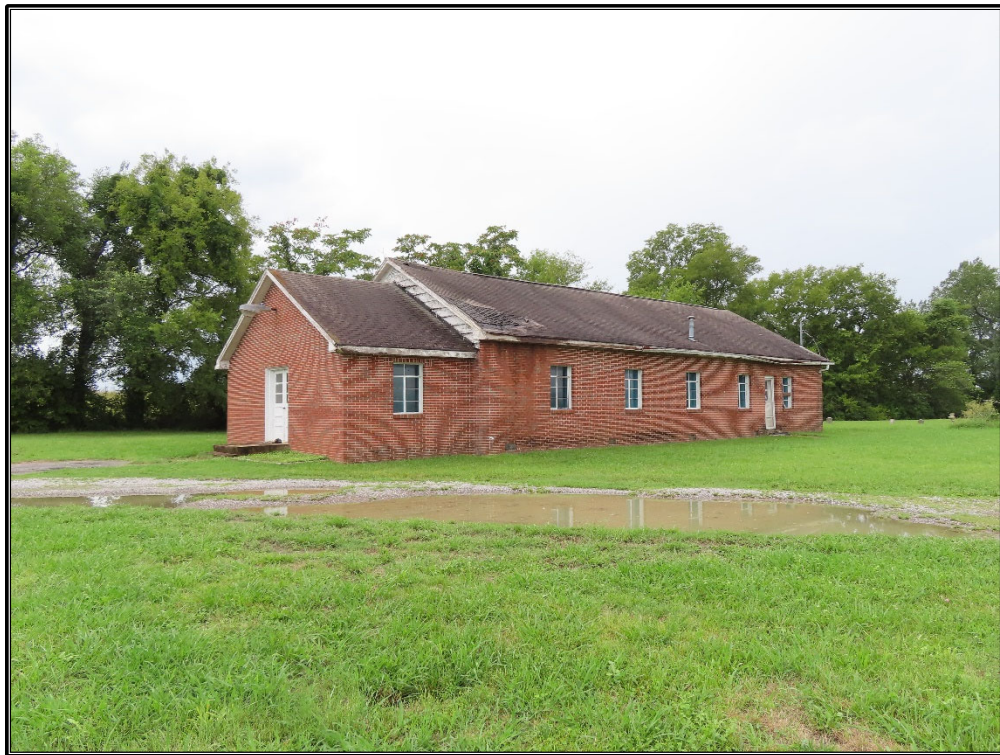
Figure 148. SP 8: Façade (east) and north elevations of church, looking southwest.

The south and north elevations of the sanctuary are each pierced by five single window bays (Figure 148). The north elevation is also pierced by a single-leaf entry filled with a four-light wood-panel door. The west (rear) elevation is pierced by three single window bays (Figure 149). An interior view of the vestibule was afforded from the front entry, which shows modern materials; a view of the interior of the sanctuary was not available (Figure 150).

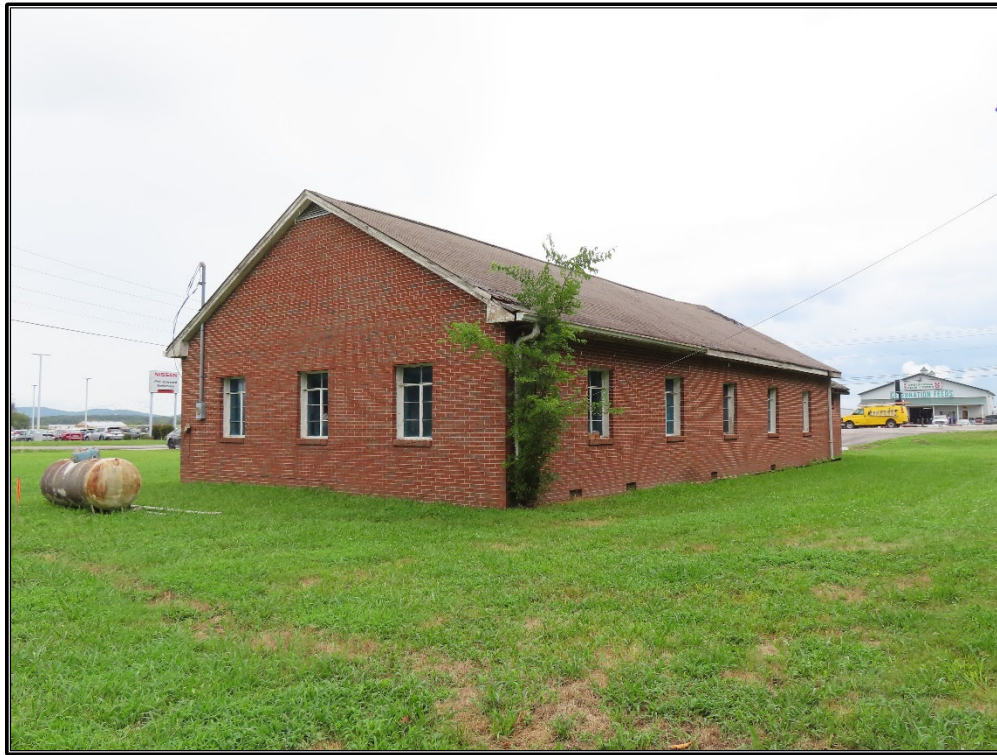
Figure 149. SP 8: West (rear) and south elevations of church, looking northeast.

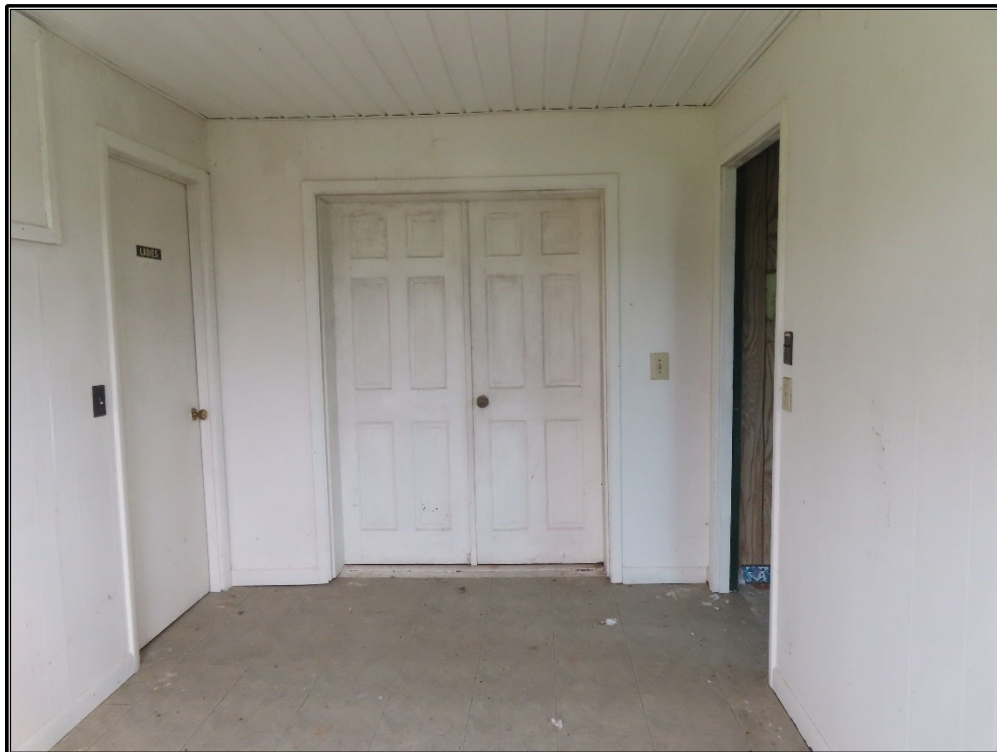
Figure 150. SP 8: Interior view of church vestibule.

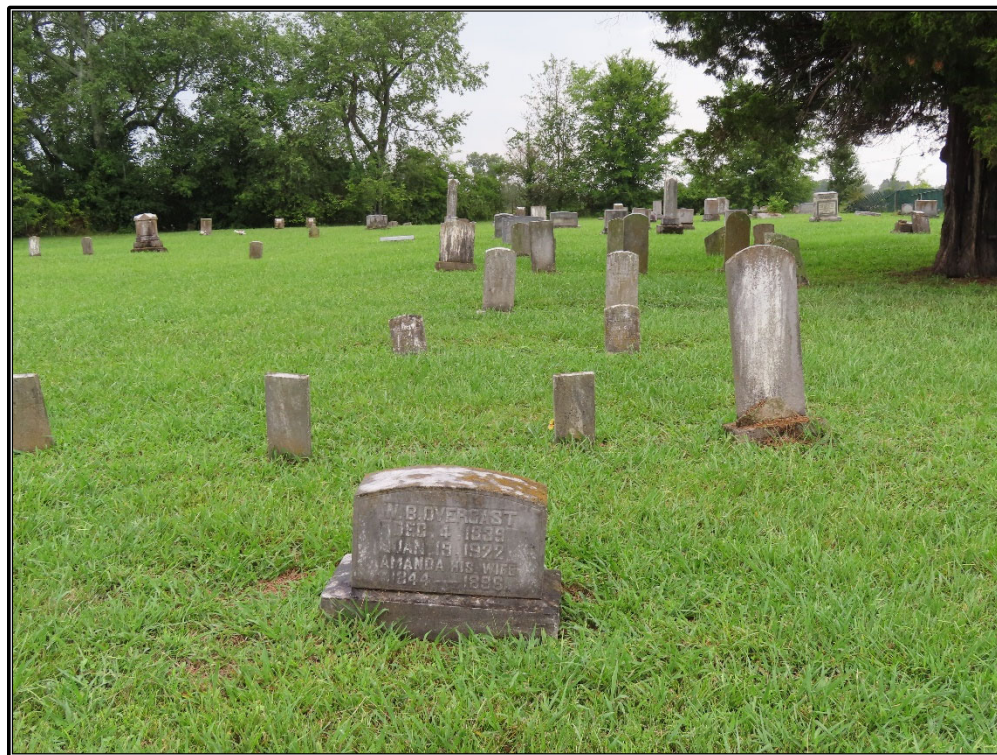
Figure 151. SP 8: Harts Chapel Cemetery, looking northwest.

West of the church is the Harts Chapel Cemetery, which is on a separate 0.39-acre parcel, although it has historically been associated with the church and with previous churches on the site (Figures 151 and 152). Find-a-Grave notes there are at least 147 known graves in the cemetery, the oldest being that of John Hart, who died in 1850 (Find-a-Grave n.d.). The most recent known gravesite dates to 1983. John Hart's grave marker could not be located during the survey, although several graves dating to the mid-nineteenth century were evident, so the cemetery was likely founded in the mid-1800s. Based on census records, the Harts and others in the community were enslavers, so there is the potential for graves of enslaved persons to be present either within or adjacent to the cemetery. There appear to be a number of graves without markers, likely due to neglect of the cemetery, and multiple grave markers are damaged. Headstone types include die, base, and cap; tablet; die in socket; die on base; pedestal; obelisk; lawn type markers; and footstones. There is at least one Civil War grave marker, for Union soldier Joseph Nicolas (Figure 153). In 1899, James and America Hart sold the northwest corner of the existing Harts Chapel Burying Ground to local community members who were trustees of the church as a burying ground specifically for white residents. It is in this portion of the cemetery where James and America are buried (Figure 154).

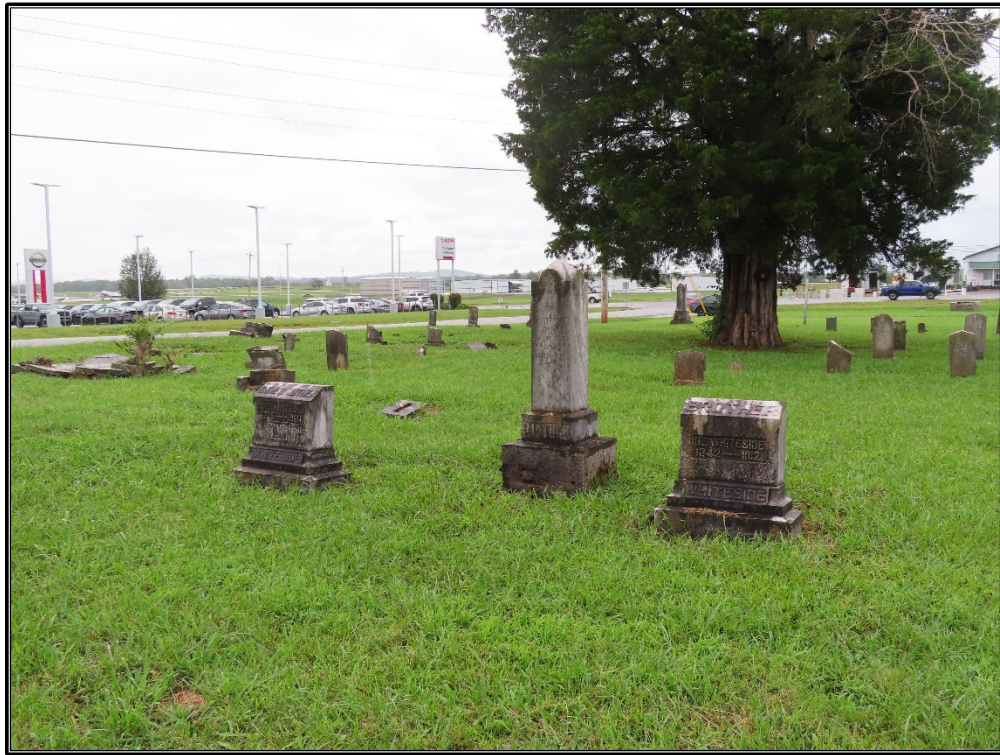
Figure 152. SP 8: Harts Chapel Cemetery, looking northeast.

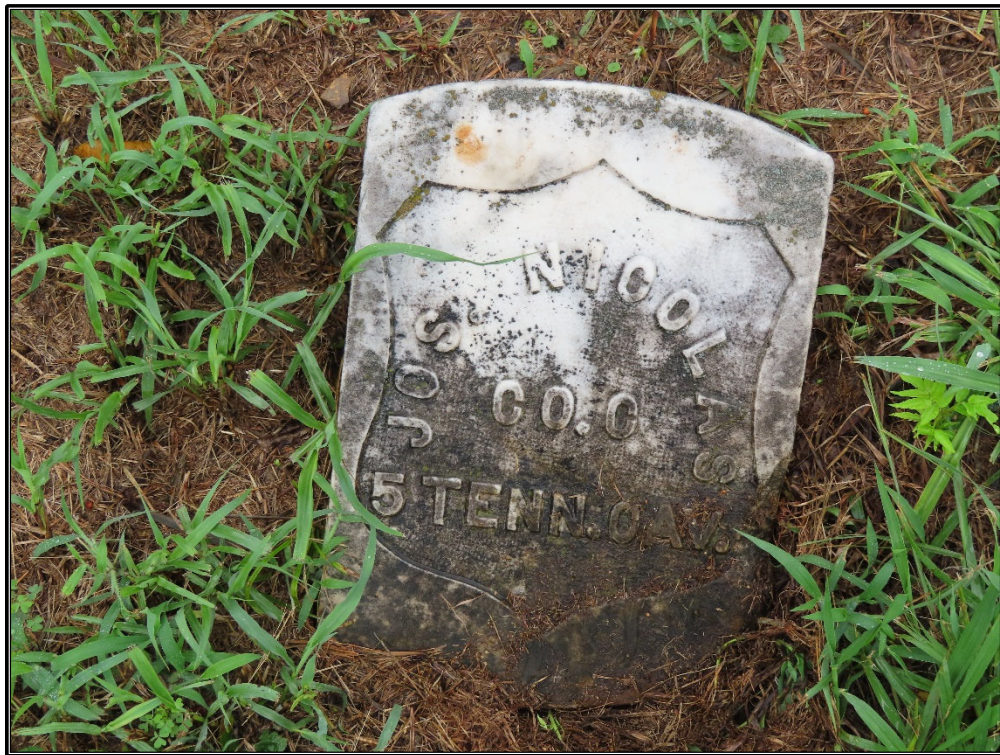
Figure 153. SP 8: Civil War grave marker in the Harts Chapel Cemetery.

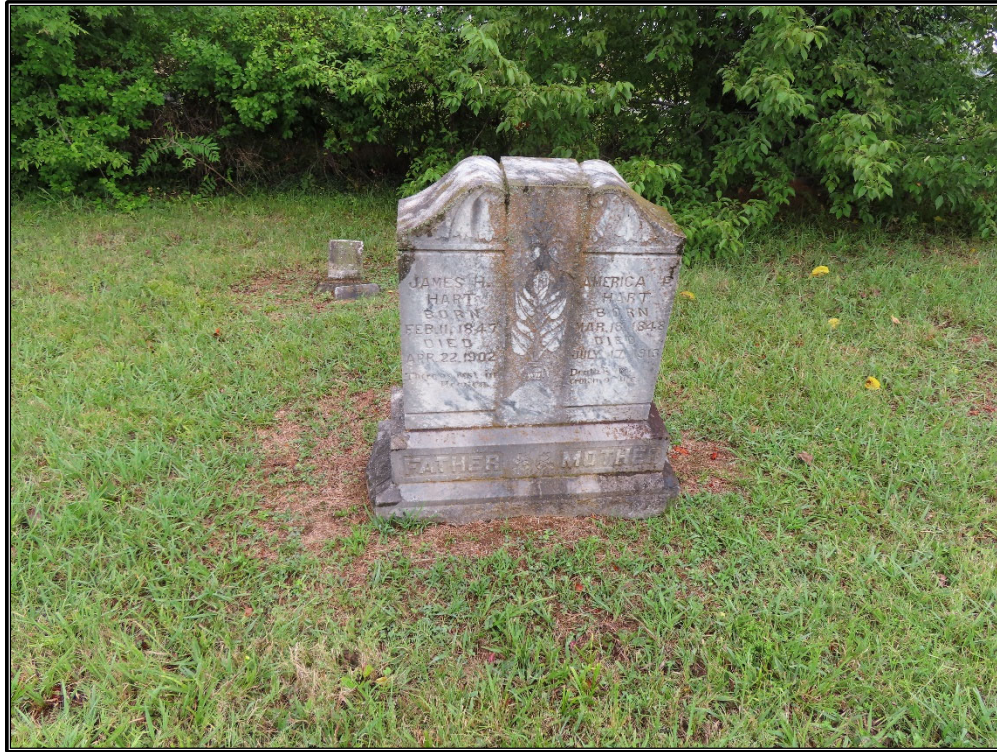
Figure 154. SP 8: Grave marker for James H. and America P. Hart. An 1878 map shows James H. Hart owning several residences in the area near the cemetery and church, including one adjacent to the chapel.

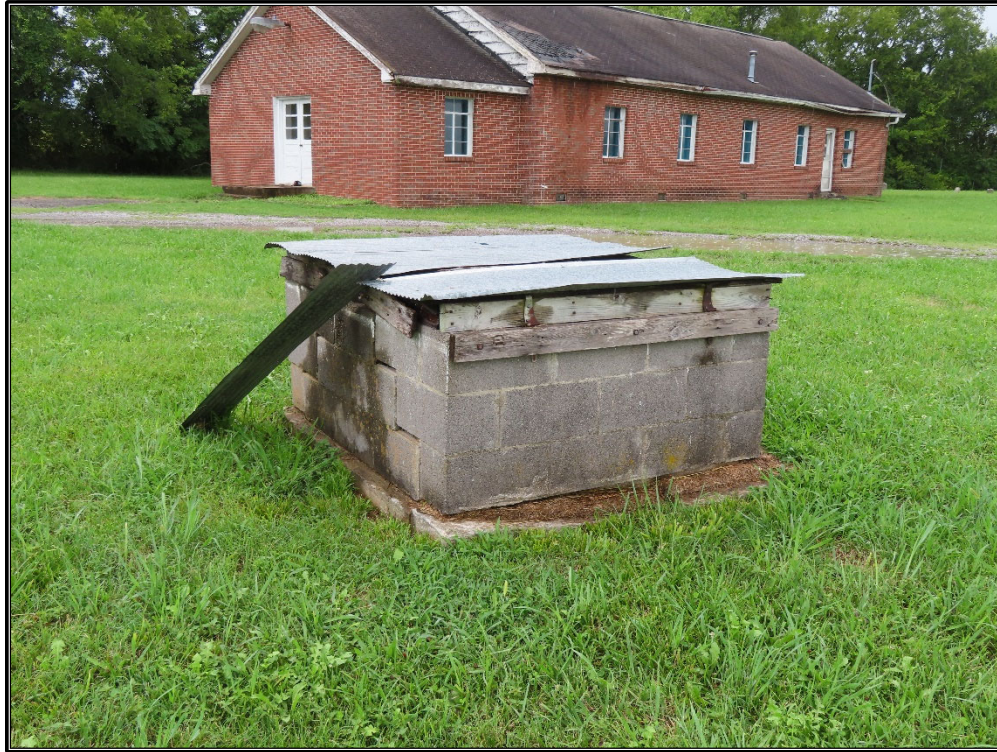
Located approximately 80 ft. east of the church is a small well house (Resource A) with concrete-block walls. The well house is set on a concrete pad and sheltered by corrugated-metal panels (Figure 155). The well house is not visible on historic aerial photographs but was likely built in the 1950s concurrent with the church.

Figure 155. SP 8: East and north elevations of well house (Resource A), looking southwest.
